LIMITED OCCURRENCE INVESTIGATION REPORT – FINAL

Reference Number	CA18/2/3/10441						
Classification	Accident	Date	15 April 2024		Time	0915Z	
Type of Operation	Private (Part 94)						
Location							
Place of Departure	Stellenbosch Aerodrome (FASH), Western Cape Province			Place of Intended Landing	Tedderfield Air Park (FATA), Gauteng Province		
Place of Occurrence	Open field near Touws River, Western Cape Province						
GPS Co-ordinates	Latitude	33°19'13.97"S	Longitude	19°51'33.62"E	Elevation	2659ft	
Aircraft Information							
Registration	ZU-MND						
Make; Model; S/N	Sling 4 TSI (Serial Number: 432s)						
Damage to Aircraft	Substantial			Total Aircraft Hours	84.6		
Pilot-in-command							
Licence Type	Private Pilot Licence (PPL) Aeroplane		Gender	Male		Age	23
Licence Valid	Yes	Total Hours	101.6		Total Hours on Type	79.5	
Total Hours 30 Days	12.5		Total Flying on Type Past 90 Days	21.7			
People On-board	1+2	Injuries	0	Fatalities	0	Other (on ground)	0

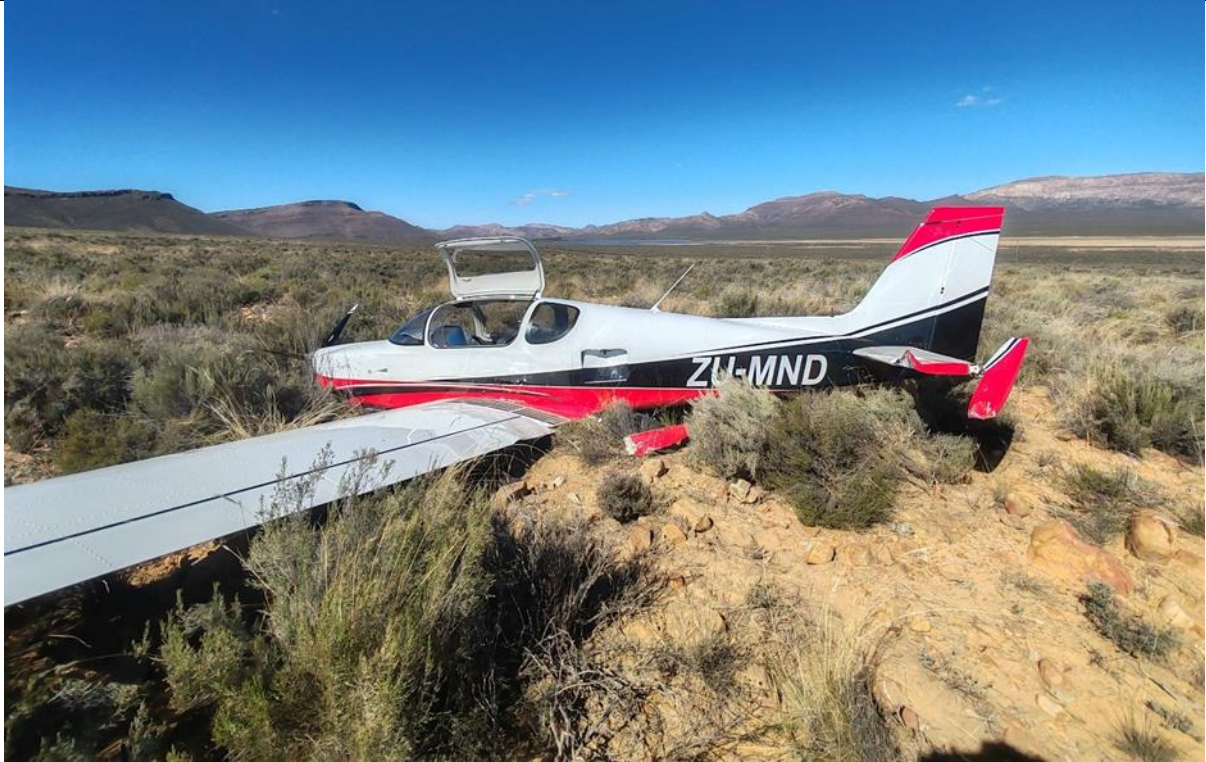
Figure 1: The aircraft skidded easterly and came to rest facing north.

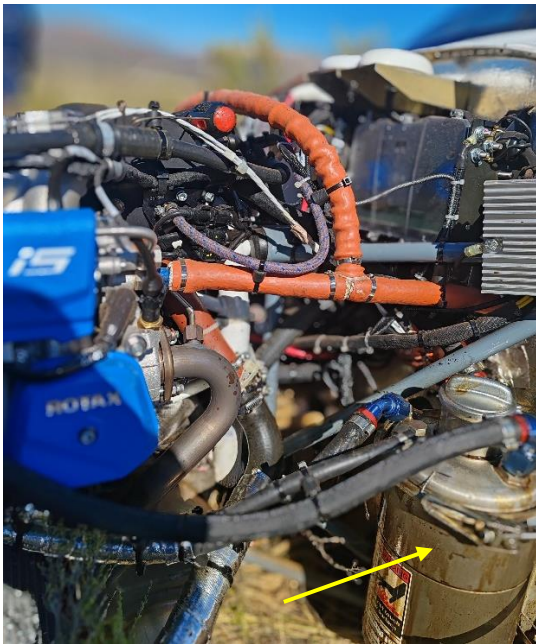
Figure 2: Traces of oil spillage mostly on the oil reservoir. **Figure 3:** The remaining oil in the reservoir was less than 100ml.

The loss of oil was caused by the piston failure whereby oil passes to the combustion area where it is partially burnt by combustion and exits through the exhaust.

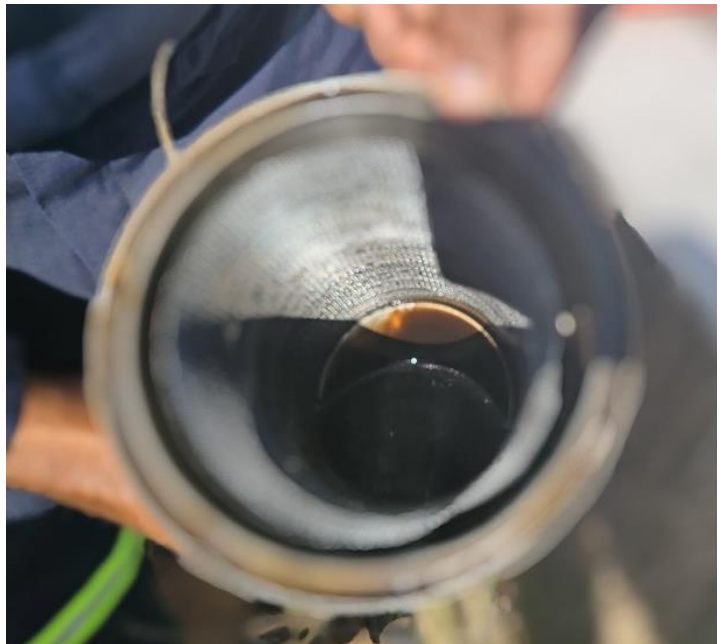
2.4 The engine lost oil pressure which resulted in a high oil temperature due to the loss of engine oil, caused by the damaged piston.

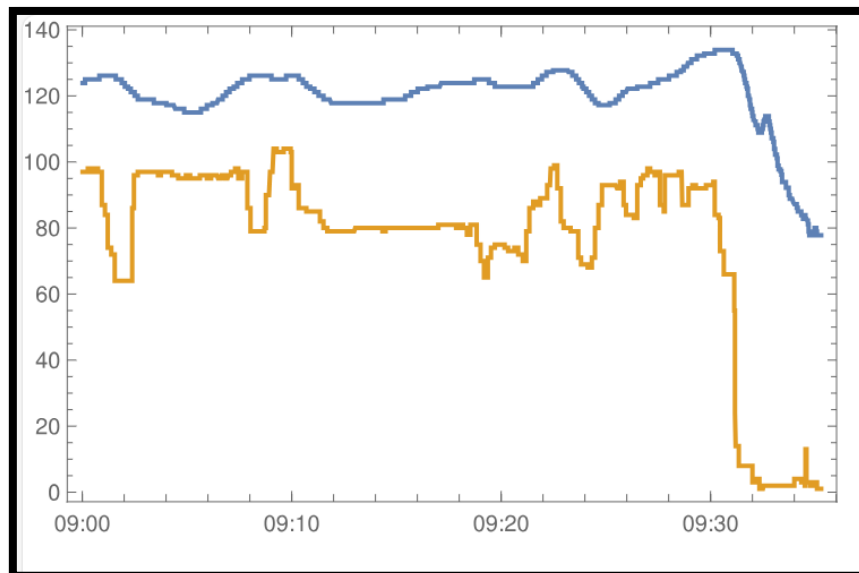
The decline in oil pressure an hour into the flight, suggests a loss of oil for reasons which are not currently known. Lower volumes of oil in the system, however, will naturally lead to higher oil temperatures. The spiking and the eventual loss of oil pressure confirms the near complete loss of oil from the engine and related components. Upon preliminary inspection, the oil pump was found normal and operational. Further inspection of the engine and its components may provide additional information. There is no evidence in the logs of an attempted restart after the engine was shut down.

Figure 7: Oil temperature vs engine power. (Source: Pilot)

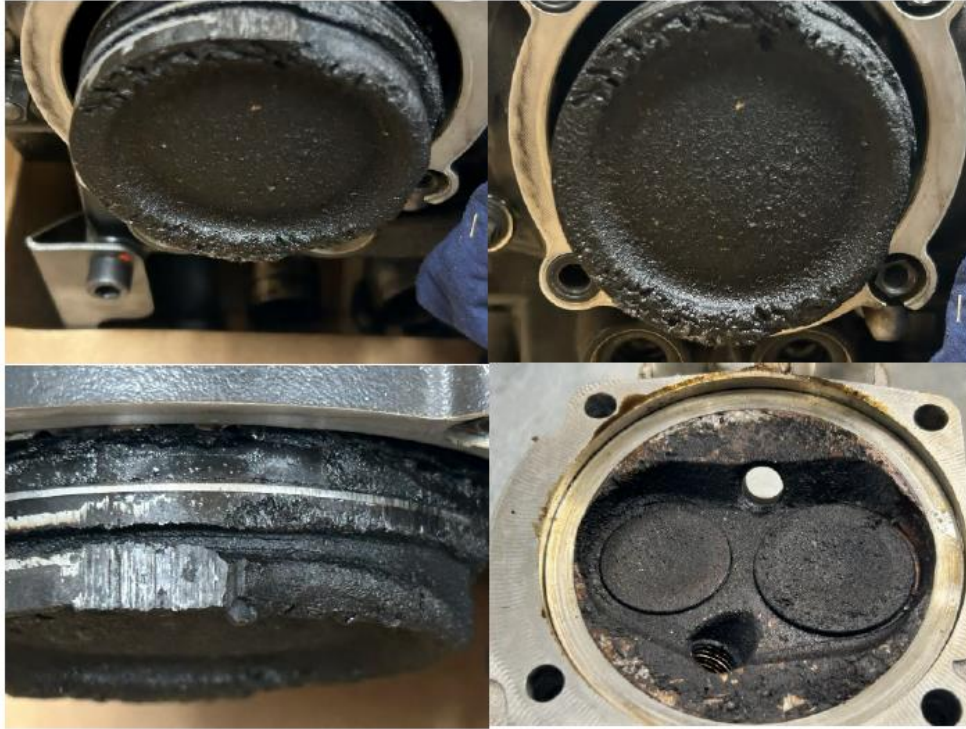
Cylinder #2 showed a catastrophic failure of the piston ring glands leading to disintegration of the piston, caused from detonation. The extreme combustion pressures and temperatures from possible multiple detonations exerts pressure on the rings leading the eventual failure as indicated in the attached pictures. The detonations could have taken place several hours before the complete failure of the engine and the nature of detonation makes it difficult to determine the exact time.

Figure 8: This report is supplementary to the report dated 19 April 2024 which relates to the same aircraft engine and accident. The engine was disassembled to inspect internal components for possible causes of the loss of oil and engine failure. (Source: Comet Aviation Supplies)
