AIRCRAFT ACCIDENT REPORT AND EXECUTIVE SUMMARY

Reference:		CA18/2/3/10442	
Aircraft Registration	ZU-EFA	Date of Accident	17 April 2024		Time of Accident	1050Z	
Type of Aircraft	Bushbaby 500		Type of Operation		Private (Part 94)		
Pilot-in-command Licence Type	Private Pilot Licence (PPL)		Age	41	Licence Valid	Yes	
Pilot-in-command Flying Experience	Total Flying Hours		142.9	Hours on Type	35.2		
Last Point of Departure	Oudtshoorn Aerodrome (FAOH), Western Cape Province						
Next Point of Intended Landing	Joubertina Private Airstrip, 20nm north-east of Plettenberg Bay Aerodrome (FAPG), Western Cape Province						
Damage to Aircraft	Substantial						
Location of the accident site with reference to easily defined geographical points (GPS readings if possible)							
Hillandale Hideaway at Global Positioning System (GPS) determined to be 33°58'55.16"S 023°26'56.44"E, at an elevation of 672 feet							
Meteorological Information	Wind velocity: 350° at 6KT; Temperature: 32°C; Dew Point: 14°C; Visibility: ≥10 km; Cloud: CAVOK; QNH: 1013 hPa

Reference Number : CA18/2/3/10442
Occurrence Category : Accident (Category 1)
Type of Operation : Private (Part 94)
Name of Operator : GJ De Villiers

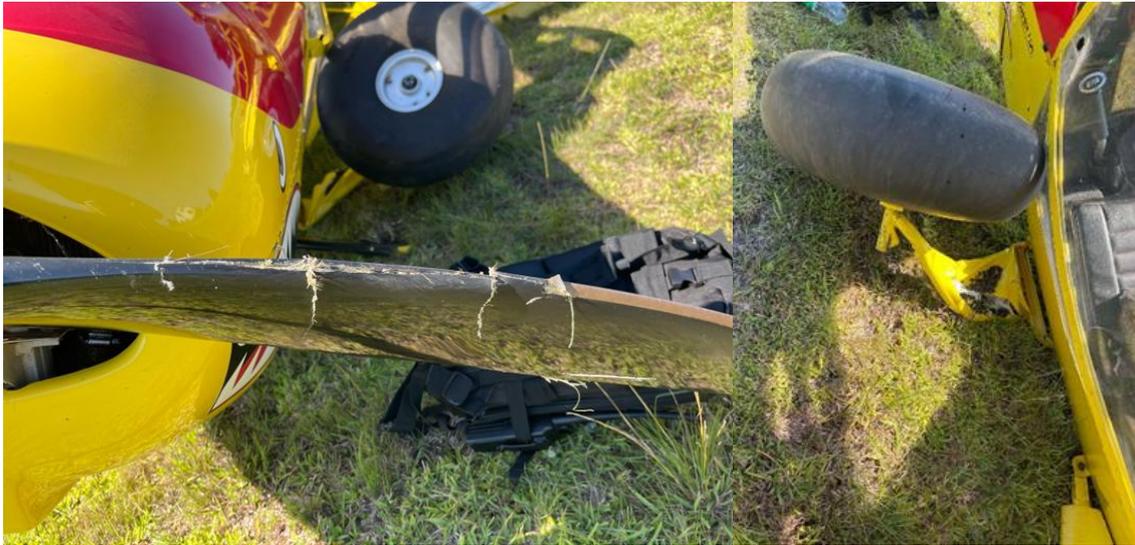
1.3.1. The aircraft sustained damage to the left main landing gear, propeller and left-wing tip.

Figure 2 and 3: The damaged left main landing gear and propeller. (Source: Pilot)

1.12.1. The aircraft landed hard on an upsloping grass-covered field and the left main landing gear failed on impact during the landing roll. The propeller and left-wing tip impacted the grass surface. The aircraft sustained damage to the left main landing gear, propeller and left-wing tip during the accident sequence.

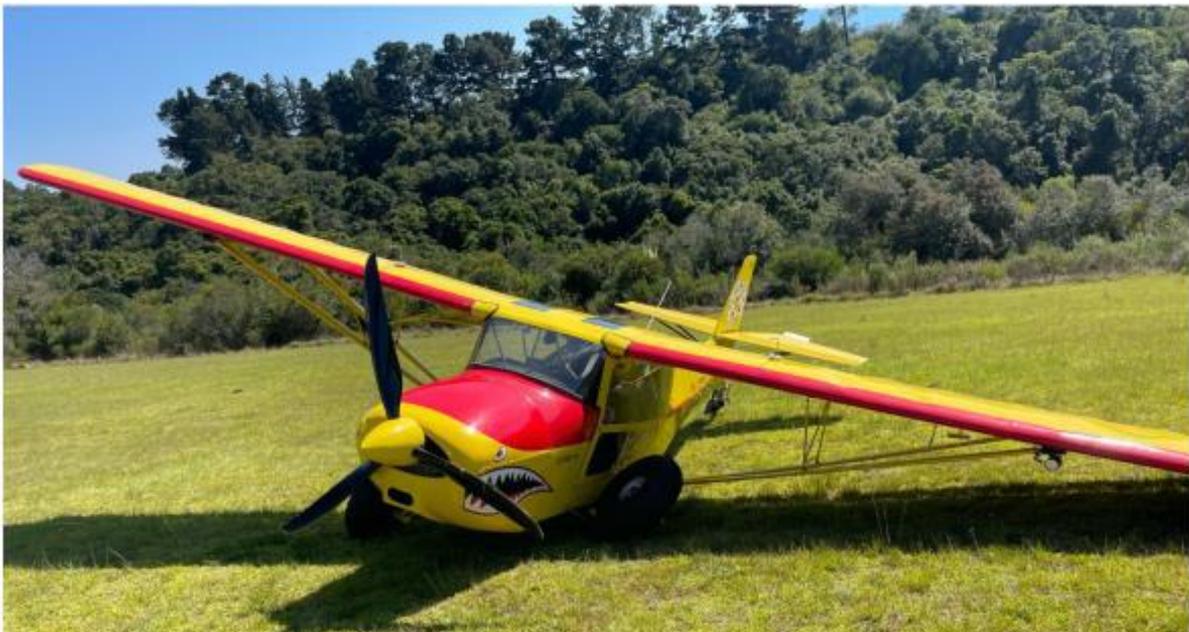
Figure 4: The aircraft after it came to rest. (Source: Pilot)

3.2.7 The aircraft had a high engine temperature indication, followed by a loss of engine power during the cruise phase of the flight. After the pilot had tried to restore engine power to no avail, he was prompted to execute a forced landing on a field at Hillandale Hideaway. The aircraft landed hard, and the left main landing gear failed during the landing roll.

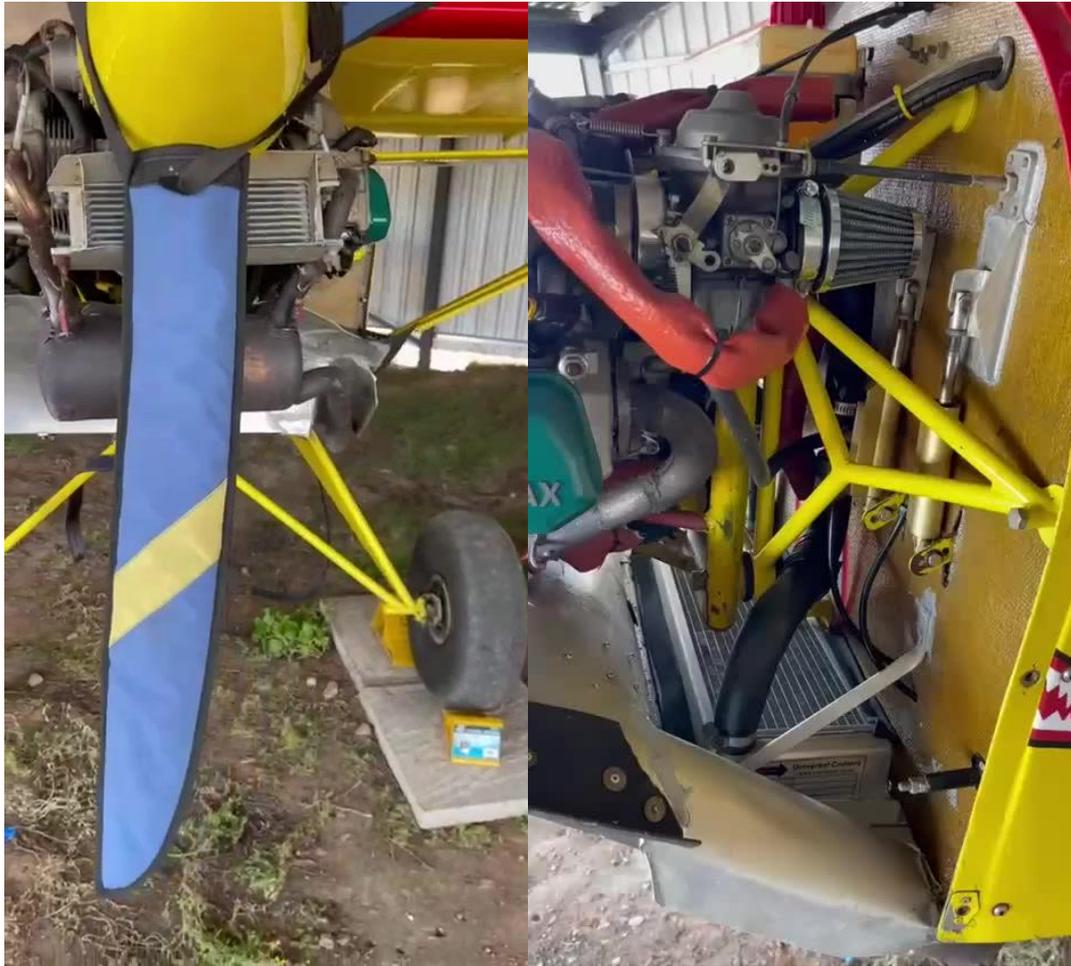
1.16.1. The aircraft was recovered and transported by road to an approved person (AP). Upon inspection, the AP noticed that the coolant radiator lacked good airflow because of the manner in which it was installed by the original builder. The crank runout test and the inspection of the reduction gearbox were in good shape and were within limits. The engine run, oil pressure and oil temperature were put on the test bed and were found to be normal; moreover, the coolant temperature was also functioning optimally. The engine reached its full power.

1.16.2. During the re-installing phase of the engine, the AP inspected the water pipes and fittings and established that the coolant pipe fittings to the Rotax-installed carburettor heat system were restricted. This explained the loss of engine power in the descent phase when throttle was applied.

Figures 5 and 6: The layout of the engine cooling system after recovery. (Source: AP)

2.2.3. The purpose of the flight was to ferry the aircraft for its 100-hour periodic check. According to the records, the aircraft was maintained in accordance with the Regulations. The aircraft was airworthy at the time of the flight. However, according to the AP observations, the engine cooling system was not installed in accordance with the aircraft manufacturer (KFA) standard installation factory instructions. This led to a restriction in the cooling system which caused a

higher-than-normal engine operating temperature and the subsequent engine power loss.

3.4.1. Improper installation of the engine cooling system.

1.16.3. The AP subsequently repositioned the radiator and re-installed the engine cooling system in accordance with the Kitplane for Africa (KFA) standard installation factory instructions.
