**AIRCRAFT ACCIDENT REPORT AND EXECUTIVE SUMMARY**

<b>Reference:</b>	CA18/2/3/10443		
<b>Aircraft Registration</b>	ZS-KNE	<b>Date of Accident</b>	21 April 2024		<b>Time of Accident</b>	1330Z	
<b>Type of Aircraft</b>	Cessna 172 RG		<b>Type of Operation</b>	Private (Part 91)			
<b>Pilot-in-command Licence Type</b>	Private Pilot Licence (PPL)		<b>Age</b>	30	<b>Licence Valid</b>	Yes	
<b>Pilot-in-command Flying Experience</b>	<b>Total Flying Hours</b>		154.7	<b>Hours on Type</b>	94.3		
<b>Last Point of Departure</b>	Witbank Airport (FAWI), Mpumalanga Province						
<b>Next Point of Intended Landing</b>	Witbank Airport (FAWI), Mpumalanga Province						
<b>Damage to Aircraft</b>	Destroyed						
<b>Location of the accident site with reference to easily defined geographical points (GPS readings if possible)</b>							
At GPS co-ordinates: 25° 50' 34.2" South 029° 11' 22.3" East, at an elevation of 5 155 feet (ft).							
<b>Meteorological Information</b>	Surface wind:030°/ 5 kt; temperature: 31°C; dew point: 12°C; CAVOK

**Synopsis**

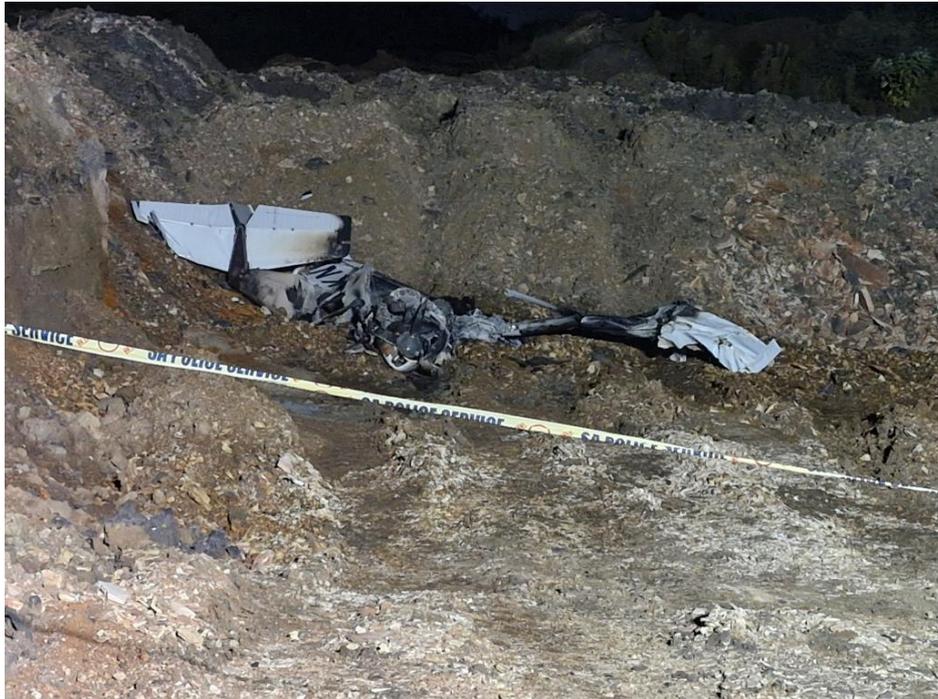
1.3.1. The aircraft was destroyed by impact forces and a post-impact fire.

**Figure 2:** The wreckage post-accident.

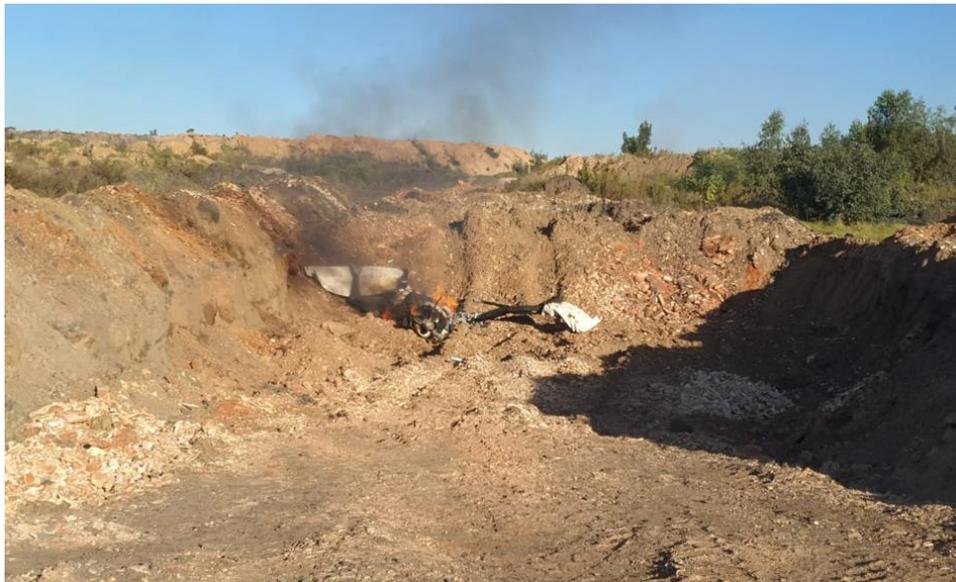
1.12.1. The wreckage was found in an inverted position with the nose facing north-west. The wreckage was contained in one area. The fuselage was consumed by the post-impact fire. The tail section was still intact with impact damage observed on the left elevator tip. The pitch control surfaces were still secured. The flight control cables were still intact and secured to their respective control surfaces. The left and right wings had impact damage; buckling and deformation were also noticed in the mid-section, outboard sides and on the leading edge. The landing gear was found retracted.

**Figure 3:** The aircraft after impact.

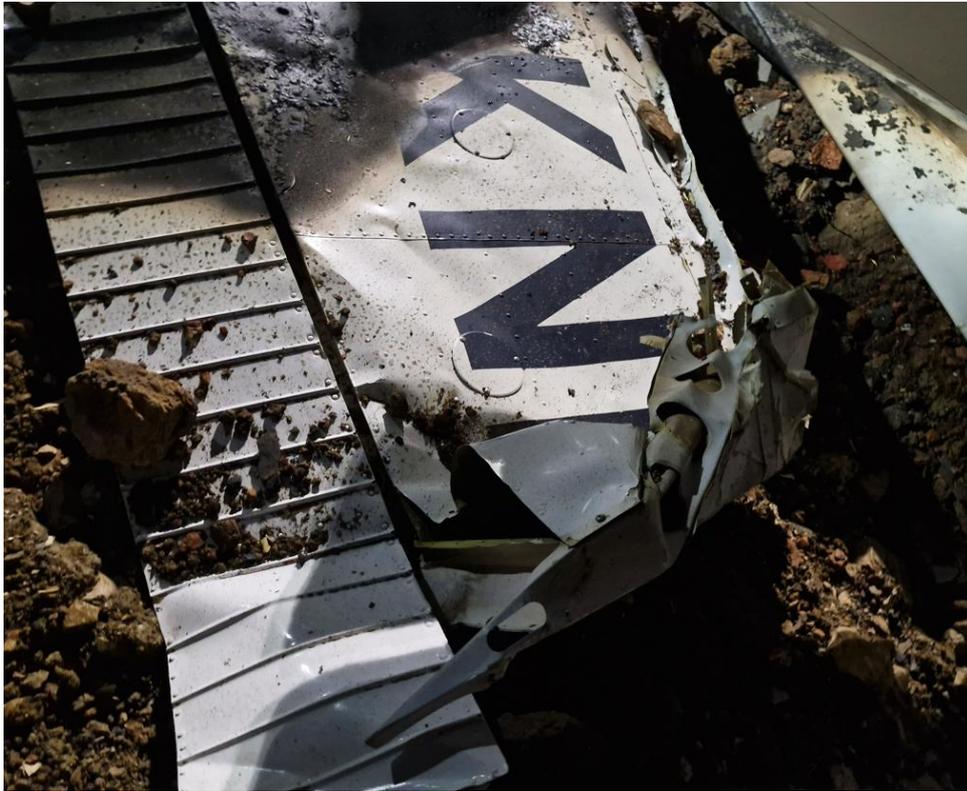
**Figure 4:** The deformed left-wing tip and aileron.

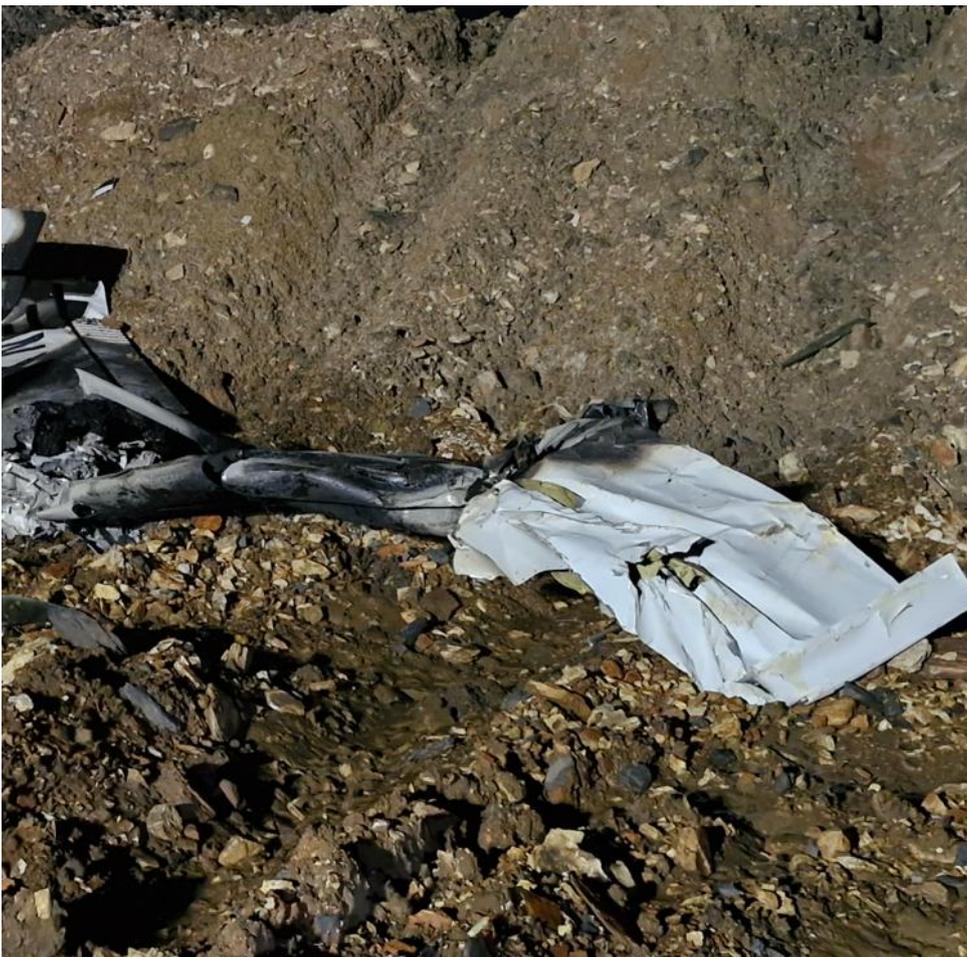
**Figure 5:** The deformed right wing.

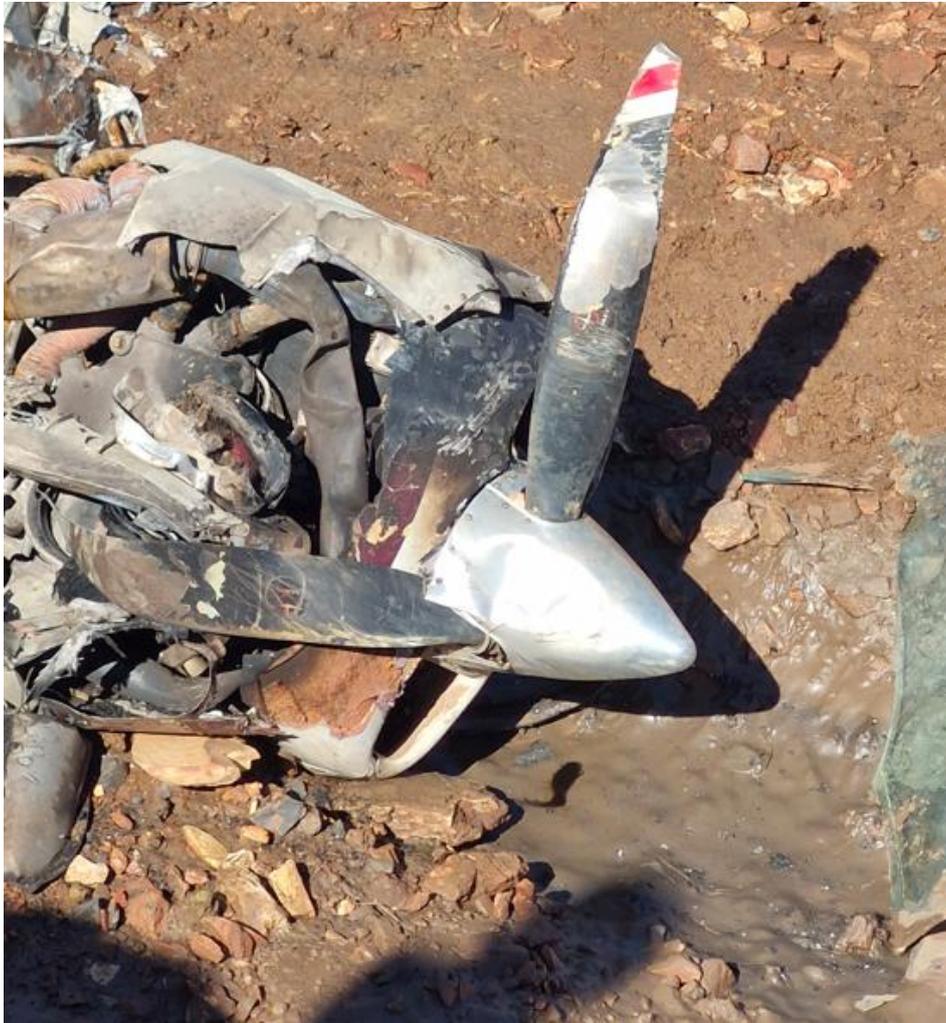
1.12.2. The engine was still secured in the cradle. The exterior condition of the engine appeared intact. The propeller flange was still connected to the engine. One of the three propeller blades had dislodged from the hub. The propeller blades were found twisted in the middle section and the tips were slightly bent backward. Deep impact markings on the leading edge indicated power signatures.

**Figure 6:** The damaged propeller blades.

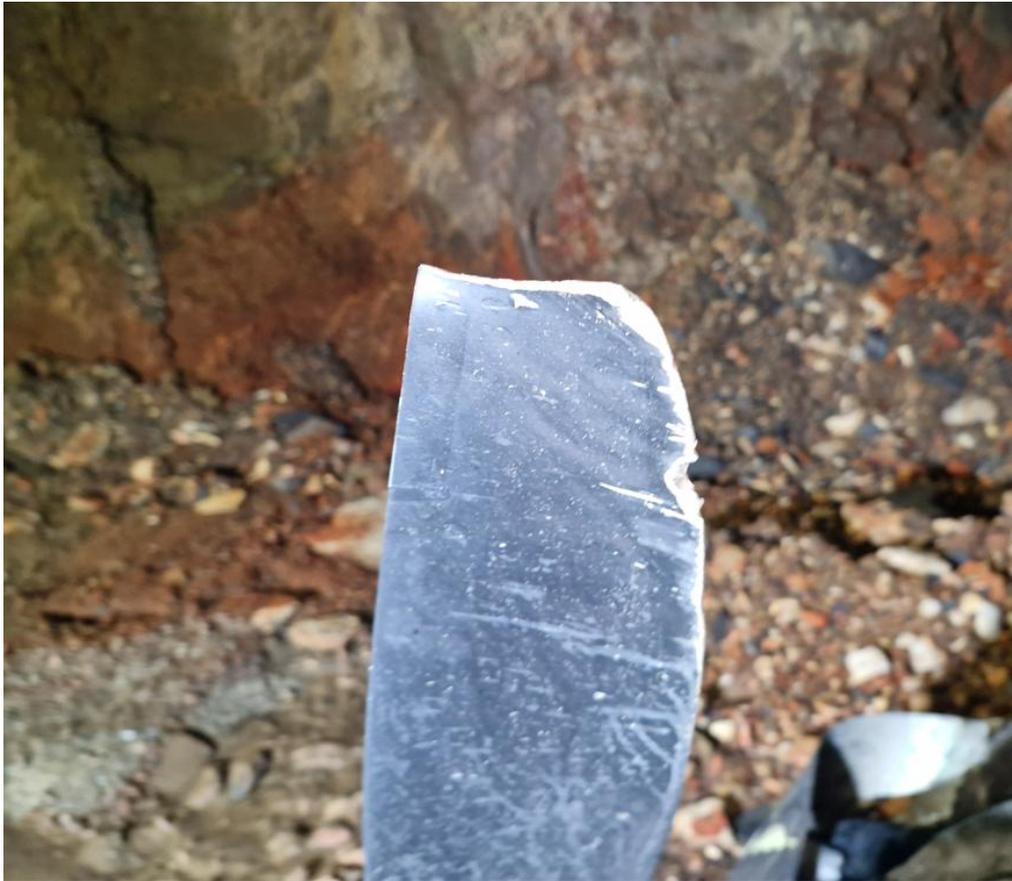
**Figure 7:** The damaged leading-edge tip.

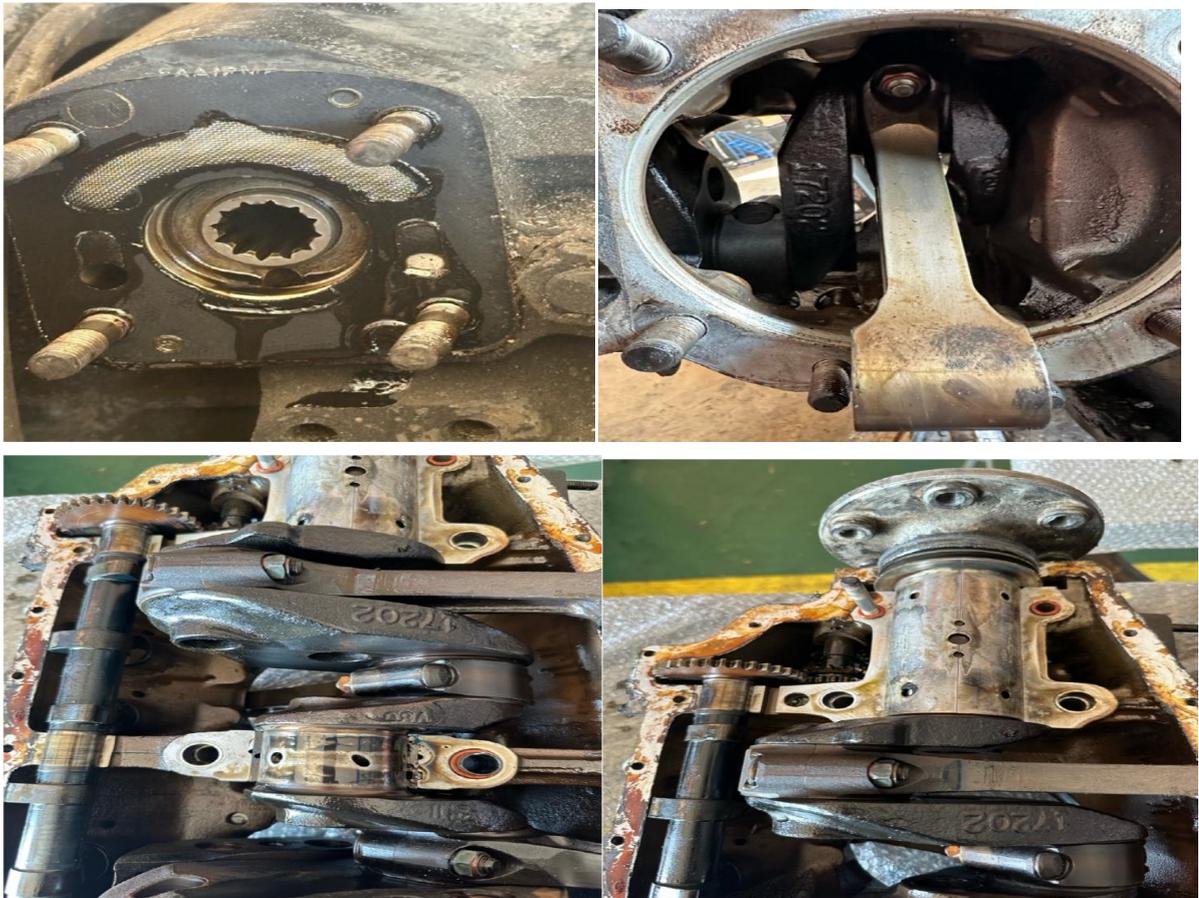
1.16.1. The aircraft maintenance organisation (AMO) personnel removed all four cylinders from the engine. No cracks were found on the cylinders and there was no visible internal damage.

The piston conrods were found intact and all pistons and conrod moved freely. The engine was split into two halves to reveal the crankshaft and big end bearings. The crankshaft rotated freely and there were no visible signs of overheating. The propshaft also showed no evidence of damage or buckling. The camshafts had no evidence of damage. All gears were still intact. One of the magnetos was burnt because of the post-accident fire; attachment points and gears where the magneto attaches were in good condition. Besides the external fire damage, the interior of the engine was found to be in good condition. All evidence revealed that there was sufficient lubrication at the time of the accident which indicates that the engine was functioning normally. All accessory drive gears and drive trains were intact at the time of teardown inspection. The components moved (turned) freely.

**Figure 8:** Cylinder and the camshaft images.
