LIMITED OCCURRENCE INVESTIGATION REPORT – FINAL

Reference Number	CA18/2/3/10444					
Classification	Accident	Date	21 April 2024		Time	1030Z
Type of Operation	Charter Commercial Flight (Part 135)					
Location						
Place of Departure	Lanseria International Airport (FALA), Gauteng Province		Place of Intended Landing	Kalahari Lion Safari Airfield, North West Province		
Place of Occurrence	RWY 35 at Kalahari Lion Safaris Airfield in North West Province					
GPS Co-ordinates	Latitude	S25°43'21.5"	Longitude	E023°28'08.7"	Elevation	3 637 feet
Aircraft Information						
Registration	ZS-NVE					
Make; Model; S/N	Cessna Aircraft Company; C402C (Serial Number: 402C-0033)					
Damage to Aircraft	Substantial		Total Aircraft Hours	12 068		
Pilot-in-command						
Licence Type	Airline Transport Pilot Licence (ATPL) Aeroplane		Gender	Male		Age 35
Licence Valid	Yes	Total Hours	2 598.3		Total Hours on Type	192
Total Hours 90 Days	73.7		Total Flying on Type Past 90 Days		71.9

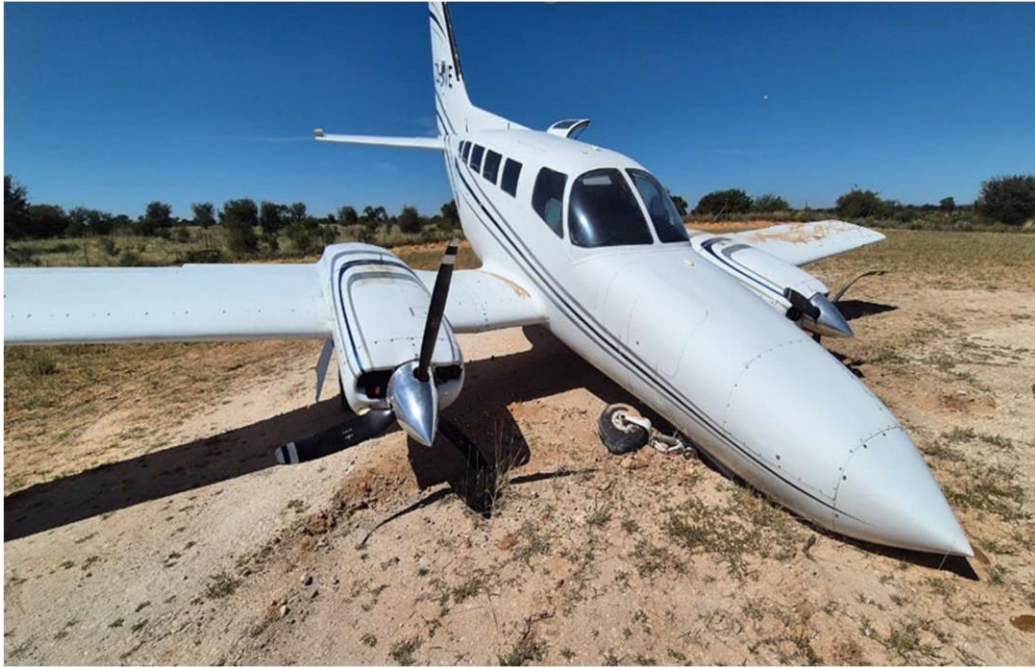
Figure 1: The front view of the aircraft after the accident. (Source: Pilot)

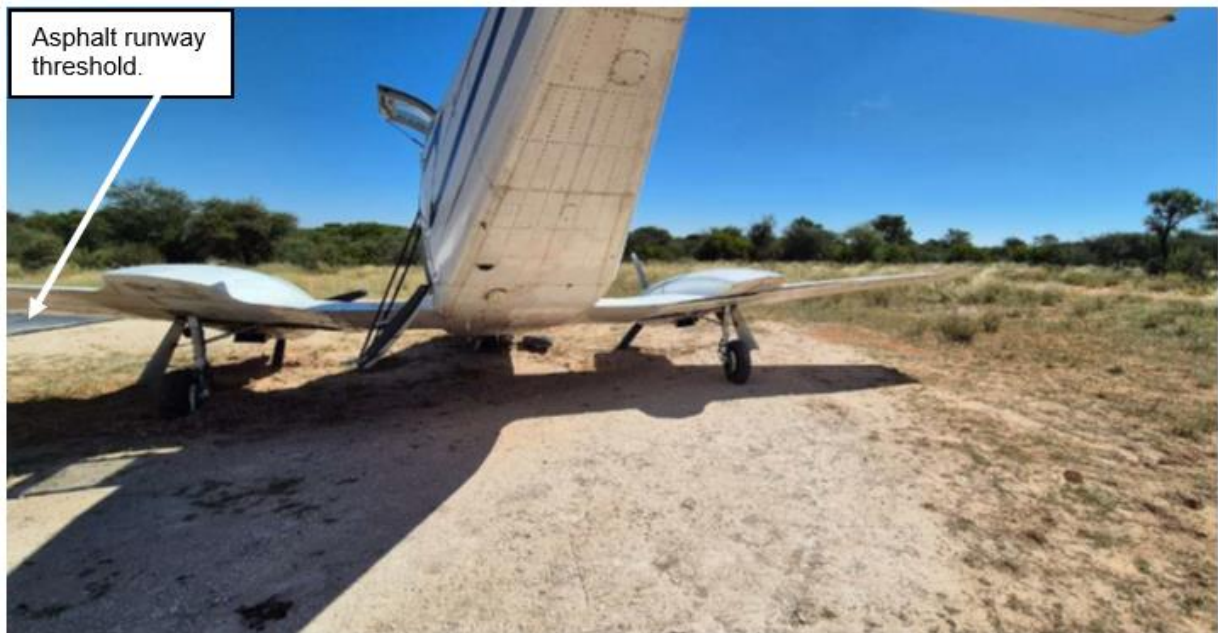
Figure 2: The aircraft on the right side of the asphalt runway. (Source: Pilot)

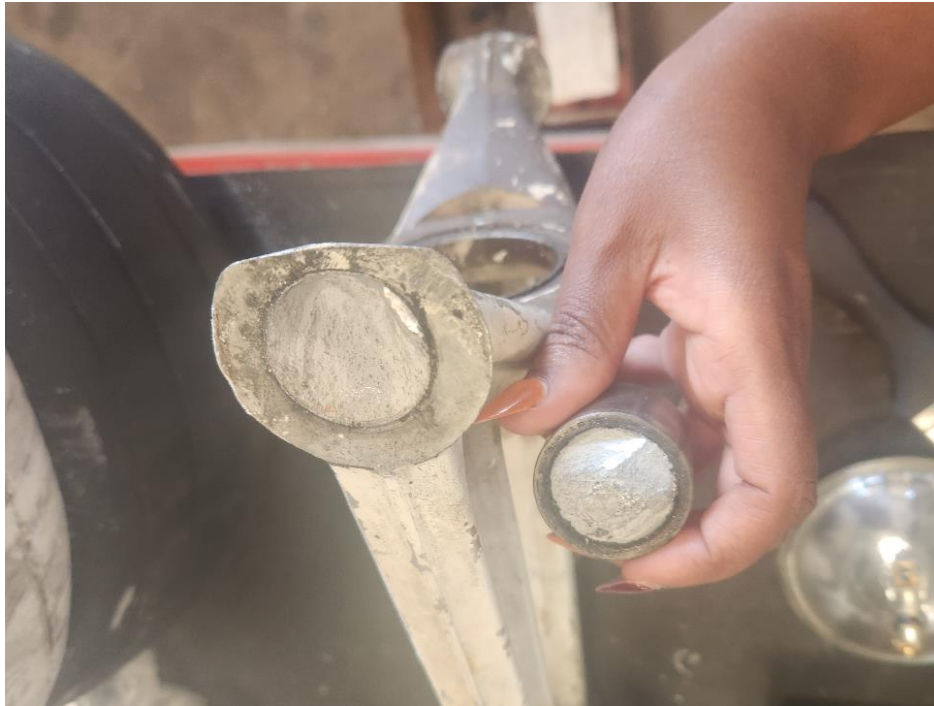
Post-accident inspection revealed that the left-side nose gear trunnion pin broke off due to overload which led to the collapse of the nose gear. Consequently, both the left- and right-side propeller blades impacted the ground.

Figure 3: The broken left-side nose gear trunnion pin.

<p>5. The aircraft maintenance organisation (AMO) which certified the last MPI had a valid AMO Certificate that was re-issued on 1 February 2024 with an expiry date of 28 February 2025.</p> <p>6. The left-side nose gear trunnion pin broke off whilst the aircraft taxied on dirt surface (soft sand); this led to the collapse of the nose gear, and both the left- and right-side propeller blades impacted the ground.</p>
<p>Probable Cause(s)</p> <p>The left-side nose gear trunnion pin broke off due to overload whilst taxiing on dirt surface (soft sand), subsequently, the nose gear collapsed, and the propeller blades impacted the ground.</p>
<p>Contributing Factor(s)</p> <p>The pilot applied excessive power to free the aircraft (left wheel) from the dirt surface (soft sand), as a result, the left-side nose gear strut trunnion broke.</p>
<p>Safety Action(s)</p> <p>None.</p>
<p>Safety Message and/or Safety Recommendation/s</p> <p>None.</p>
