**LIMITED OCCURRENCE INVESTIGATION REPORT – FINAL**

| <b>Reference Number</b> | | CA18/2/3/10445 | | | | | | |
| Registration | | ZU-IWA | | | | | | |
| Make; Model; S/N | | Van's Aircraft; RV14 (Serial Number: 140342) | | | | | | |

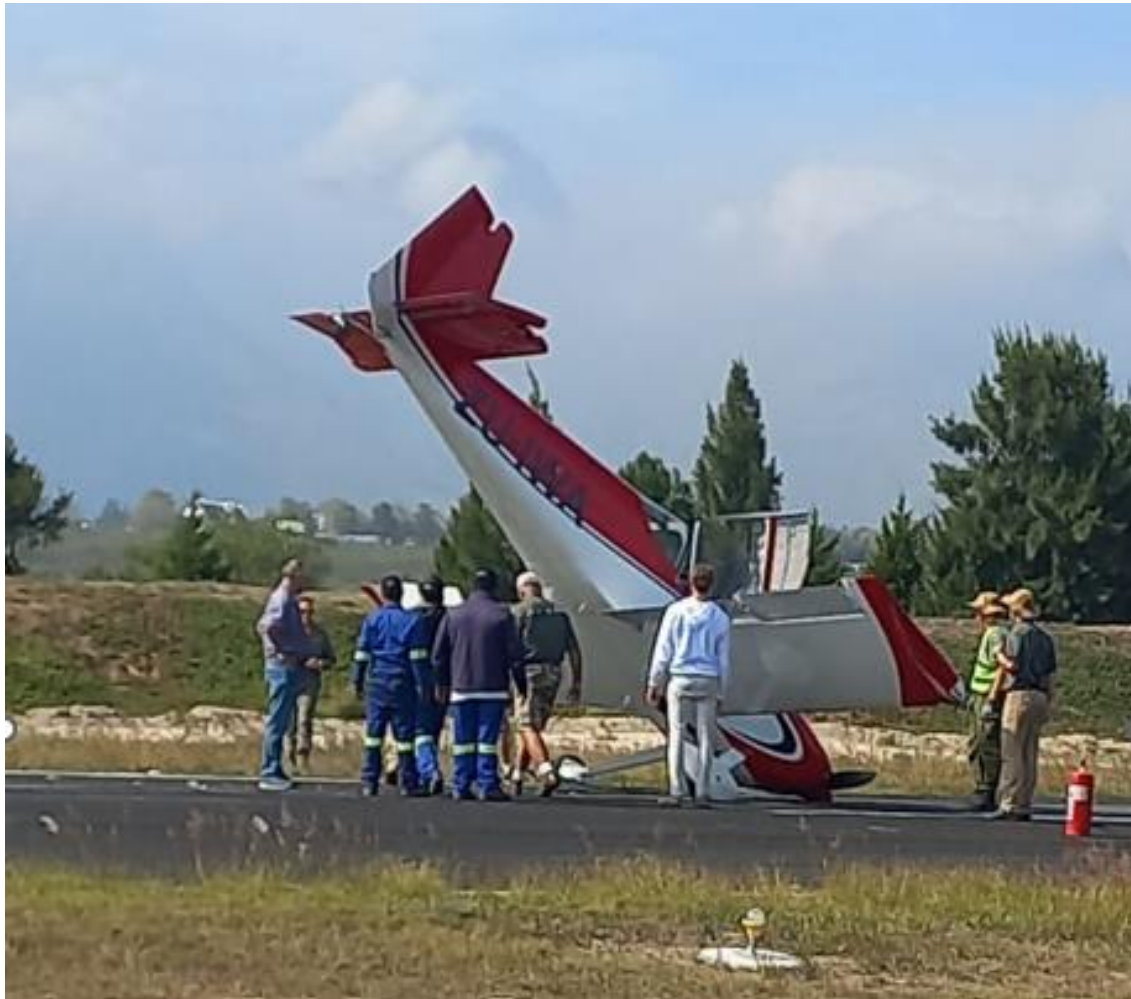
| <p>On 23 April 2024, a pilot on-board an RV14 tail dragger aircraft with registration ZU-IWA took off on a private flight from Stellenbosch Airfield in the Western Cape province. The pilot intended to conduct touch-and-go circuits in the airfield. The flight was conducted under visual meteorological conditions (VMC) by day and under the provisions of Part 94 of the Civil Aviation Regulations (CAR) 2011 as amended.</p> <p>According to the pilot, he intended to perform a full stop landing on the third circuit after approximately 25 minutes of flight time. The aircraft was stable on approach for Runway 19 at 65 knots (kts), followed by an uneventful touchdown. During the landing roll whilst travelling at approximately 30 kts, he applied excessive brakes to reduce the speed in preparation to make a turn into an exit taxiway. The aircraft nosed over, and the propeller impacted the runway; it came to a stop in a tail-high attitude.</p> <p>The pilot was not injured during the accident sequence. The propeller, nose section and the left main wheel fairing were damaged.</p> <p>Fine weather conditions prevailed at the time of the flight.</p> | | | | | | | | |

**Figure 1:** The aircraft after the accident. (Source: Pilot)

6. The pilot applied excessive brakes during an attempt to reduce speed to turn from the runway and onto the taxiway.
7. The aircraft came to a stop in a tail-high attitude.

The pilot applied excessive brakes during the landing roll which caused the aircraft to nose over; it came to a stop in a tail-high attitude.
