LIMITED OCCURRENCE INVESTIGATION REPORT – FINAL

Reference Number	CA18/2/3/10446						
Classification	Accident	Date	21 April 2024		Time	1318Z	
Type of Operation	Private (Part 94)						
Location							
Place of Departure	Nandoni Private Airstrip, Thohoyandou, Limpopo Province			Place of Intended Landing	Polokwane Civil Aerodrome, Limpopo Province		
Place of Occurrence	Nandoni Private Airstrip, Thohoyandou, Limpopo Province						
GPS Co-ordinates	Latitude	22°59'29" S	Longitude	030°32'53" E	Elevation	1 750ft	
Aircraft Information							
Registration	ZU-MJM						
Make; Model; S/N	Jabiru J430, (Serial Number: 513)						
Damage to Aircraft	Substantial			Total Aircraft Hours	881.1		
Pilot-in-command							
Licence Type	Private Pilot Licence (PPL)		Gender	Male		Age	21
Licence Valid	Yes	Total Hours	125.6		Total Hours on Type	97.7	
Total Hours 30 Days	21.5		Total Flying on Type Past 90 Days	37.1			
People On-board	1+3	Injuries	0	Fatalities	0	Other (on ground)	0

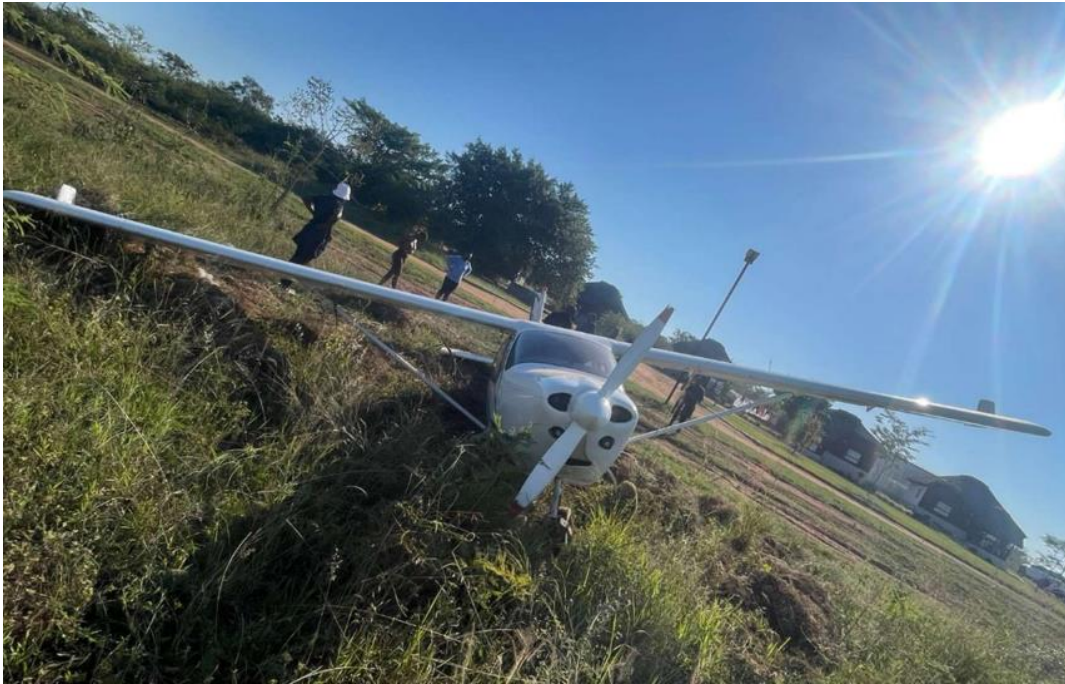
What Happened							
<p>On 21 April 2024 at 1318Z, a pilot and three passengers on-board a Jabiru J430 aircraft with registration ZU-MJM took off on a recreational flight from Nandoni private airstrip in Limpopo province to Polokwane Civil Aerodrome (FAPI) in the same province, with the intention to return to the departure airstrip. The flight was conducted under visual meteorological conditions by day and under the provisions of Part 94 of the Civil Aviation Regulations (CAR) 2011 as amended. Clear weather conditions prevailed at the time of the flight.</p> <p>According to the pilot, a pre-flight inspection was conducted, and no anomalies were found. The aircraft had a total of 125 litres of fuel with an endurance of 3 hours. Before take-off, the pilot set the flaps to 10°, checked the circuit breakers to ensure that the battery was charging, and that the revolutions per minute (RPM) were steadily increasing. During the take-off phase from Runway 14, the pilot applied full power and the aircraft accelerated, however, he noticed that the indicated airspeed (IAS) remained at zero. The pilot immediately closed the throttle and applied the brakes. At that time, the aircraft had already used almost half of the runway length, and the remaining runway surface sloped downwards which made it hard for the pilot to bring the aircraft to a safe stop. As the pilot deduced that he is running out of runway surface, he steered the aircraft slightly to the right and exited the runway into the wetland to minimise damage to the aircraft. However, the aircraft was substantially damaged; it sustained damage to the propeller blades, right main gear strut and the right-wing tip. No person was injured.</p>

Figure 1: The aircraft after it came to a stop. (Source: Pilot)

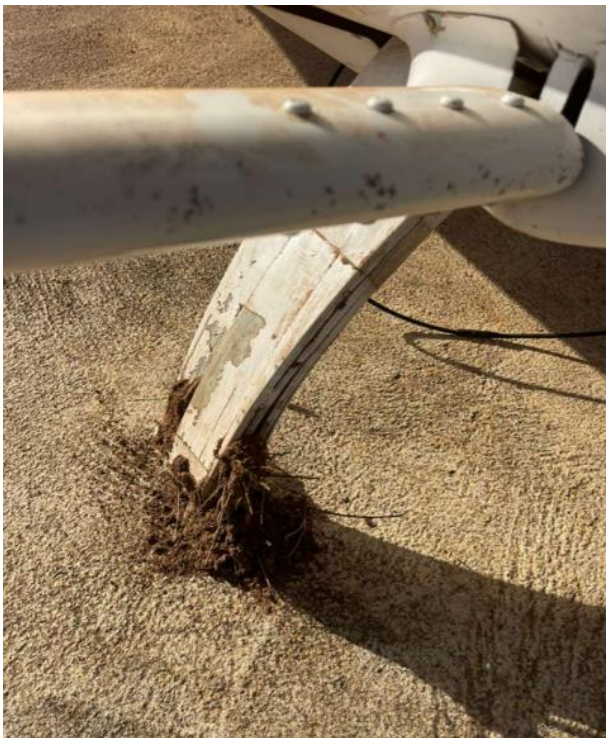
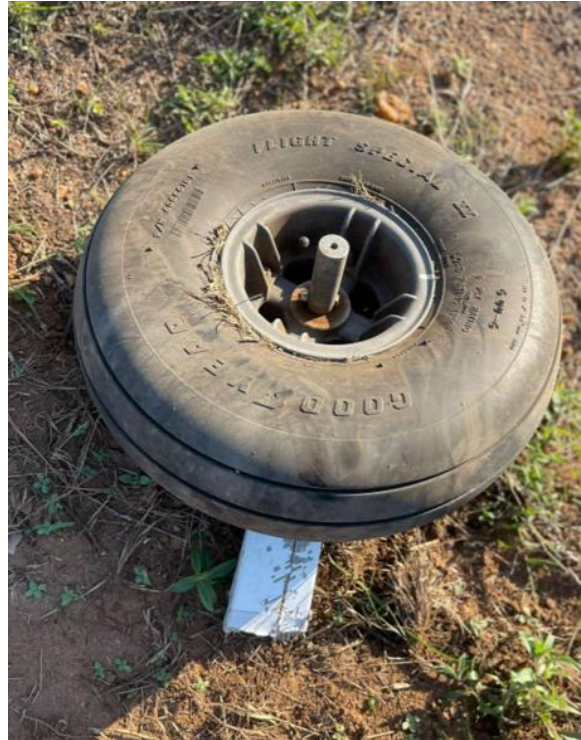
Figures 2 and 3: Shows the damaged right gear strut (left) and wheel assembly (right). (Source: Pilot)

6. The Certificate of Registration (C of R) was issued to the current owner on 27 February 2024.
7. During the take-off run when the aircraft was halfway through the runway, the pilot noticed that the airspeed indicator had remained at zero. The misreading on the gauge was caused by a bug that was stuck inside the pitot tube. The take-off was aborted late, and the remaining runway was insufficient to safely bring the aircraft to a stop.

The pilot aborted take-off due to a bug that had lodged in the pitot tube and, as a result, caused the airspeed readings to remain at zero. The pilot could not bring the aircraft to a safe stop on the remaining runway and he decided to exit to the right to minimise damage.
