LIMITED OCCURRENCE INVESTIGATION REPORT – FINAL

Reference Number	CA18/2/3/10447						
Classification	Accident	Date	30 April 2024		Time	1625Z	
Type of Operation	Private (Part 91)						
Location							
Place of Departure	Kruger Mpumalanga International Airport (FAKN), Mpumalanga Province		Place of Intended Landing		Wonderboom Airport (FAWB), Gauteng Province		
Place of Occurrence	Wonderboom Airport on Runway 11, Gauteng Province						
GPS Co-ordinates	Latitude	25°39'13.0 S	Longitude	28°13'27" E	Elevation	4078ft	
Aircraft Information							
Registration	ZS-MGW						
Make; Model; S/N	Piper PA-34-200T (Serial Number: 34-7970296)						
Damage to Aircraft	Substantial			Total Aircraft Hours	5729.28		
Pilot-in-command							
Licence Type	Commercial Pilot Licence (CPL) Aeroplane		Gender	Female		Age	24
Licence Valid	Yes	Total Hours	1591.1		Total Hours on Type	38.8	
Total Hours 30 Days	44.7		Total Flying on Type Past 90 Days	22			
People On-board	1+1	Injuries	0	Fatalities	0	Other (on ground)	0

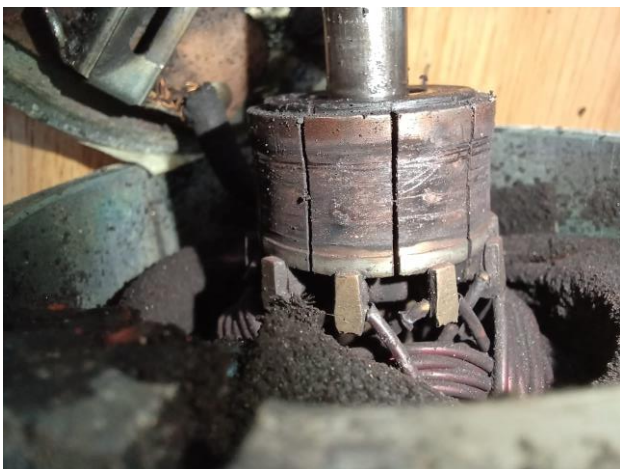
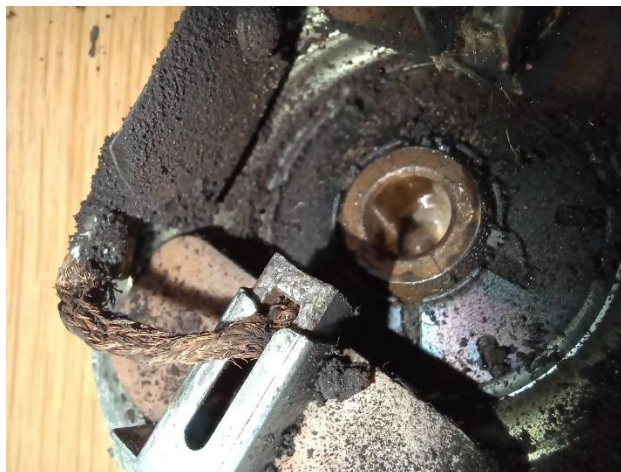
"The reason the motor failed was because the brushes were worn, they do not make contact with the armature and the motor stops turning. As seen in the pictures there are traces of oil on the inside of the motor which soften the brushes and cause them to wear excessively. The electric motor is mounted on top of the hydraulic pump which has an oil seal that I suspect has started leaking hydraulic oil towards the electric motor. I would say it is wear and tear, but was accelerated by the fact that hydraulic oil leaked into the motor."

Figures 1 and 2: Oil deposits found inside the motor caused the brushes to soften and, thus, preventing proper contact.

- 2.7 The electrical motor failed due to a hydraulic leak which softened the brushes; this resulted in imperfect contact.
- 2.8 The pilot did not follow the emergency landing gear extension procedure correctly as prescribed in the POH.

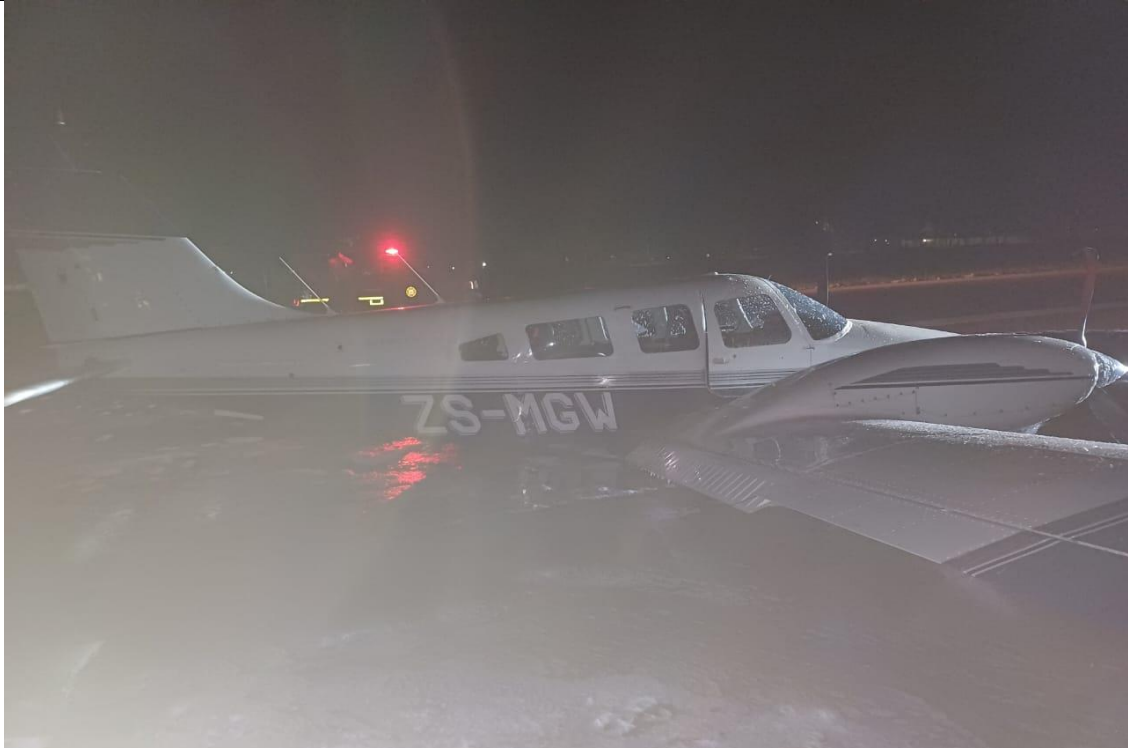
Figure 3: Foam applied to the runway after the aircraft had stopped. (Source: Operator)

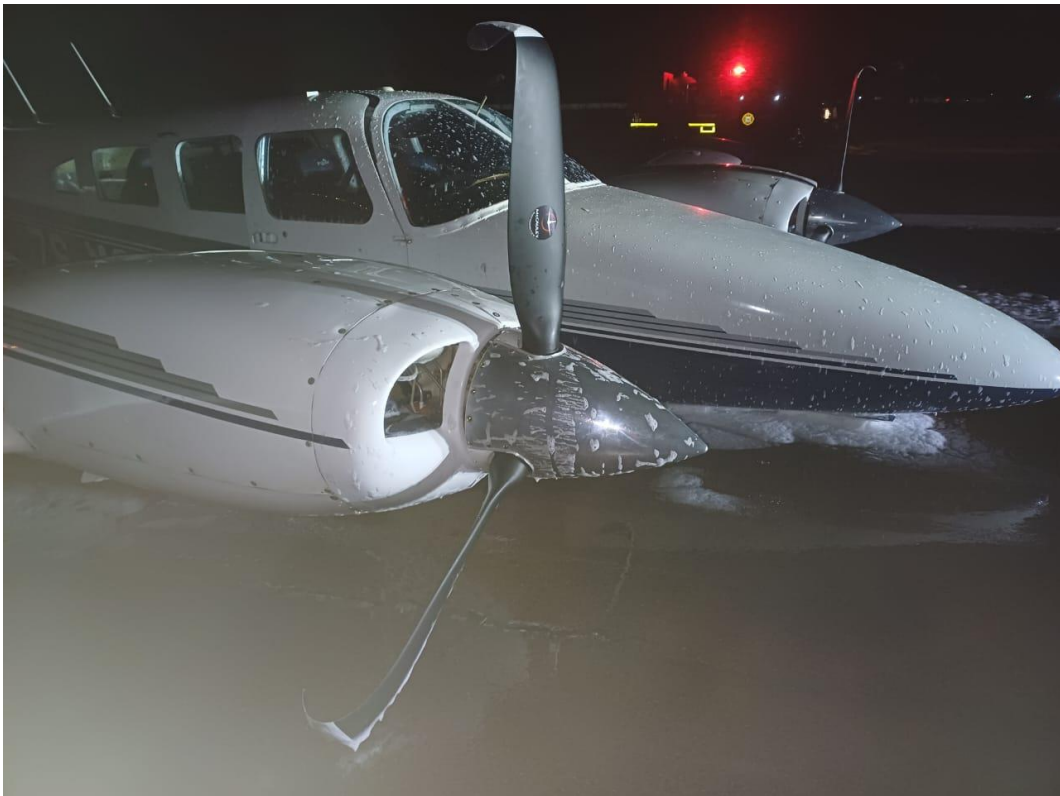
could not confirm if they were locked into position. The ZS-MGW pilot decided to conduct a precautionary landing. She lowered the landing gears and removed the lock on the emergency gear extension to release pressure and use gravity to bring the undercarriage down. The Pilot's Operating Handbook (POH) states that once the emergency extension has been pulled out, it should remain in that position to avoid pressure from being reapplied which would stop the manual extension. When the aircraft touched down, the landing gears collapsed. The aircraft skidded on its belly before it stopped on Runway 11. No person was injured; the aircraft sustained substantial damage to the underbelly and the propeller blades.

Figure 4: Damaged propeller blades and the scarred underbelly. (Source: Operator)

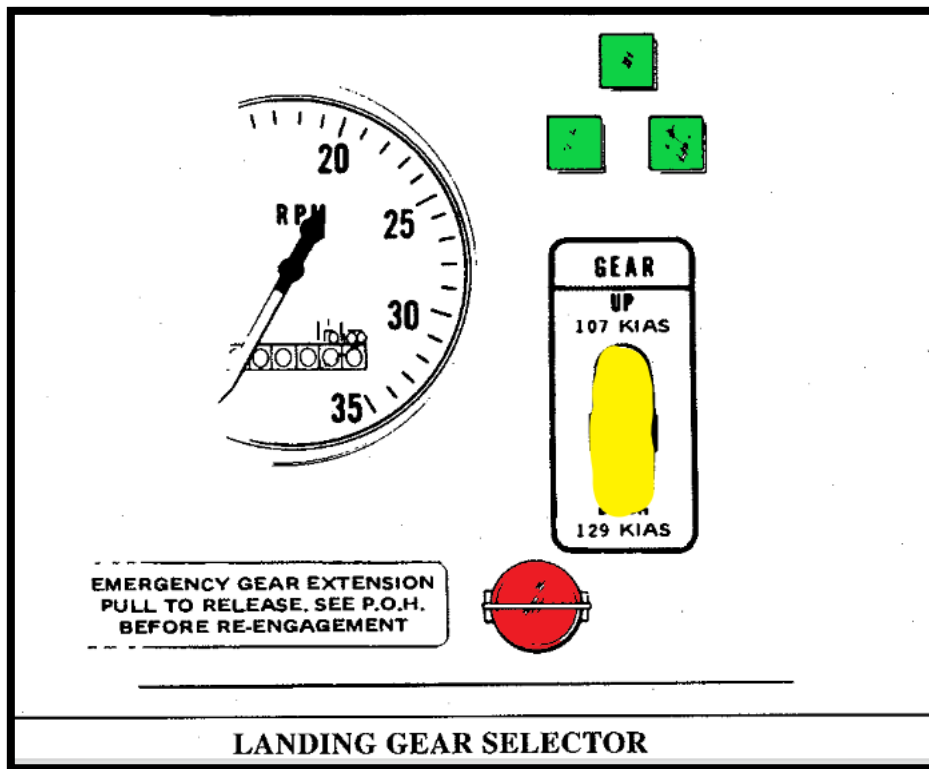
"The emergency gear lever was activated and then reset or pushed back to its stowed position before the gears were down and locked. The emergency procedure states that the lever must be left in the out position (pulled out). The lever pushed back is not the correct procedure for the emergency gear extension. Excessive brush wear on the undercarriage motor can occur when there is excessive resistance in the hydraulic system which could be caused by numerous factors."

Figure 7: Emergency gear extension with the guard in place to prevent inadvertent operation.
(Source: Piper PA-34-200T POH)
