**LIMITED OCCURRENCE INVESTIGATION REPORT – FINAL**

<b>Reference Number</b>	CA18/2/3/10448					
<b>Classification</b>	Accident	<b>Date</b>	5 May 2024		<b>Time</b>	0910Z
<b>Type of Operation</b>	Private (Part 91)					
<b>Location</b>						
<b>Place of Departure</b>	Landfontein Private Airstrip near Smithfield, Free State Province		<b>Place of Intended Landing</b>	Welkom Airfield (FAWM), Free State Province		
<b>Place of Occurrence</b>	On Runway 01 at New Tempe Aerodrome (FATP), Free State Province					
<b>GPS Co-ordinates</b>	<b>Latitude</b>	29°02'30.8"S	<b>Longitude</b>	26°16'32.85" E	<b>Elevation</b>	4 542 ft
<b>Aircraft Information</b>						
<b>Registration</b>	ZS-NVM					
<b>Make; Model; S/N</b>	Cessna Aircraft Corporation; T210L (Serial Number: 210-61372)					
<b>Damage to Aircraft</b>	Substantial		<b>Total Aircraft Hours</b>	4243		
<b>Pilot-in-command</b>						
<b>Licence Type</b>	Commercial Pilot Licence (CPL)		<b>Gender</b>	Male		<b>Age</b> 40
<b>Licence Valid</b>	Yes	<b>Total Hours</b>	1 927		<b>Total Hours on Type</b>	938.8

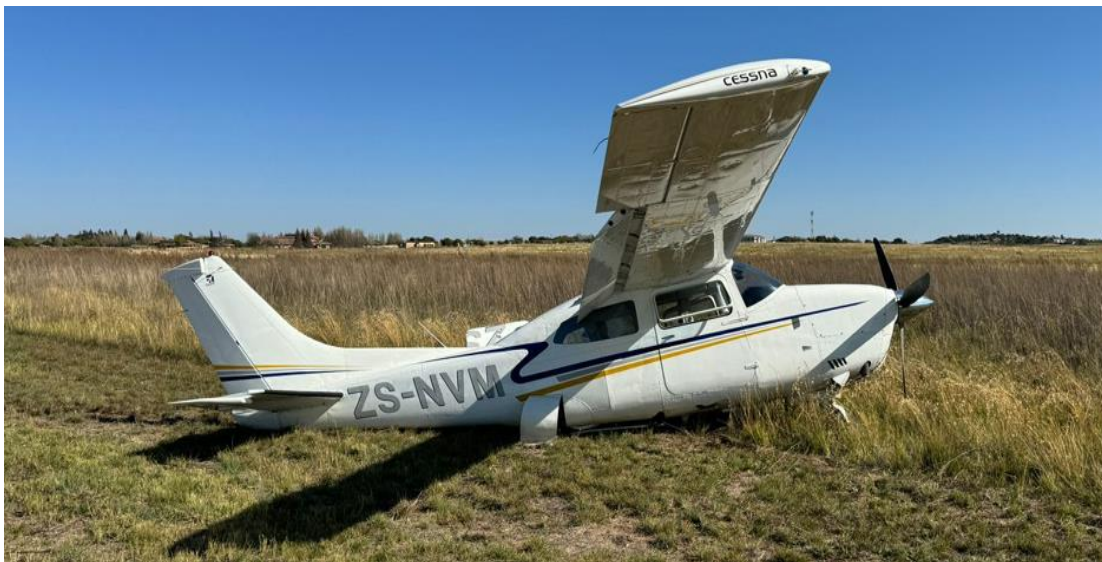
During the accident sequence, the main landing gear doors, bottom aft fuselage, left horizontal stabiliser and the left elevator were damaged.

**Figure 2:** The aircraft as it came to rest after the accident with the nose gear extended. (Source: Pilot)

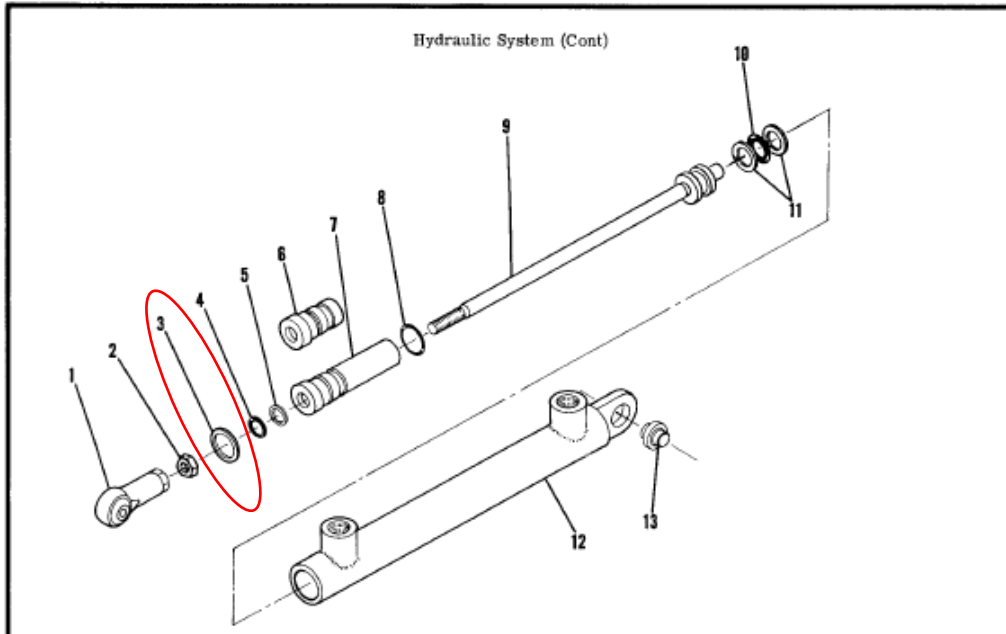
Figure 128. Main Gear Doors & Nose Gear Doors Actuator Assembly

*After recovering the aircraft at our [aircraft maintenance organisation (AMO)] facility, the hydraulic system was inspected, and found that the hydraulic reservoir was almost empty. We flushed the hydraulic system to clean the incorrect oil residue that was added to the reservoir during the flight. Further inspection revealed that the left main landing gear door actuator gland retaining ring broke free from the actuator assembly, allowing the cylinder rod to become adrift from the actuator. Due to the damage sustained following the wheels-up landing, it cannot be determined with certainty if this occurred before landing or because of the aircraft weight coming to rest on the left main landing gear door. Our suspicion is the latter, as the retaining ring and all other components were still hanging from the gland assembly after recovery. We suspect that they would have been lost if this occurred in flight. The actuator was re-assembled to test the undercarriage system. After filling the hydraulic reservoir to the correct level, the aircraft was placed on jacks, and the system function was tested and found to be operating satisfactorily. The emergency system was also tested at this time and found to be functioning normally and no hydraulic fluid (MIL-H-5606) could be found leaking from the system.*

Figure 3: The failed retaining ring. (Source: Cessna T210 K, L Parts Catalogue)

The left main landing gear door actuator gland retaining ring separated from the actuator and the hydraulic fluid escaped through the actuator. This rendered the landing gear system inoperative due to a lack of hydraulic fluid in the system to control the opening of the landing gear doors as well as lock them into position.

<b>Probable Cause</b>
The landing gear system failed to extend due to a lack of hydraulic fluid in the system; this resulted in a gear-up landing.
<b>Contributing Factors</b>
Poor fitment of the locking or retaining pin which resulted in its separation 24.54 hours after the last maintenance.
<b>Safety Action(s)</b>
None.
<b>Safety Message and Recommendation</b>
<b>Safety message:</b> In the interest of safety, AMOs must put systems in place to ensure that the maintenance is conducted in accordance with the manufacturers' prescripts and regulations to prevent injury or damage to property.
<b>About this Report</b>
<p><i>The decision to conduct a limited investigation is based on factors including whether the cause is known and the evidence supporting the cause is clear, the level of safety benefit likely to be obtained from an investigation, and that will determine the scope of an investigation. For this occurrence, a limited investigation has been conducted, and the Accident and Incident Investigations Division (AIID) has relied on the information submitted by the affected person/s and organisation/s to compile this limited report. The report has been compiled using information supplied in the initial notification, as well as from follow-up desktop inquiries to bring awareness of potential safety issues to the industry in respect of this occurrence, as well as safety action/s that the industry might want to consider in preventing a recurrence of a similar occurrence.</i></p> <p><i>All times given in this report are Co-ordinated Universal Time (UTC) and will be denoted by (Z). South African Standard Time is UTC plus 2 hours.</i></p>
