AIRCRAFT ACCIDENT REPORT AND EXECUTIVE SUMMARY

Reference:		CA18/2/3/10450	
Aircraft Registration	ZU-COB	Date of Accident	8 May 2024		Time of Accident	1445Z	
Type of Aircraft	Orion Cub		Type of Operation		Private (Part 94)		
Pilot-in-command Licence Type	National Pilot Licence (NPL)		Age	65	Licence Valid	Yes	
Pilot-in-command Flying Experience	Total Flying Hours		6 820		Hours on Type	200	
Last Point of Departure	Krugersdorp Aerodrome (FAKR), Gauteng Province						
Next Point of Intended Landing	Krugersdorp Aerodrome (FAKR), Gauteng Province						
Damage to Aircraft	Substantial						
Location of the accident site with reference to easily defined geographical points (GPS readings if possible)							
Approximately 2 kilometres (km) north of FAKR at Global Positioning System (GPS) co-ordinates determined to be 26°4'14.23" South 27°43'22.90" East, at 5 400 feet (ft) AMSL							
Meteorological Information	Wind direction: 180°; Wind speed: 03kts; Temperature: 21°C; Dew Point: 16°C; Cloud Cover: Nil; Cloud Base: Nil; Visibility: CAVOK; QNH: 1015hPa

Synopsis

Reference Number : CA18/2/3/10450
Occurrence Category : Category 2
Type of Operation : Private (Part 94)
Name of Operator : Avroy Sh

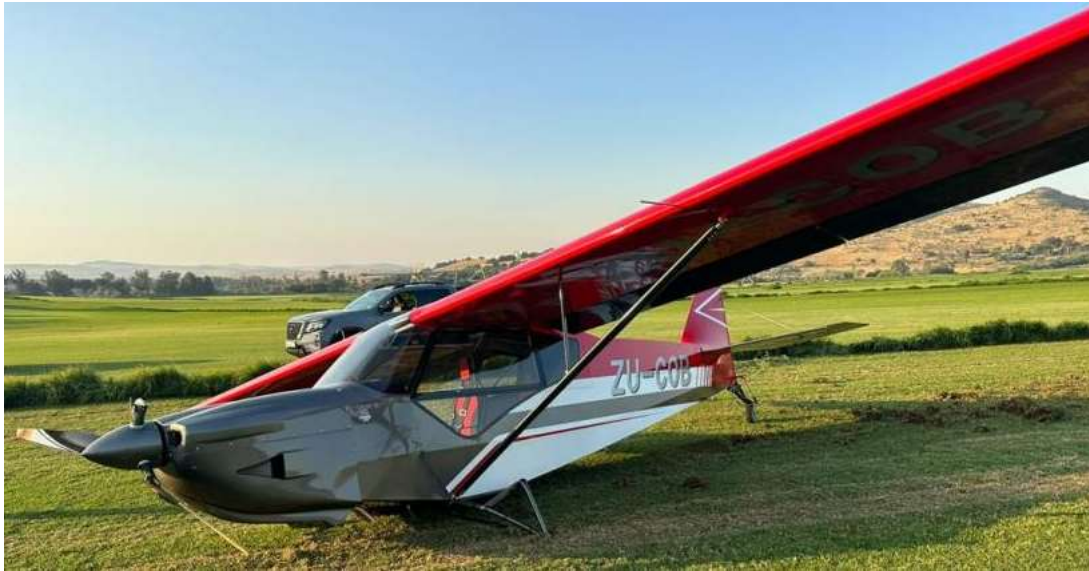
1.3.1. The aircraft was substantially damaged.

Figure 2: The aircraft at the accident site. (Source: Pilot)

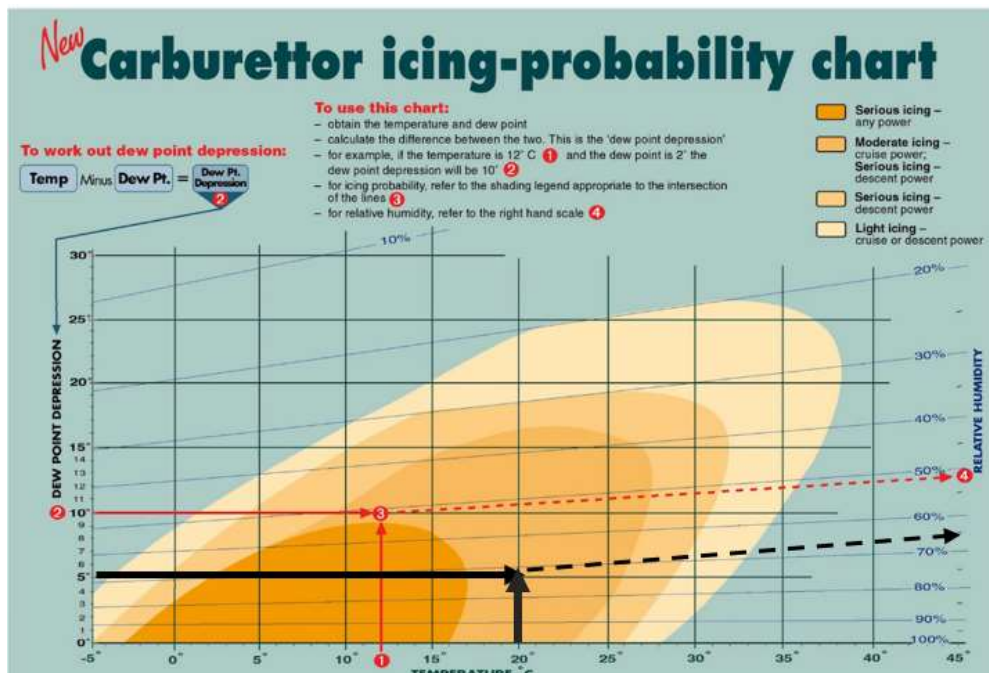
Chart 1: Carburettor icing chart.

1.7.3. According to the carburettor icing chart calculations, the temperature was 21°C and the dew point was 16°C; the dew point depression was 5°C. When plotting these numbers on the carburettor icing chart, the relative humidity was calculated at approximately 65%, which indicated moderate icing conditions at cruise and serious icing conditions at descent. The aircraft was on descent to land and the engine experienced serious icing conditions.

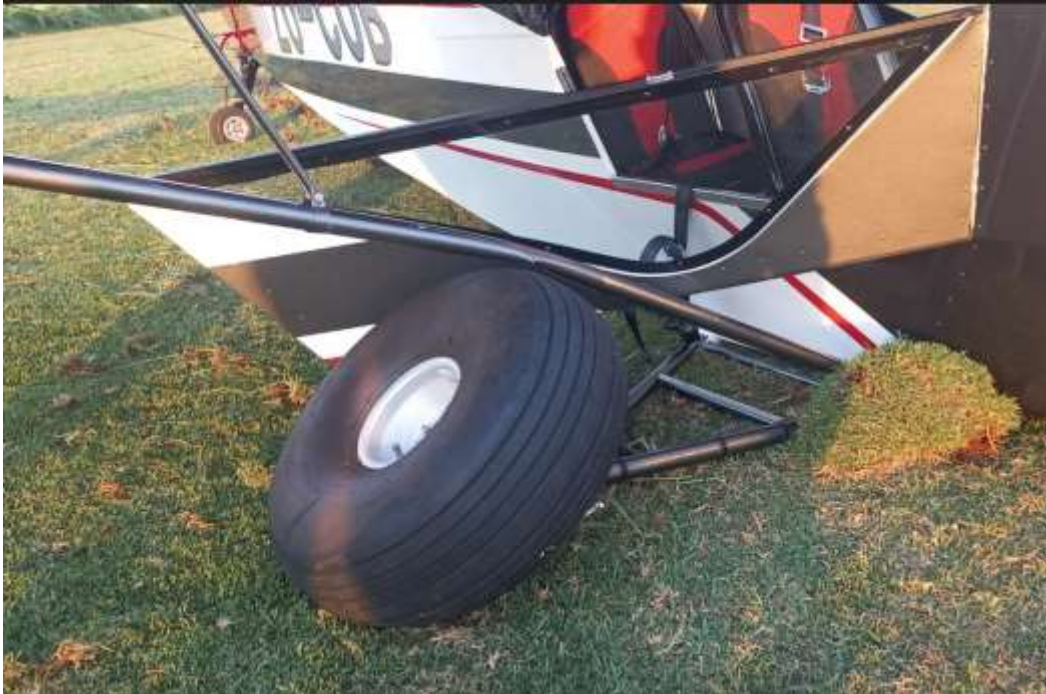
1.12.1. The aircraft landed hard with the main landing gear wheels which caused the right gear strut to bend outward. The left gear strut also bent, and the axle broke. Thus, the aircraft's nose pitched down, which resulted in the propeller striking the ground.

Figure 3: The right main landing gear strut that bent outward. (Source: Pilot).

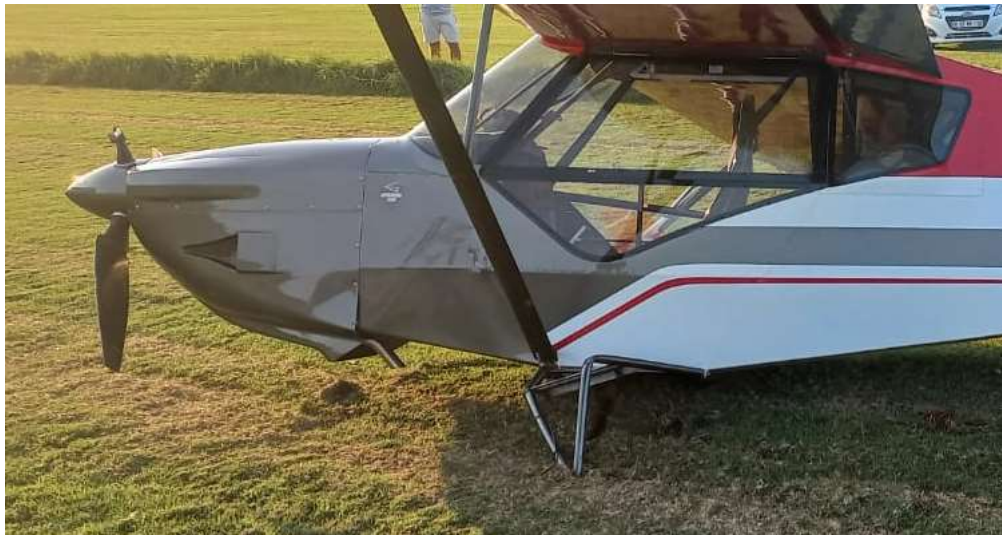
Figure 4: The bent left main gear strut, and the broken axle. (Source: Pilot)

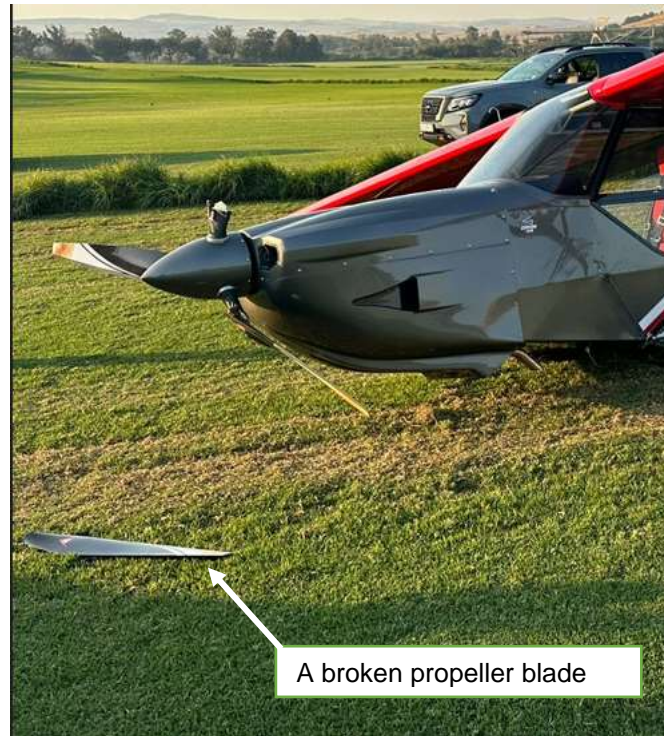
Figure 5: The propeller blade that broke off. (Source: Pilot).
