LIMITED OCCURRENCE INVESTIGATION REPORT – FINAL

Reference Number	CA18/2/3/10451						
Classification	Accident	Date	11 May 2024		Time	1540Z	
Type of Operation	Private (Part 94)						
Location							
Place of Departure	Kitty Hawk Airfield (FAKT) Gauteng Province		Place of Intended Landing		Kitty Hawk Airfield (FAKT) Gauteng Province		
Place of Occurrence	Runway 19 FAKT						
GPS Co-ordinates	Latitude	25° 51' 28.58" S	Longitude	28° 26' 58.40" E	Elevation	4580 ft	
Aircraft Information							
Registration	ZU-FIP						
Make; Model; S/N	Aveko VL-3 Flamingo (Serial Number: VL-3-57)						
Damage to Aircraft	Substantial			Total Aircraft Hours	145.9		
Pilot-in-command							
Licence Type	Commercial Pilot Licence (CPL)		Gender	Female		Age	63
Licence Valid	Yes	Total Hours	1152.36		Total Hours on Type	34.76	
Total Hours 30 Days	3		Total Flying on Type Past 90 Days	18.7			
People On-board	1+0	Injuries	0	Fatalities	0	Other (on ground)	0
What Happened							
<p>On Saturday afternoon, 11 May 2024, a pilot on-board an Aveko VL-3 aircraft with registration ZU-FIP took off on a local flight from Kitty Hawk Aerodrome (FAKT) in Gauteng province to the general flying area (GFA) and, thereafter, back to F

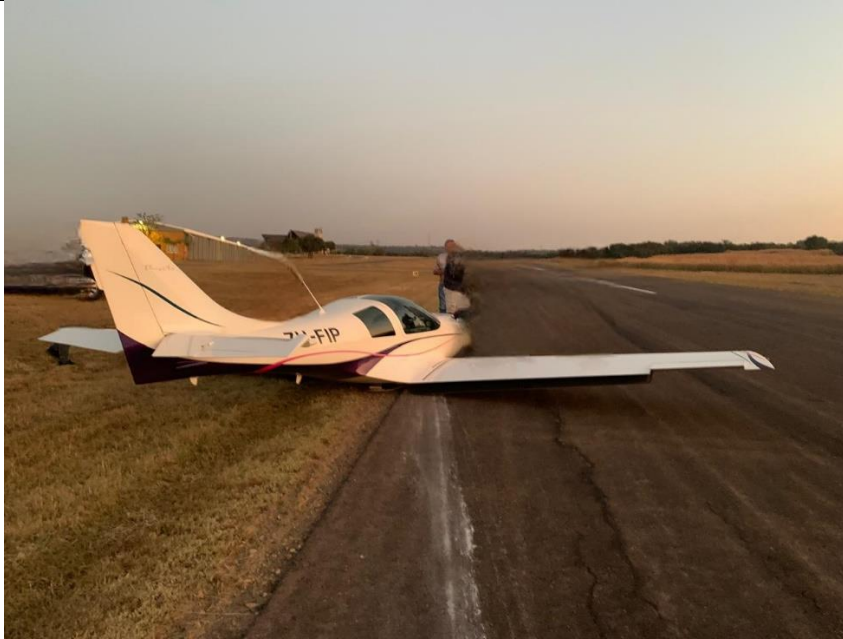
The aircraft's propeller and the under belly were damaged. The pilot was not injured during the accident.

Figure 2: The aircraft at the accident site. (Source: Pilot)

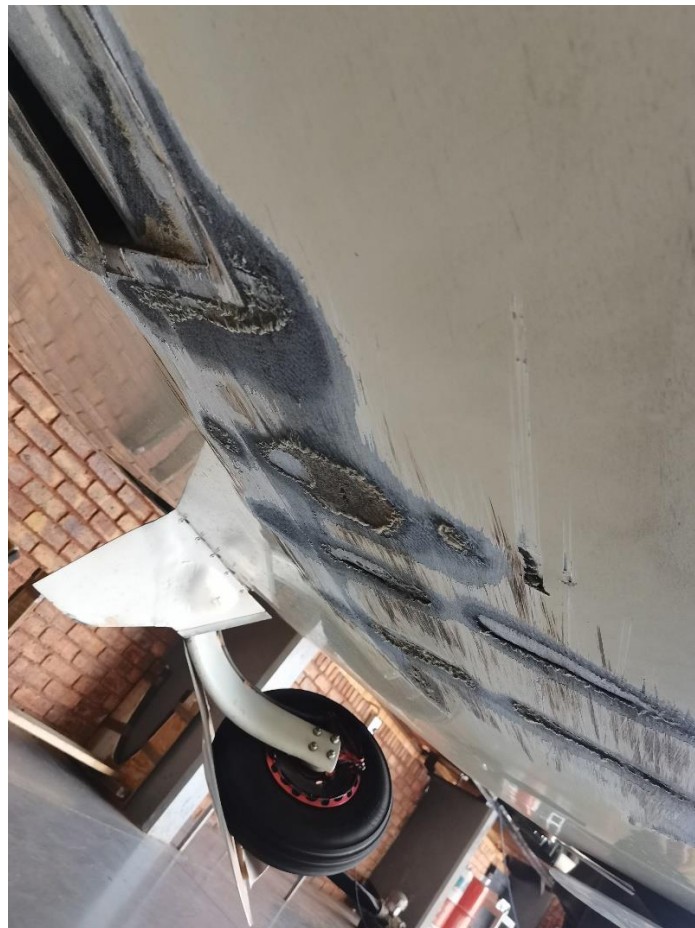
Figure 3: The damaged underbelly.

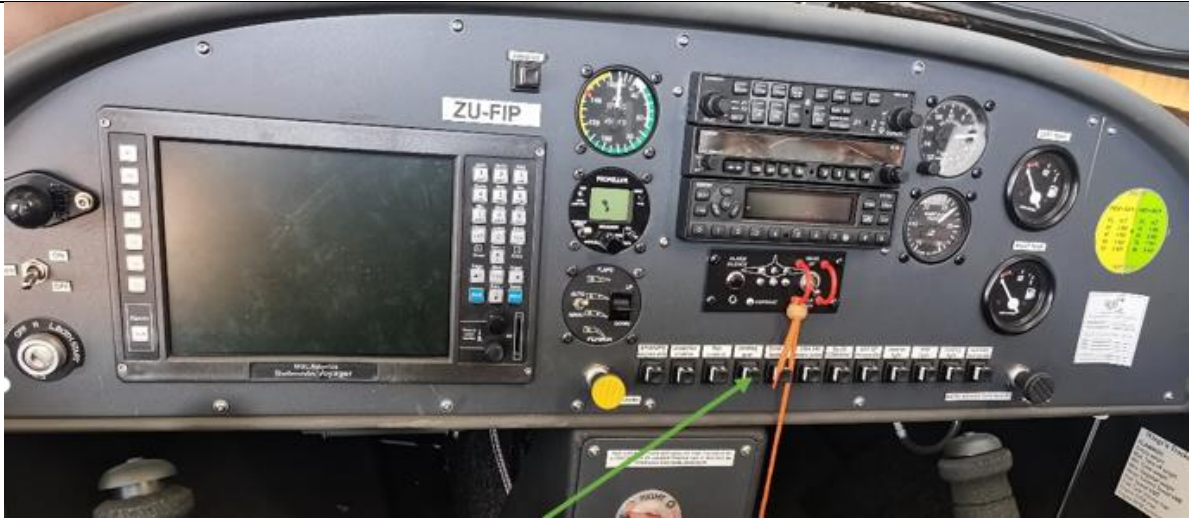
Figure 4: Landing gear switch.

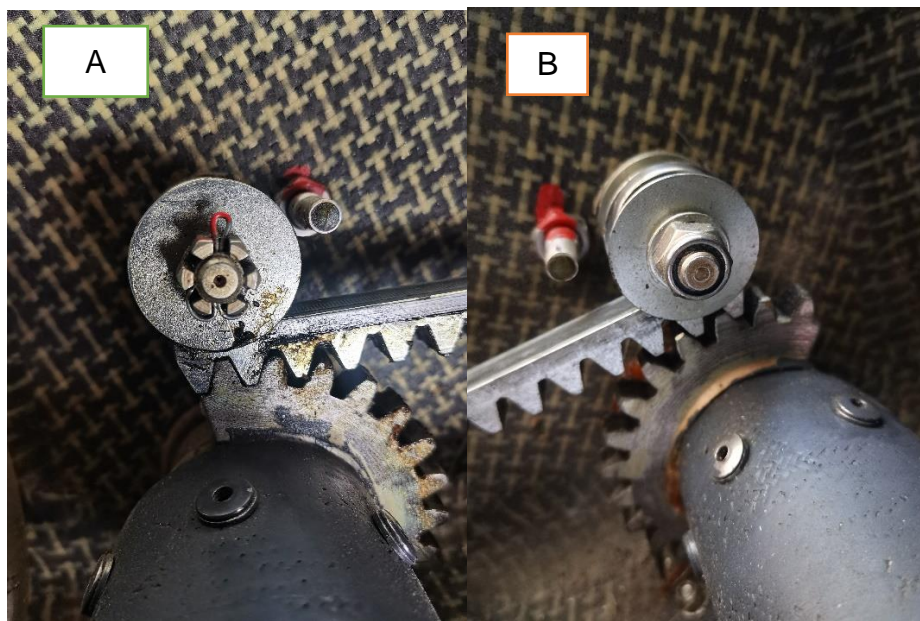
Figure 5: Picture A shows the landing gear track position of the left main landing gear. Picture B shows track position of the right main landing gear.

bearing (Figure 6) was damaged (possibly due to wear and tear). The damage had caused a gap between the track and gears (Figure 5 b) which then caused the right gear to skip the track on the landing gear strut. This made it impossible for the gear to travel the maximum (entire) length when extended or retracted.

A castle nut (Figure 5A) is a fastener which is widely used in the industry. It has an internal threaded hole and its edges are notched like a castle wall. The notched sides allow for the subsequent installation of cotter pins, which lock the nut to ensure it won't come loose during operation.

A lock nut (Figure 5B) is a fastener that to secure another nut or bolt. It typically has a round body with threads on the outside and an internally threaded hole at the centre. The main purpose of this specialised nut is to prevent unintentional loosening due to vibration or tampering. Lock nuts come in various shapes, sizes and materials, but all work using a locking mechanism that makes it easier to spin with tools being applied first.

The manufacturer was contacted to request the type of nut with which the bearing on the aircraft should be secured; the manufacturer had responded to the query stating that they had used the type in Figure 5A and that they had only built VL3 (kits) from serial number 100. The manufacturer also stated that they had no responsibility for the airworthiness of the VL3 kits up to serial number 99 and that they had limited access to documentation on how the kits were produced.

6. The pilot stated that the manual extension system used to extend the landing gears was difficult to operate and the gears did not extend.
7. The bearing had a flat surface and was flown in that condition (Figure 7) for some time. As a result, the bearing could not rotate optimally due to the gaps between the gears on the strut and track (Figure 5 B); therefore, the landing gear could not fully extend.

9. The investigator tested the manual pump and found it to be operational although this did not extend the landing gear due to some tracks that were skipped (Figure 5B).

12. The different nuts (Figure 5 A and B) used to secure the bearing were adequate to keep the bearing in place as the bearing mechanism did not fail.

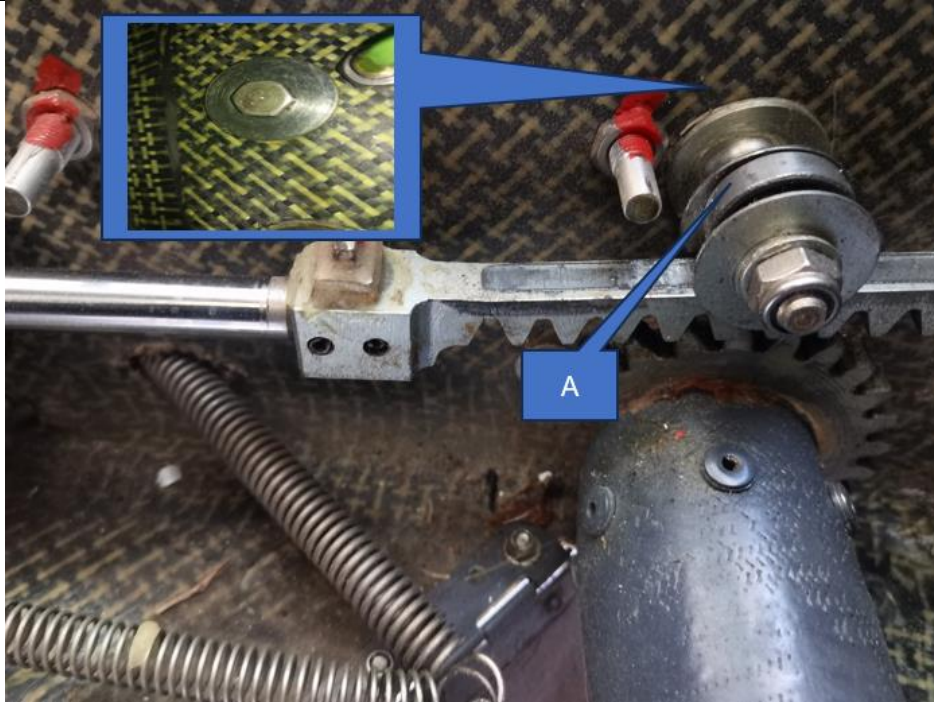
Figure 6: The collapsed bearing (A) which caused the gears to skip tracks when retracting. The inset picture shows damage to the head of the bolt securing the bearing.

The investigator inspected the aircraft after it was recovered and found that when the landing gear was extended, the nose and left main gear extended fully and the right main gear extended about 80%. When retracting the gears, the nose and left main gear retracted fully but the right main gear stopped before it entered the wheel well. Upon further investigation, it was discovered that the

Probable Cause(s)
It is probable that during the last annual inspection, the right main landing gear bearing was not properly inspected which resulted in the bearing failure and, thus, the landing gear skipped some tracks on the strut and prevented full extension of the right landing gear.
Contributing Factor(s)
Poor maintenance practices.
Safety Action(s)
None.
Safety Message and/or Safety Recommendation/s
It is recommended that the approved persons who maintain aircraft should properly inspect the landing gear extension mechanisms, particularly the bearings, at every annual inspection as prescribed in the maintenance schedule.
About this Report
<p><i>The decision to conduct a limited investigation is based on factors including whether the cause is known and the evidence supporting the cause is clear, the level of safety benefit likely to be obtained from an investigation and that will determine the scope of an investigation. For this occurrence, a limited investigation has been conducted, and the Accident and Incident Investigations Division (AIID) has relied on the information submitted by the affected person/s and organisation/s to compile this limited report. The report has been compiled using information supplied in the initial notification, as well as from follow-up desk top enquiries to bring awareness of potential safety issues to the industry in respect of this occurrence, as well as possible safety action/s that the industry might want to consider in preventing a recurrence of a similar occurrence.</i></p> <p><i>All times given in this report are Co-ordinated Universal Time (UTC) and will be denoted by (Z). South African Standard Time is UTC plus 2 hours.</i></p>

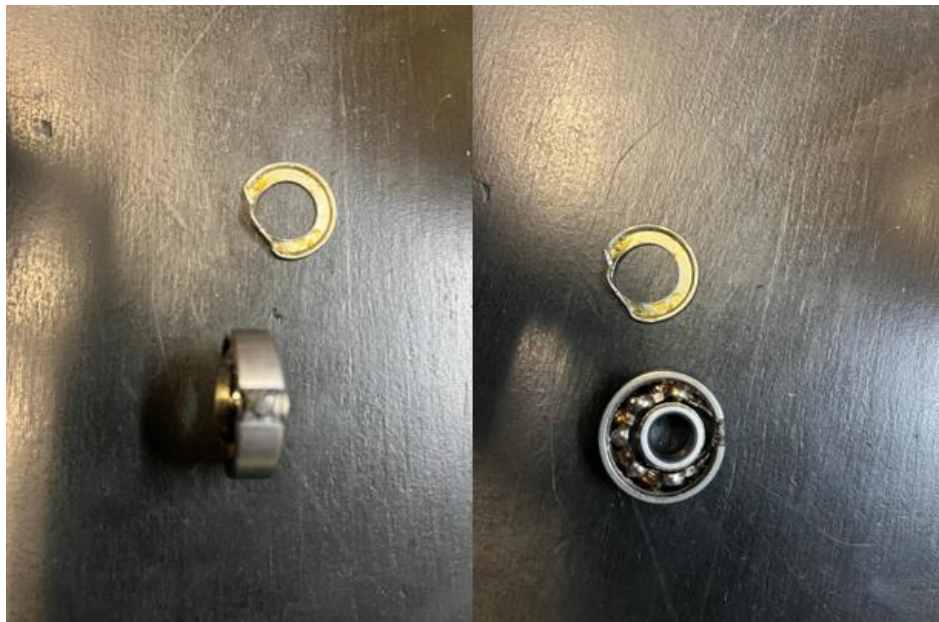
Figure 7: Damage to the bearing.

8. The annual inspection on the aircraft was conducted on 8 December 2023 at 141 hours. The aircraft accrued 4.9 hours since the last annual inspection. The investigation could not determine the time of the landing gear failure; however, the flat surface had developed some time in the past.

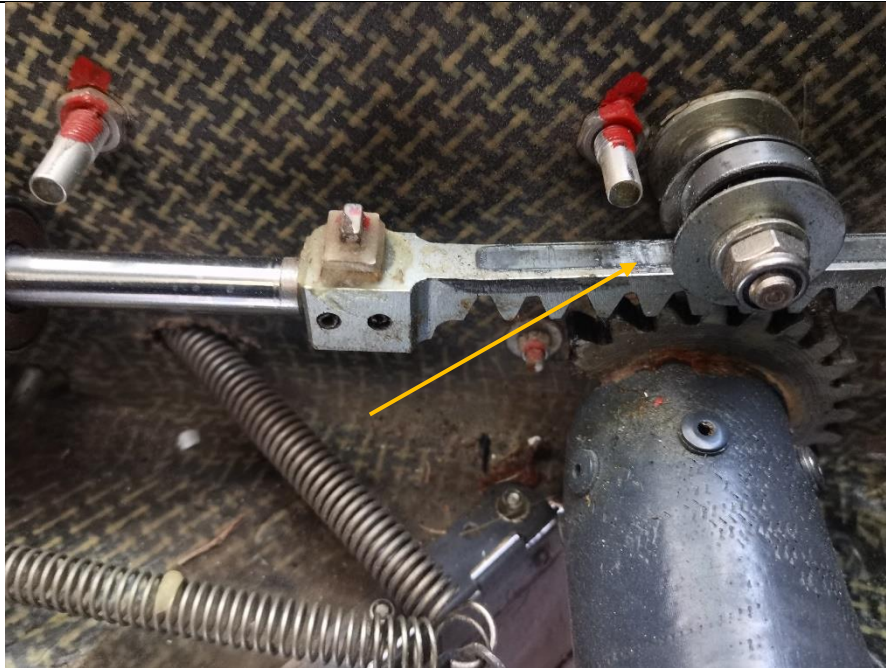
Figure 8: The scarred landing gear track.

10. The damage to the landing gear track was caused by the collapse of the bearing (Figure 8) which made a gap between the track and the strut gears.
11. It is unlikely that the maintenance team would have noticed the anomaly because the Aircraft Maintenance Schedule [figure 9, 1.4 (4)] specifies the inspection of the retraction and locking mechanism, thus, it is probable that it was not properly inspected, or it was missed during the last maintenance.
