**LIMITED OCCURRENCE INVESTIGATION REPORT – FINAL**

<b>Reference Number</b>	CA18/2/3/10453						
<b>Classification</b>	Accident		<b>Date</b>	11 May 2024		<b>Time</b>	1100Z
<b>Type of Operation</b>	Private (Part 94)						
<b>Place of Departure</b>	Delareyville Aerodrome (FADL) North West Province		<b>Place of Landing</b>		Springs Aerodrome (FASI), Gauteng Province		
<b>Place of Occurrence</b>	Private farm outside Delareyville Aerodrome (FADL) in North West Province						
<b>GPS Co-ordinates</b>	<b>Latitude</b>	26° 41' 52.96" S	<b>Longitude</b>	025° 28' 07.54" E	<b>Elevation</b>	4 434 ft	
<b>Aircraft Information</b>							
<b>Registration</b>	ZU-EGA						
<b>Make; Model; S/N</b>	Magni Gyro; M-22 (Serial Number: 22-06-3554)						
<b>Damage to Aircraft</b>	Minor		<b>Total Aircraft Hours</b>	1 229.0			
<b>Pilot-in-command</b>							
<b>Licence Type</b>	Airline Transport Pilot Licence (ATPL)		<b>Gender</b>	Male		<b>Age</b>	56
<b>Licence Valid</b>	Yes		<b>Total Hours</b>	4 900		<b>Total Hours on Type</b>	883

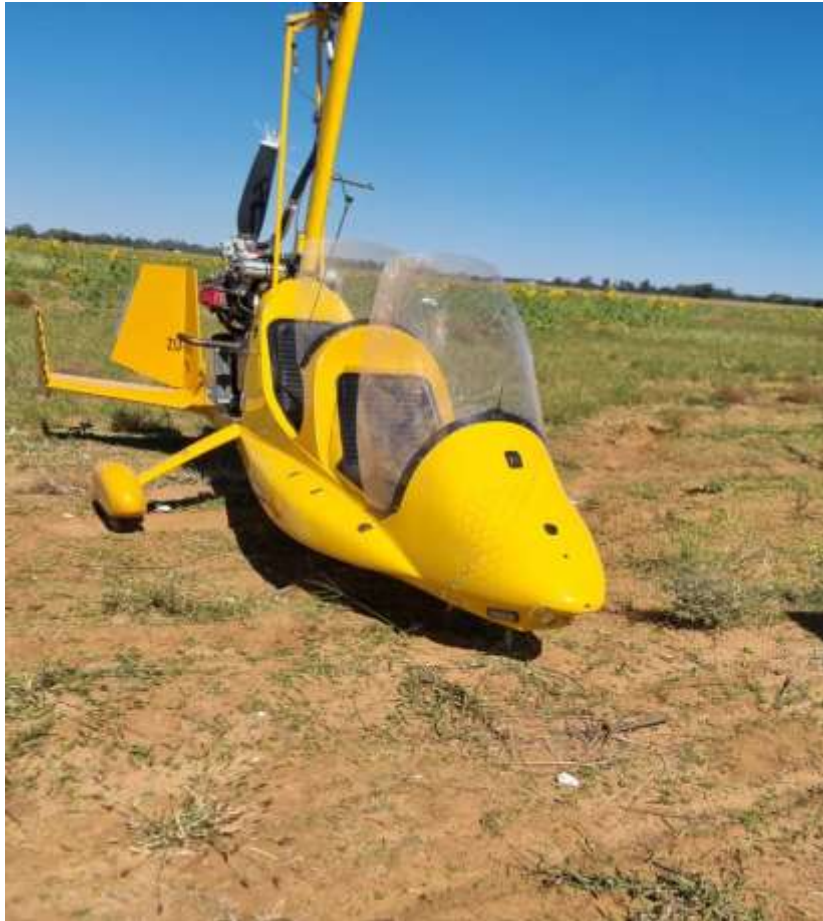
**Figure 1:** The aircraft after it was recovered from the sunflower field. (Source: Pilot)

The aircraft was overweight during take-off, and it lost height during the initial climb. The pilot conducted a forced landing on a farm and the nose wheel was caught in a furrow, which caused the gear strut to buckle.
