LIMITED OCCURRENCE INVESTIGATION REPORT – FINAL

Reference Number	CA18/2/3/10454							
Classification	Accident			Date	14 May 2024		Time	0648Z
Type of Operation	Training (Part 141)							
Location								
Place of Departure	Port Alfred Aerodrome (FAPA), Eastern Cape Province			Place of Intended Landing	Port Alfred Aerodrome (FAPA), Eastern Cape Province			
Place of Occurrence	Left of Runway 10L at FAPA, Eastern Capen Province							
GPS Co-ordinates	Latitude	33°33'16.38" S	Longitude	26°52'29.93" E	Elevation	319ft		
Aircraft Information								
Registration	ZS-IKJ							
Make; Model; S/N	Piper PA-28 180F (Serial Number: 28-7105145)							
Damage to Aircraft	Substantial			Total Aircraft Hours	18547			
Pilot-in-command								
Licence Type	Student Pilot Licence (SPL)		Gender	Male		Age	28	
Licence Valid	Yes	Total Hours	31.8		Total Hours on Type	31.8		
Total Hours 30 Days	6.5		Total Flying on Type Past 90 Days	28.4				
People On-board	1+1	Injuries	0	Fatalities	0	Other (on ground)	0

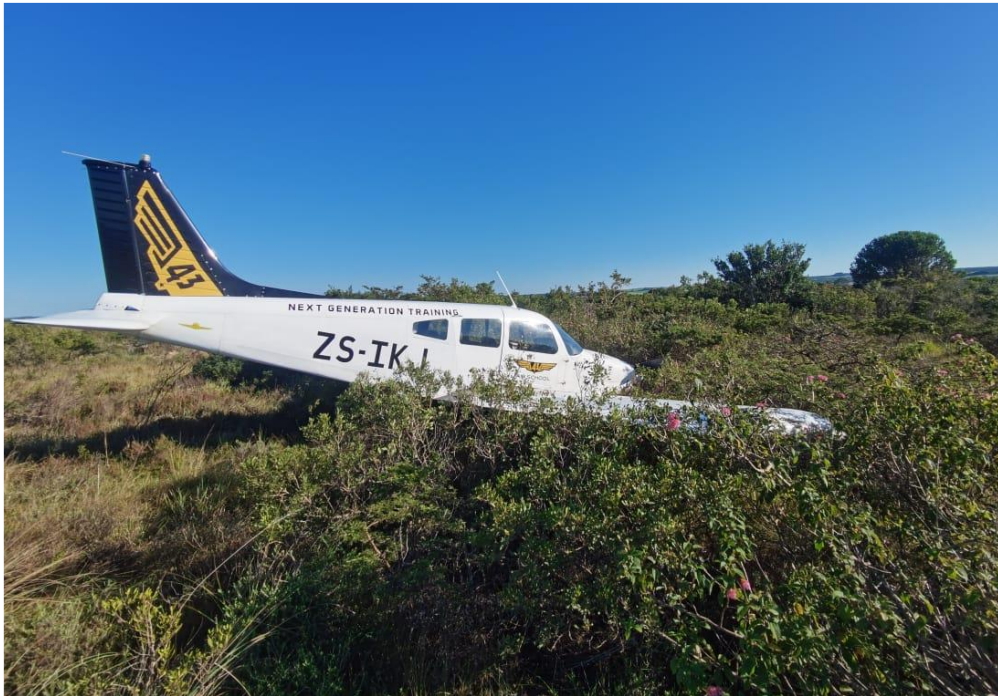
turned off the master switch, as well as removed the key from the ignition slot. The aircraft's nose wheel had failed, and the right-wing leading edge and the propeller were damaged. No person was injured.

Figure 1: The aircraft came to rest on the left side of the runway. (Source: Operator)

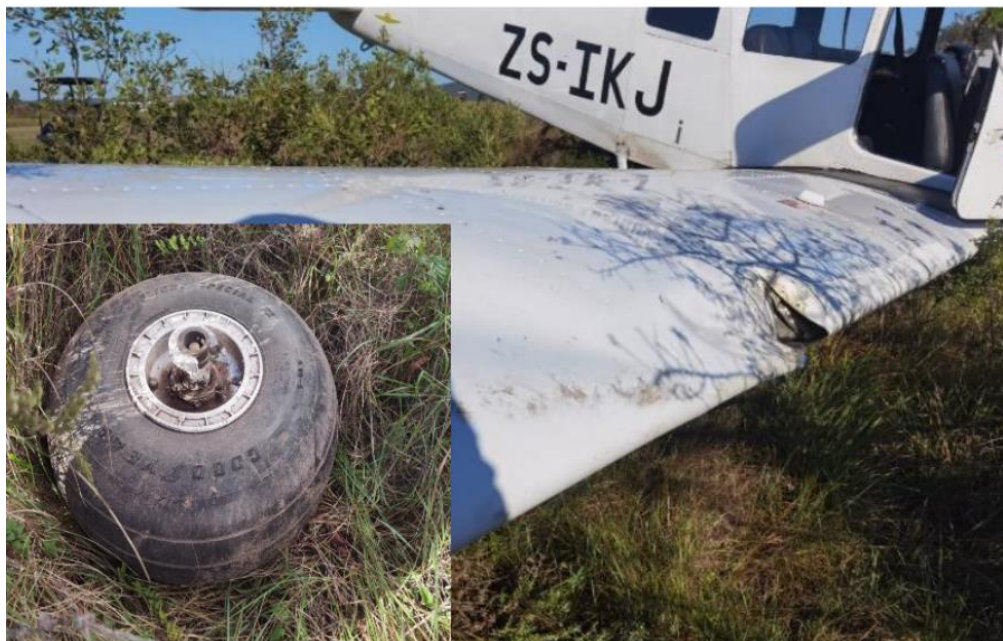
Figure 2: The nose gear that broke off and the damaged right-side wing. (Source: Operator)

<p>2. <u>Aircraft Information</u></p> <p>2.1 The last mandatory periodic inspection (MPI) that was conducted on the aircraft before the accident flight was certified on 22 March 2024 at 18 478.0 airframe hours with an expiry date of 21 March 2025 or at 18 578 airframe hours, whichever comes first. The accident occurred at 18 547 total flight hours, which meant that the aircraft had accrued 69 hours since the last inspection.</p> <p>2.2 The aircraft had a valid Certificate of Airworthiness (C of A) that was initially issued by the Regulator on 3 September 2019. The latest C of A was issued on 15 May 2023 with an expiry date of 10 June 2024. The aircraft was airworthy when it was dispatched for the flight.</p> <p>2.3 The aircraft's Certificate of Registration (C of R) was issued to the present owner on 19 July 2017.</p> <p>2.4 The aircraft was issued a Certificate of Release to Service (CRS) on 22 March 2024 with an expiry date of 21 March 2025 or at 18 578 airframe hours, whichever occurs first.</p> <p>2.5 The aircraft maintenance organisation (AMO) had a valid AMO Certificate that was issued on 4 October 2023 with an expiry date of 30 September 2024. The aircraft maintenance engineer (AME) had a valid AME Certificate that was issued on 21 January 2024 with an expiry date of 21 August 2024. The AME had an airframe rating on the aircraft type.</p> <p>2.6 The aircraft flew past the reference point (240 metres from the threshold) at a height of approximately 290 ft AGL instead of 10 to 20 ft (as prescribed in the FAA Flying Handbook) AGL for flaring and a smooth landing. The aircraft was flared too high which resulted in a hard landing with the nose gear first. The nose gear failed before the aircraft veered off to the left of the runway.</p>

<p>Probable Cause(s)</p>
<p>The aircraft's height above ground level was too high on the final approach and the pilot flared the aircraft which resulted in a hard landing with the nose gear first which subsequently failed. This led to a runway excursion to the left.</p>
<p>Contributing Factor(s)</p>
<p>Failure to execute a go-around.</p>
<p>Safety Action(s)</p>
<p>None.</p>
<p>Safety Message and/or Safety Recommendation/s</p>
<p>None.</p>
<p>About this Report</p>
<p><i>The decision to conduct a limited investigation is based on factors including whether the cause is known and the evidence supporting the cause is clear, the level of safety benefit likely to be obtained from an investigation and that will determine the scope of an investigation. For this occurrence, a limited investigation has been conducted, and the Accident and Incident Investigations Division (AIID) has relied on the information submitted by the affected person/s and organisation/s to compile this limited report. The report has been compiled using information supplied in the initial notification, as well as from follow-up desk top enquiries to bring awareness of potential safety issues to the industry in respect of this occurrence, as well as possible safety action/s that the industry might want to consider in preventing a recurrence of a similar occurrence.</i></p>
