LIMITED OCCURRENCE INVESTIGATION REPORT – FINAL

Reference Number	CA18/2/3/10455						
Classification	Accident	Date	29 April 2024		Time	0915Z	
Type of Operation	Private (Part 94)						
Location							
Place of Departure	Groutville Airfield near Ballito, KwaZulu-Natal Province		Place of Intended Landing		Vryheid Airfield (FAVY), KwaZulu-Natal Province		
Place of Occurrence	Runway 19 at Vryheid Airfield (FAVY), KwaZulu-Natal Province						
GPS Co-ordinates	Latitude	27°47'13.01" S	Longitude	30°48'01.69" E	Elevation	3 800ft	
Aircraft Information							
Registration	ZU-ITV						
Make; Model; S/N	SkyReach Aircraft; Cheetah XLS Bushcat (Serial Number: CH-163C)						
Damage to Aircraft	Minor		Total Airframe Hours		112.8		
Pilot-in-command							
Licence Type	Private Pilot Licence (PPL)		Gender	Male		Age	53
Licence Valid	Yes	Total Hours	236.4		Total Hours on Type	52.5	
Total Hours 30 Days	15.4		Total Flying Hours on Type Past 90 Days		15.4		
People On-board	1 + 0	Injuries	0	Fatalities	0	Other (On the ground)	0

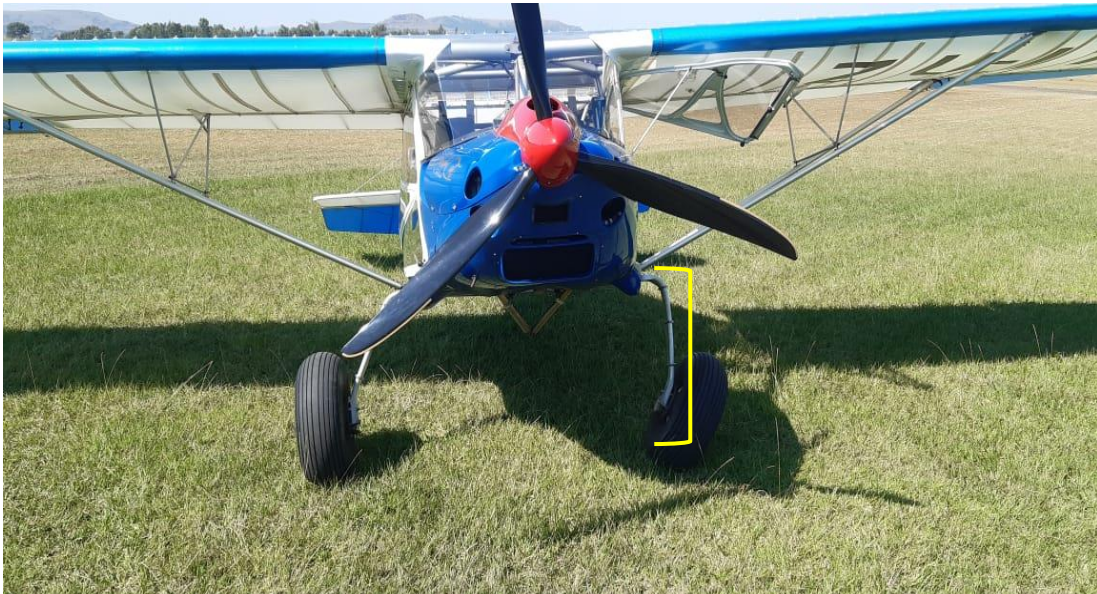
The pilot selected two notches of flaps in preparation for landing on Runway 19 which was 944 metres (m) in length. According to the pilot, the approach was stable. After touchdown, the aircraft veered off to the left. The pilot applied right rudder to maintain heading, but the aircraft continued to drift to the left and came to a halt outside the demarcated landing area. The pilot switched off the master and disembarked from the aircraft; he was unharmed. Post-accident examination of the aircraft indicated a bent spring aluminium on the left main gear strut. The main landing gear tyres showed no signs of flat spots.

Figure 1: The aircraft at the accident site with a bent left main gear strut. (Source: Pilot)

It is possible that the aircraft was unstable during approach, and it touched down hard with the left main wheel first; consequently, the left main gear strut bent.

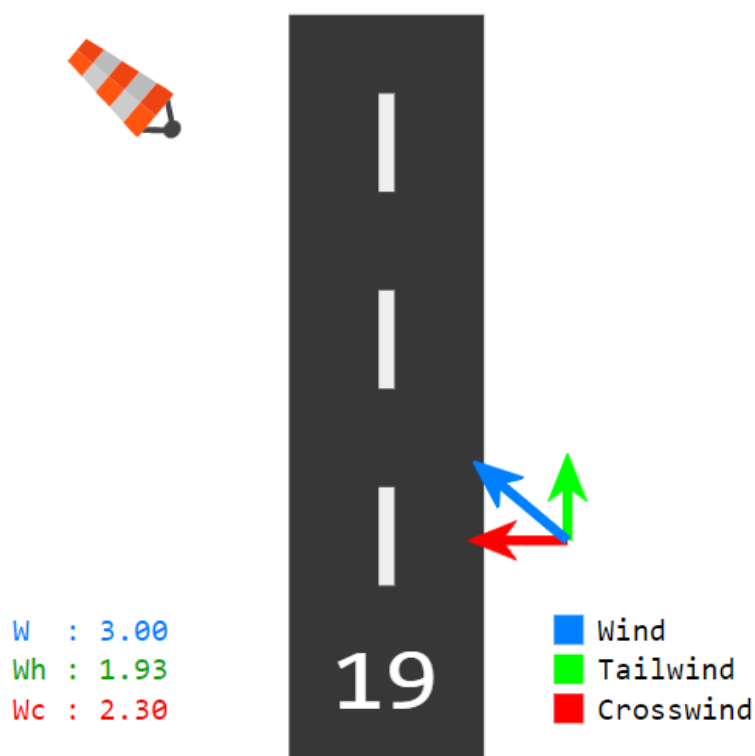
Crosswind Component

The crosswind component at the time of the flight was calculated to be 3 knots from the right. A Cheetah XLS Bushcat aircraft has a maximum crosswind velocity of 32 miles per hour (mph) (27 knots) demonstrated at full flap setting. There should be no challenge maintaining the runway centreline during the 3 knots crosswind condition.
