LIMITED OCCURRENCE INVESTIGATION REPORT – FINAL

Reference Number	CA18/2/3/10456						
Classification	Accident	Date	10 February 2024	Time	1025Z		
Type of Operation	Private (Part 94)						
Location							
Place of Departure	Morningstar Airfield, Western Cape Province	Place of Intended Landing	Klipfontein Airfield near Bonnievale, Western Cape Province				
Place of Occurrence	Private Airstrip near Bonnievale, Western Cape Province						
GPS Co-ordinates	Latitude	S34°03'43"S	Longitude	E20°09'51" E	Elevation	252 ft	
Aircraft Information							
Registration	ZU-FUR						
Make; Model; S/N	Paul Grobler; RV-7 (Serial Number: 73951)						
Damage to Aircraft	Substantial	Total Aircraft Hours	627.14				
Pilot-in-command							
Licence Type	Private Pilot Licence (PPL)	Gender	Male	Age	58		
Licence Valid	Yes	Total Flying Hours	759.29	Total Hours on Type	441.0		
Total Hours 30 Days	2.0		Total Flying on Type Past 90 Days	5.0			
People On-board	1+0	Injuries	0	Fatalities	0	Other (on the ground)	0

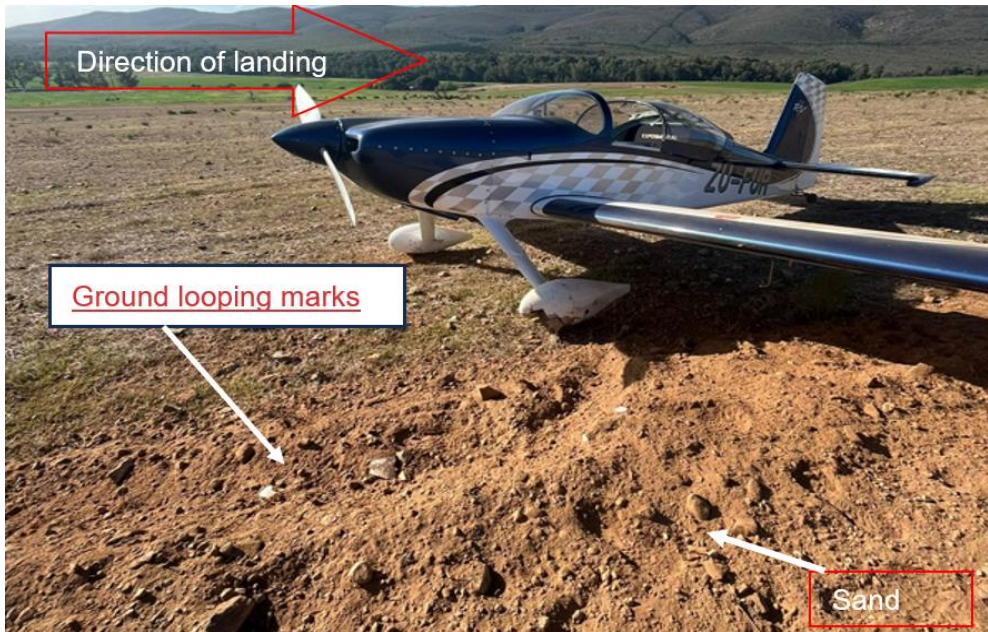
What Happened							
<p>On 10 February 2024, a pilot on-board a Vans RV-7 aircraft with registration ZU-FUR took off on a private flight from Morningstar Airfield in the Western Cape province to Klipfontein Airfield near Bonnievale in the same province when the accident occurred. The flight was conducted under visual meteorological conditions (VMC) by day and under the provisions of Part 94 of the Civil Aviation Regulations (CAR) 2011 as amended.</p> <p>The pilot stated that he conducted a pre-flight inspection on the aircraft and no anomalies were found. The flight segment from Morningstar Airfield to Klipfontein Airfield was uneventful. Once at Klipfontein Airfield, the pilot assessed the weather conditions which favoured Runway 26. The approach was initiated at a speed of 75 knots (kts) (138 kilometres per hour) with the flaps selected to 40 degrees. According to the Pilot's Operating Handbook (POH), the approach speed of the aircraft ranges from 70 to 80 kts, and the recommended landing speed is 70 to 75 kts.</p> <p>The pilot reported that the aircraft touched down on the threshold of Runway 26. However, during the landing roll whilst the aircraft was approximately halfway (about 200 metres) down the dirt runway, he lost directional control and the aircraft ground looped to the left. The left-wing tip</p>

impacted the ground before the aircraft came to a halt facing the direction from which it had approached. The aircraft was substantially damaged. The pilot vacated the aircraft unharmed.

Figure 2: Ground loop marks on the dirt runway. (Source: Operator)

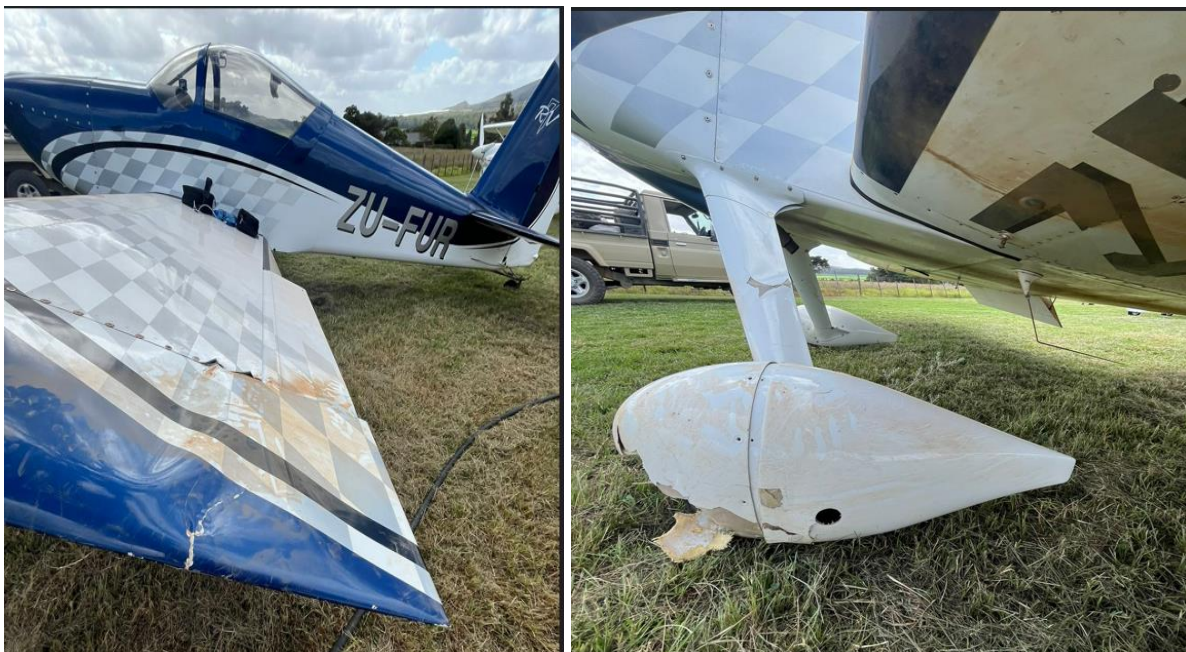
Figure 3: The damage sustained to the left wing (left picture). The damaged left main gear wheel fairing (right picture). (Source: Pilot)

The pilot lost directional control of the aircraft during the landing roll which caused the aircraft to ground loop.

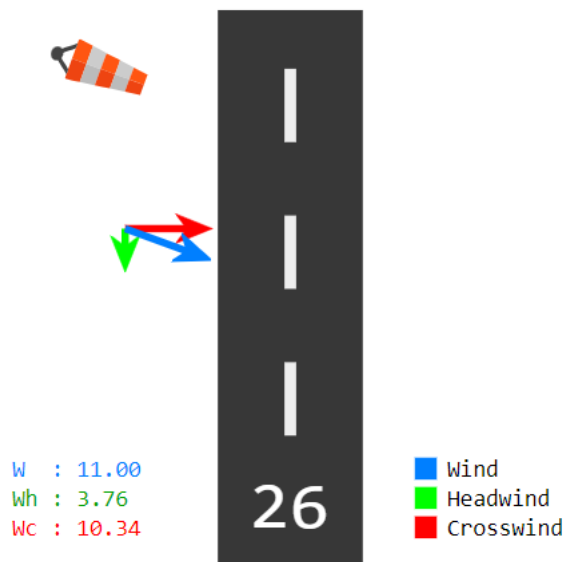
- The weather report indicated a crosswind component of 11 kts during landing.
- The crosswind component which refers to the maximum crosswind velocity that an aircraft can effectively handle during take-off and landing is not specified in the Van’s RV-7 POH.
