LIMITED OCCURRENCE INVESTIGATION REPORT – FINAL

Reference Number	CA18/2/3/10457						
Classification	Accident	Date	27 May 2024			Time	0848Z
Type of Operation	Training (Part 141)						
Location							
Place of Departure	Virginia Aerodrome (FAVG), KwaZulu-Natal Province		Place of Intended Landing		Virginia Aerodrome (FAVG), KwaZulu-Natal Province		
Place of Occurrence	Runway 23 Virginia Aerodrome						
GPS Co-ordinates	Latitude	29°46'15" S	Longitude	031°03'30.39" E	Elevation	25 ft	
Aircraft Information							
Registration	ZU-WNW						
Make; Model; S/N	Sling Aircraft Factory; Sling 4TSI (Serial Number: 366s)						
Damage to Aircraft	Substantial			Total Aircraft Hours	127		
Pilot-in-command							
Licence Type	Student Pilot Licence (SPL)		Gender	Male		Age	57
Licence Valid	Yes	Total Hours	36.0		Total Hours on Type	13.9	
Total Hours Past 30 Days	12.4		Total Flying Hours on Type Past 90 Days			13.9	
People On-board	1 + 0	Injuries	0	Fatalities	0	Other (on ground)	0

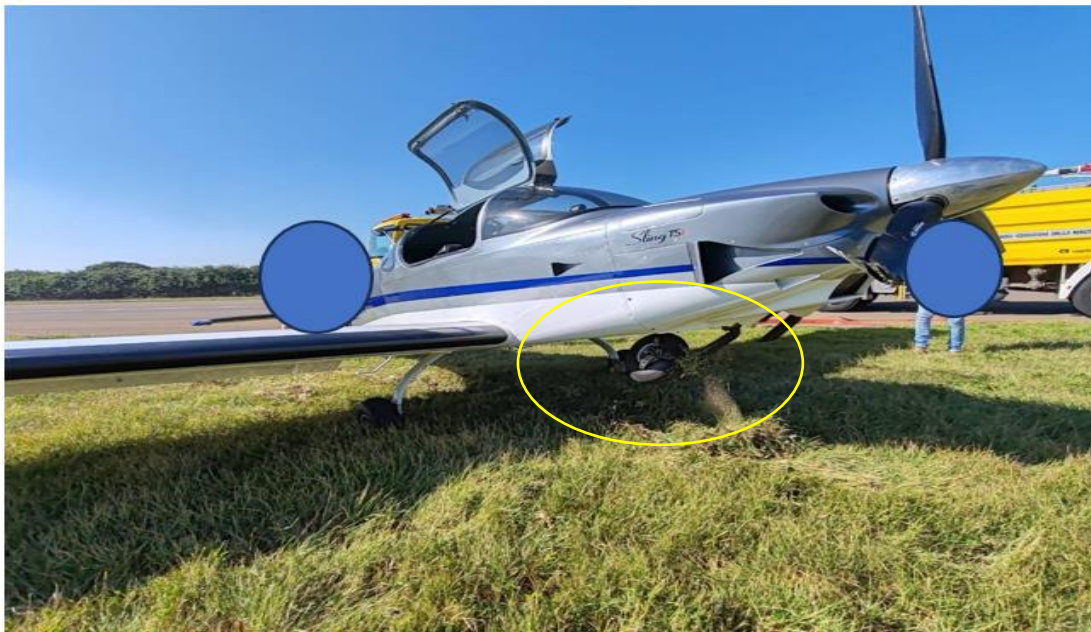
Figure 2: The aircraft at the accident site with the collapsed nose gear (yellow circle). (Source: CFI)

The student pilot landed the aircraft without flaring and with the nose gear first; as a result, the nose gear failed, and the propeller struck the runway.

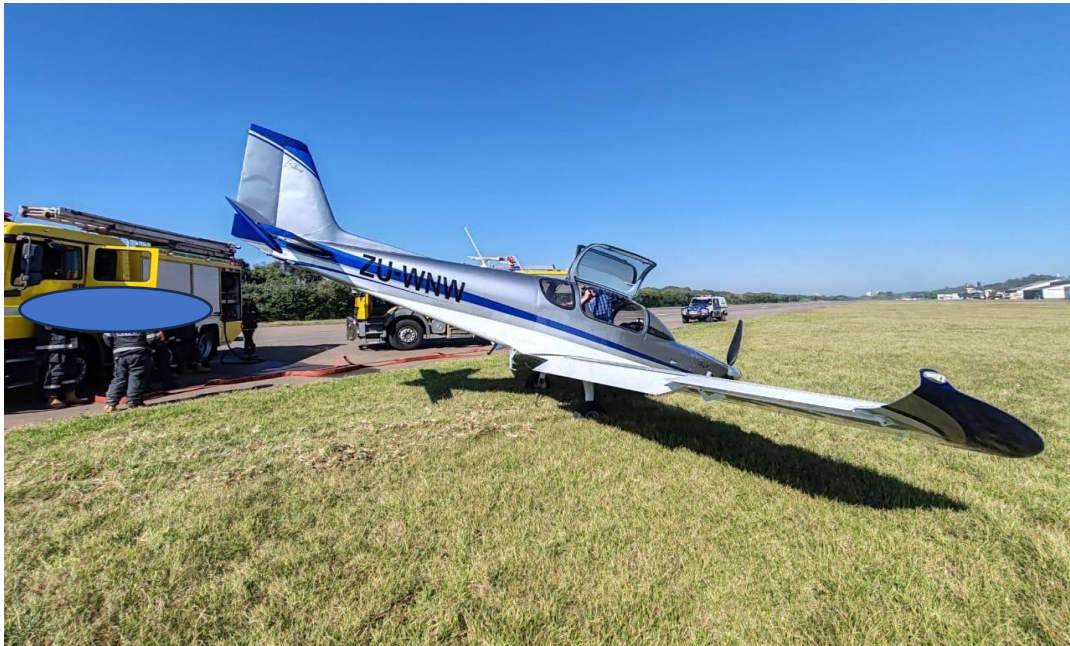
Figure 3: A side view of the aircraft at the accident site. (Source: CFI)
