LIMITED OCCURRENCE INVESTIGATION REPORT – FINAL

Reference Number	CA18/2/3/10458					
Classification	Accident	Date	30 May 2024	Time	1015Z	
Type of Operation	Private (Part 94)					
Location						
Place of Departure	Port Elizabeth Airport (FAPE), Eastern Cape Province		Place of Intended Landing	Wings Park Aerodrome, Eastern Cape Province		
Place of Occurrence	Runway 22 at Wings Park Aerodrome near East London, Eastern Cape Province					
GPS Co-ordinates	Latitude	32° 49'31.1" S	Longitude	027° 50'07.7" E	Elevation	1 278 ft
Aircraft Information						
Registration	ZU-EWJ					
Make; Model; S/N	Yakovlev; YAK52 (Serial Number: 855406)					
Damage to Aircraft	Substantial		Total Aircraft Hours	1 229.0		
Pilot-in-command						
Licence Type	Airline Transport Pilot Licence (ATPL)		Gender	Male	Age	56
Licence Valid	Yes	Total Hours	4 900	Total Hours on Type	12.5	
Total Hours 30 Days	24.5		Total Flying on Type Past 90 Days	12.5		
People on-board	1+0	Injuries	0	Fatalities	0	Other (on ground) 0

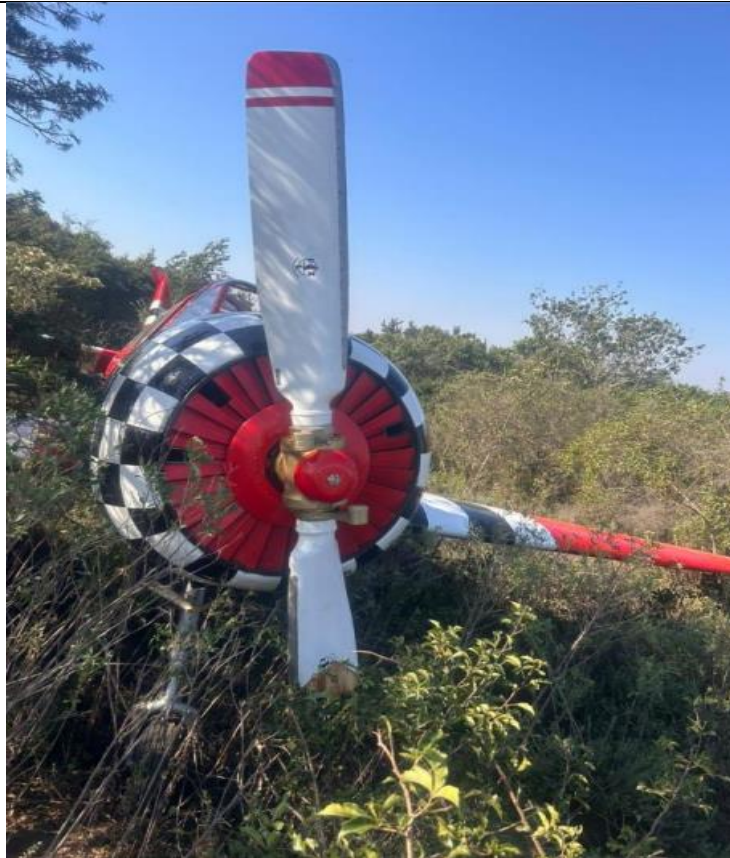
Figure 1: The damaged propeller. (Source: Operator)

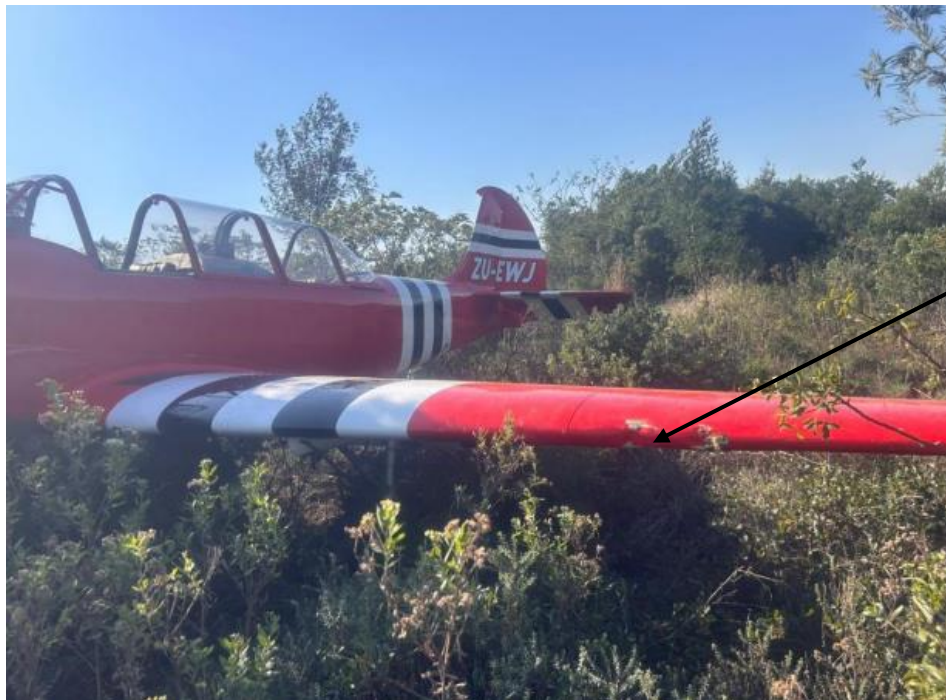
Figure 2: The dented left wing leading edge. (Source: Operator)

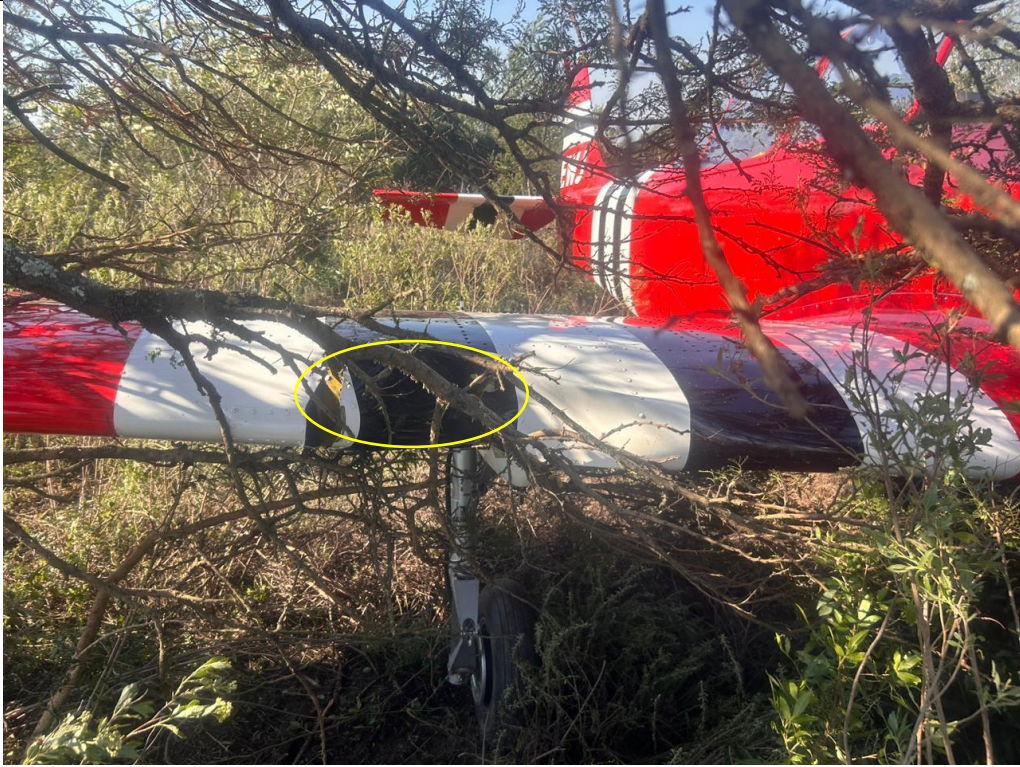
Figure 3: The damaged right wing (indicated in the yellow circle). (Source: Operator)

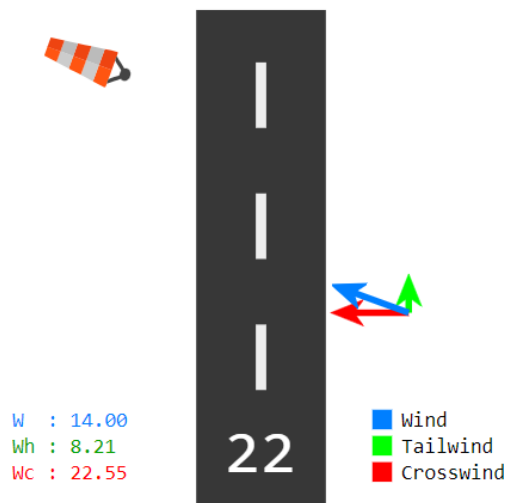
Figure 4: Wind, tailwind and crosswind calculations. (Source: <https://e6bx.com/wind-components/>)

- Figure 4 indicates a crosswind of 22.4 kts and a tailwind of 8.21 kts.
- The crosswind component that an aircraft can endure during take-off and landing is specified in the YAK52 Flight Manual as 11.6 kts (6 metres per second). The crosswind at the time of the accident was 10.8 knots more than the maximum crosswind velocity a YAK52 aircraft can endure.
- The maximum wind speed on take-off and landing in headwind is 29 kts (15 metres per second).

4. At the time of the flight, the wind was 14 kts gusting 24 kts with a crosswind of 22.4 kts. The aircraft's maximum crosswind is 11.6 kts. The aircraft was operated in a crosswind that is 10.8 kts more than its maximum crosswind.
