LIMITED OCCURRENCE INVESTIGATION REPORT – FINAL

Reference Number	CA18/2/3/10459						
Classification	Accident	Date	6 June 2024		Time	1415Z	
Type of Operation	Private (Part 94)						
Location							
Place of Departure	Middleburg Airfield (FAMB), Mpumalanga Province		Place of Intended Landing		Paradise Creek Game Farm Private Airstrip, Mpumalanga Province		
Place of Occurrence	Left side of Runway 32 at Paradise Creek Game Farm						
GPS Co-ordinates	Latitude	23° 25' 29.65" S	Longitude	28° 13' 02.22" E	Elevation	3 123 ft	
Aircraft Information							
Registration	ZU-PAT						
Make; Model; S/N	Kitfox II (Serial Number: 649)						
Damage to Aircraft	Substantial			Total Aircraft Hours	215		
Pilot-in-command							
Licence Type	Private Pilot Licence (PPL)		Gender	Male		Age	53
Licence Valid	Yes	Total Hours	363.1		Total Hours on Type	290	
Total Hours 30 Days	4.5		Total Flying on Type Past 90 Days	29			
People On-board	1+0	Injuries	0	Fatalities	0	Other (on ground)	0

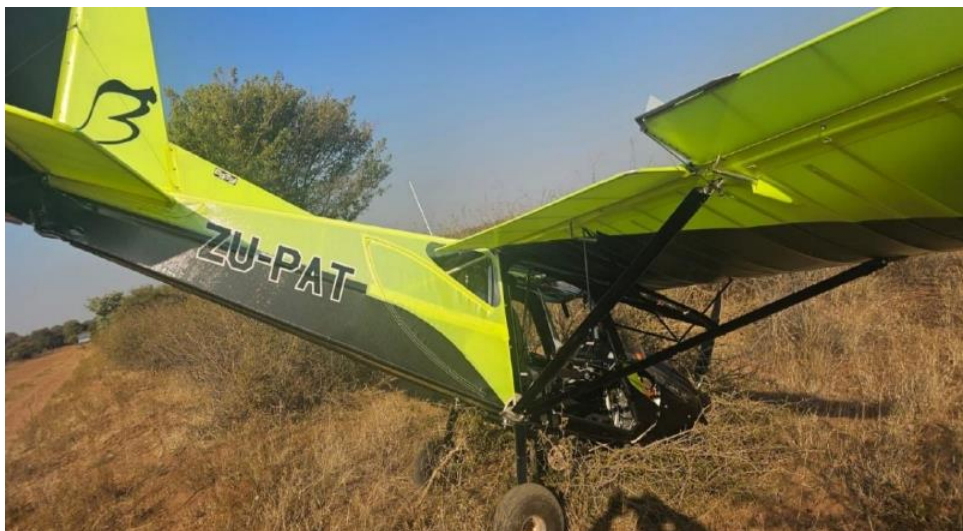
Figure 2: The aircraft after the accident. (Source: Pilot)

The pilot stated that after the aircraft had come to a stop, he disembarked to inspect it and found that the left main landing gear tyre had deflated.

7.	The aircraft's left main landing gear tyre had deflated; after landing, the aircraft veered off to the left and impacted the bushy terrain.
Probable Cause(s)	
The aircraft's left main landing gear tyre had deflated, and after landing, the aircraft veered off to the left and impacted the bushy terrain.	
Contributing Factor(s)	
None.	
Safety Action(s)	
None.	
Safety Message and/or Safety Recommendation/s	
None.	
About this Report	
<p><i>The decision to conduct a limited investigation is based on factors including whether the cause is known and the evidence supporting the cause is clear, the level of safety benefit likely to be obtained from an investigation and that will determine the scope of an investigation. For this occurrence, a limited investigation has been conducted, and the Accident and Incident Investigations Division (AIID) has relied on the information submitted by the affected person/s and organisation/s to compile this limited report. The report has been compiled using information supplied in the initial notification, as well as from follow-up desk top enquiries to bring awareness of potential safety issues to the industry in respect of this occurrence, as well as possible safety action/s that the industry might want to consider in preventing a recurrence of a similar occurrence.</i></p> <p><i>All times given in this report are Co-ordinated Universal Time (UTC) and will be denoted by (Z). South African Standard Time is UTC plus 2 hours.</i></p>
