LIMITED OCCURRENCE INVESTIGATION REPORT – DRAFT

Reference Number	CA18/2/3/10460						
Classification	Accident	Date	08 June 2024		Time	0740Z	
Type of Operation	Private (Part 94)						
Location							
Place of Departure	Stellenbosch Aerodrome (FASH), Western Cape Province		Place of Intended Landing		Caledon Airfield (FACG), Western Cape Province		
Place of Occurrence	Strawberry farm, approximately 500 metres (m) from the threshold of Stellenbosch Aerodrome (FASH) Runway 19						
GPS Co-ordinates	Latitude	33°59.1476' S	Longitude	018°49.4180' E	Elevation	337 ft	
Aircraft Information							
Registration	ZU-DWK						
Make; Model; S/N	Jabiru; J160C (Serial Number: 018)						
Damage to Aircraft	Substantial			Total Aircraft Hours	2 540.8		
Pilot-in-command							
Licence Type	Commercial Pilot Licence (CPL) Aeroplane		Gender	Male		Age	40
Licence Valid	Yes	Total Hours	1 265		Total Hours on Type	274	
Total Hours 30 Days	2.5		Total Hours on Type Past 90 Days		78

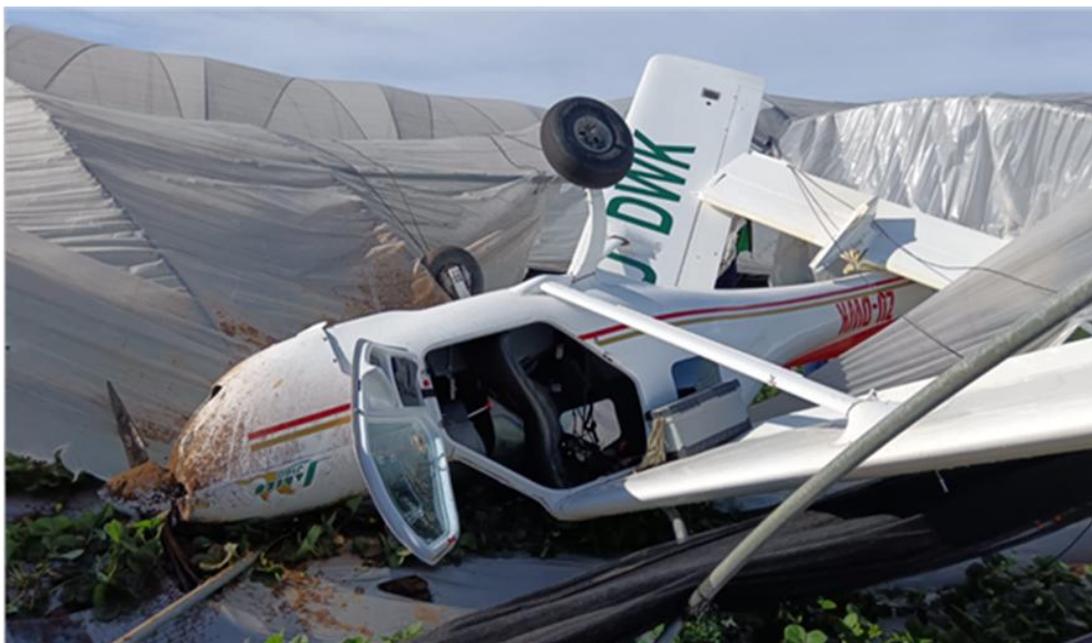
a forced landing on a field; the aircraft crash-landed on a strawberry crop field (farm) near FASH. The aircraft's fuselage, wings, empennage, landing gears and the propeller blades were damaged. The pilot sustained minor injuries and the passenger was unharmed. Third party damage was limited to the strawberry crops and the plastic sunshade that was used to cover (protect) the crops.

Figure 2: The aircraft rested on the strawberry crops which were covered with a plastic sunshade. (Source: Pilot)

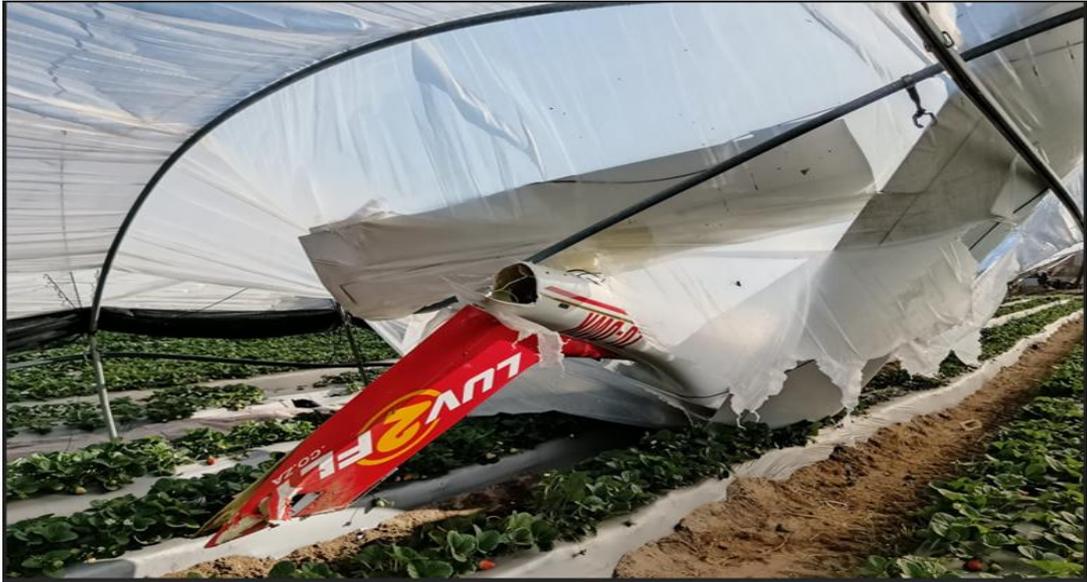
Figure 3: The teared plastic sunshade and the damaged crops. (Source: Pilot)

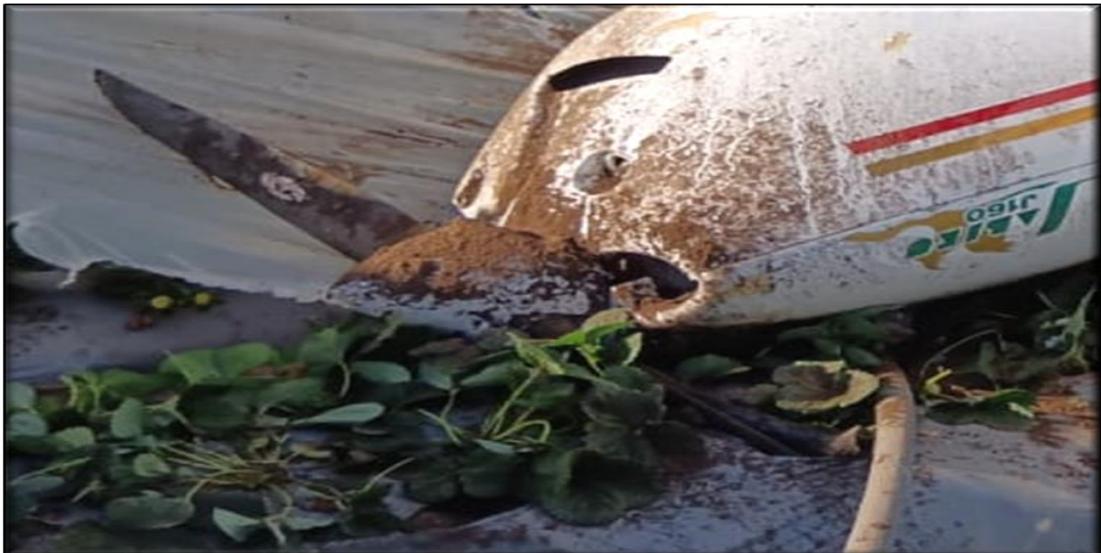
Figure 4: Unbent propeller blades after the crash. (Source: Pilot)
