AIRCRAFT ACCIDENT REPORT AND EXECUTIVE SUMMARY

Reference:		CA18/2/3/10461	
Aircraft Registration	ZS-URO	Date of Accident	11 June 2024		Time of Accident	0635Z	
Type of Aircraft	Cessna 182T Skylane			Type of Operation	Private (Part 91)		
Pilot-in-command Licence Type	Commercial Pilot Licence (CPL)		Age	48	Licence Valid	Yes	
Pilot-in-command Flying Experience	Total Flying Hours		6 279.8		Hours on Type	1 202.0	
Last Point of Departure	Mooketsi Airstrip near Tzaneen, Limpopo Province						
Next Point of Intended Landing	Esme 4 Farm Airstrip, Limpopo Province						
Damage to the Aircraft	Substantial						
Location of the accident site with reference to easily defined geographical points (GPS readings if possible)							
Approximately 19 nautical miles (nm) from Mooketsi Airstrip on public road D3732 near Tzaneen, Limpopo province (GPS position: 23°34'00" South 030°09' 00" East), at an elevation of 2 300 feet (ft)							
Meteorological Information	Temperature: 13.3°C; Dew point: 9.7°C; Cloud: Broken stratocumulus

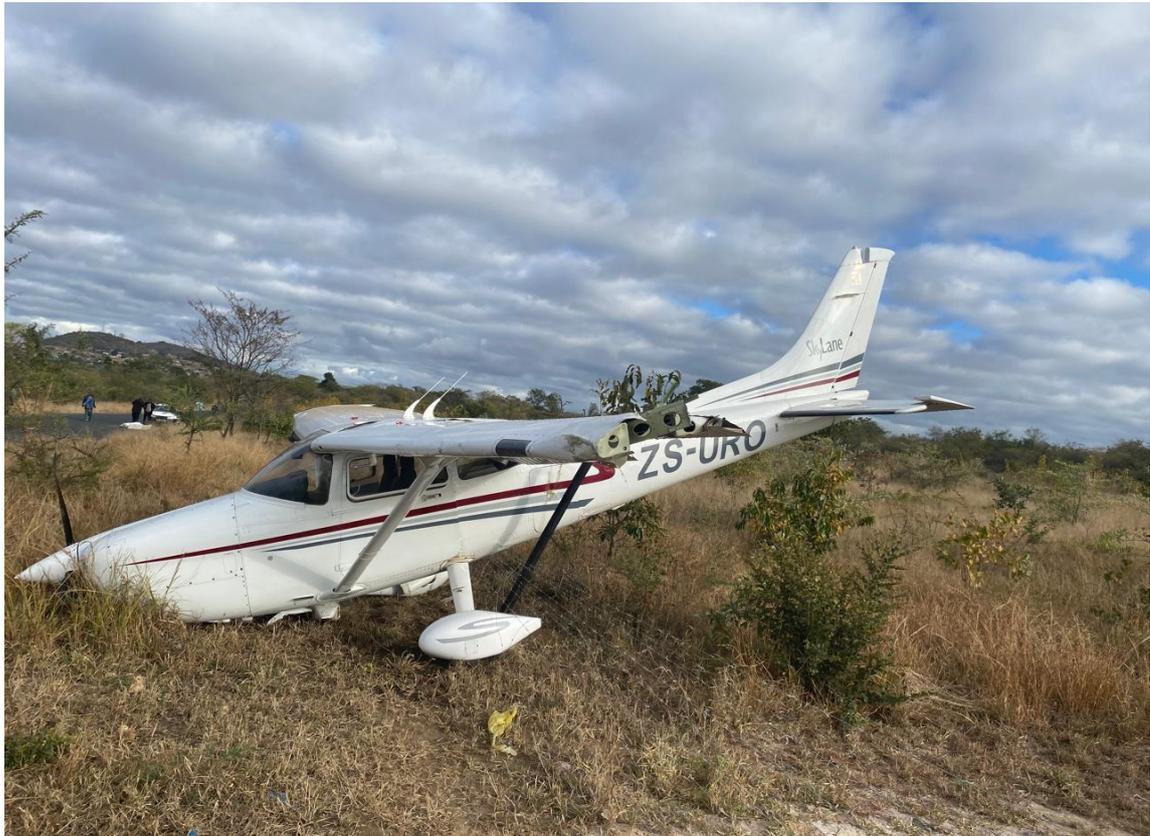
1.3.1. The aircraft sustained substantial damage.

Figure 2: The aircraft as it came to rest next to the road. (Source: Pilot)

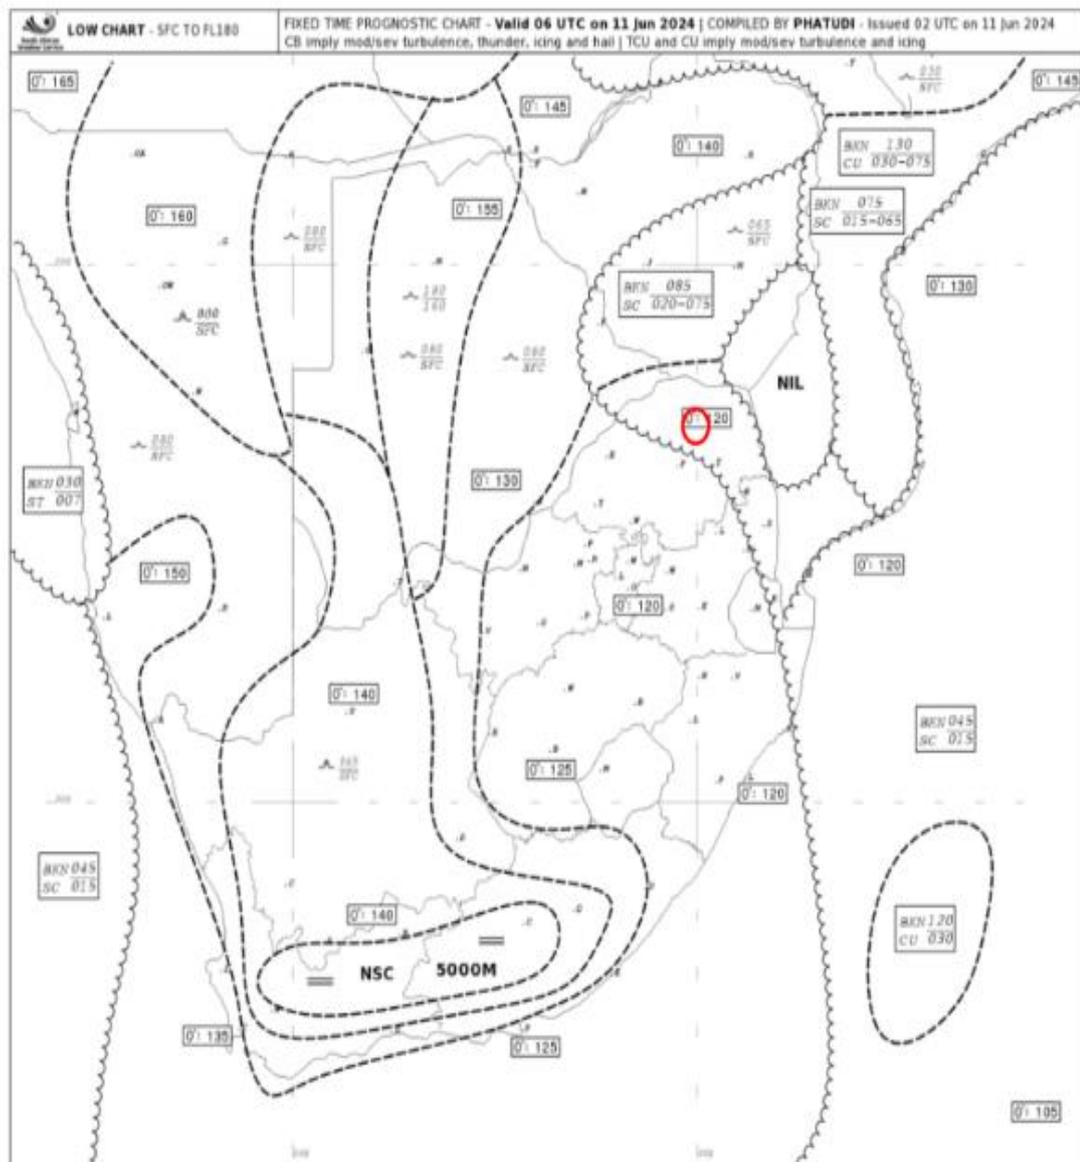
1.7.1. At the time of the accident, broken stratocumulus clouds prevailed (see Figure 5). Given the stated forecast and observations, the significant weather at the time of the accident may have been broken stratocumulus cloud. Moreover, the pilot stated that he flew through broken clouds.

Figure 5: Low-level significant weather chart valid until 0900Z. The accident area is highlighted in red. (Source: South African Weather Service)

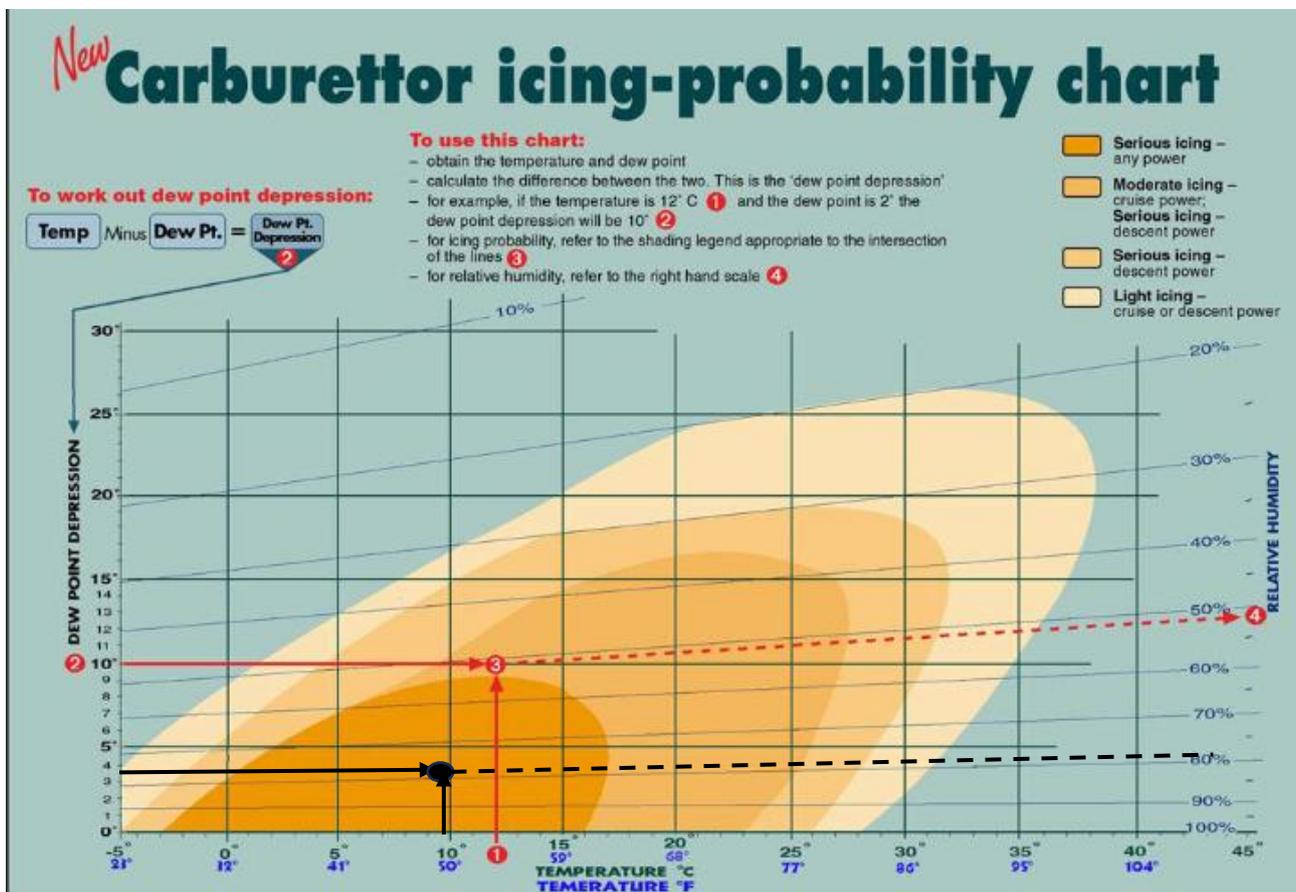
1.7.3. According to the information derived from 1.7.2, the approximate dew point temperature was 9.7°C. The calculated dew point depression (3.6°C) suggested that the weather conditions

at the time of the accident were conducive for the formation of serious carburettor icing at any power setting. Therefore, these conditions increased the likelihood of carburettor icing (as indicated by the black solid line, along with the black dot, in Figure 7).

Temperature	13.3 °C
Dewpoint	9.7°C
Dewpoint depression	3.6°C
Relative humidity	79%

Figure 7: Carburettor icing probability chart.

- 2.2.7. The corresponding dew point depression placed the weather conditions (temperature 13°C; dew point 10°C) within the range that was conducive to the formation of serious carburettor icing at any power setting. The ambient temperature and humidity levels were conducive to carburettor ice formation. High relative humidity (79%) significantly increased the potential for ice accumulation within the carburettor venturi which led to airflow restriction and fuel-air mixture imbalance. The reported symptoms, including engine unresponsiveness and loss of power, were consistent with the effects of carburettor icing.

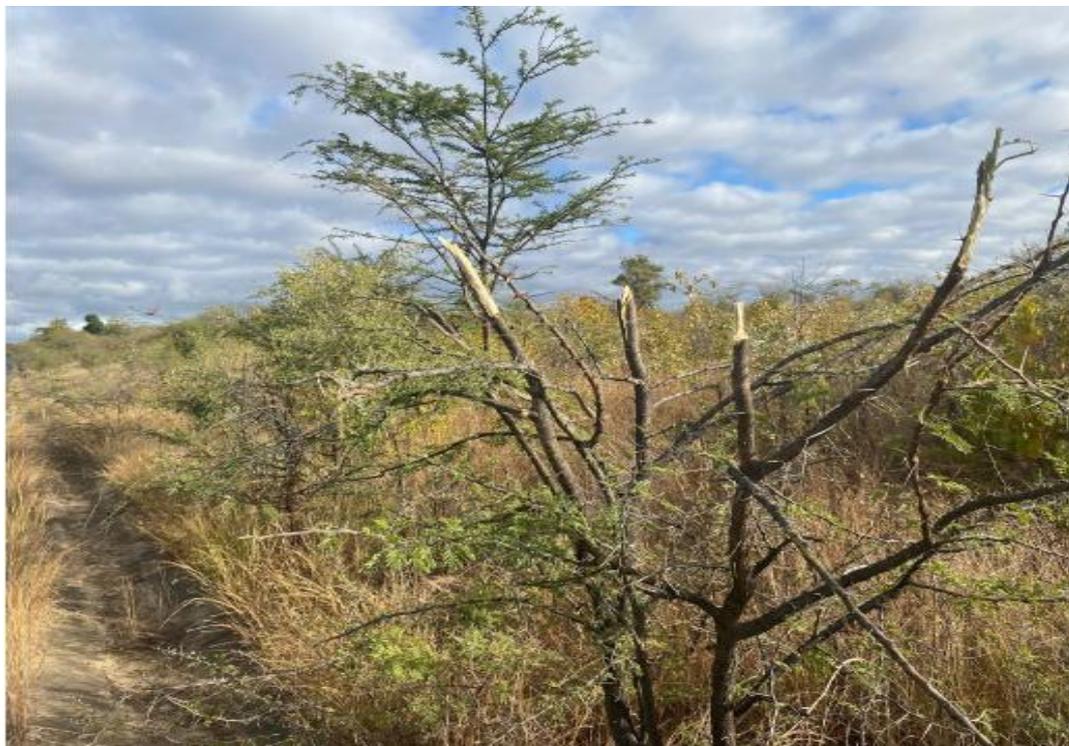
1.12.1. The pilot executed a forced landing on a tarred public road. During the landing roll, the left wing struck multiple trees on the side of the road which resulted in complete separation of the outboard section of the left wing, including the attached aileron.

Figure 8: The left wing severed several tree branches during the landing roll. (Source: Pilot).

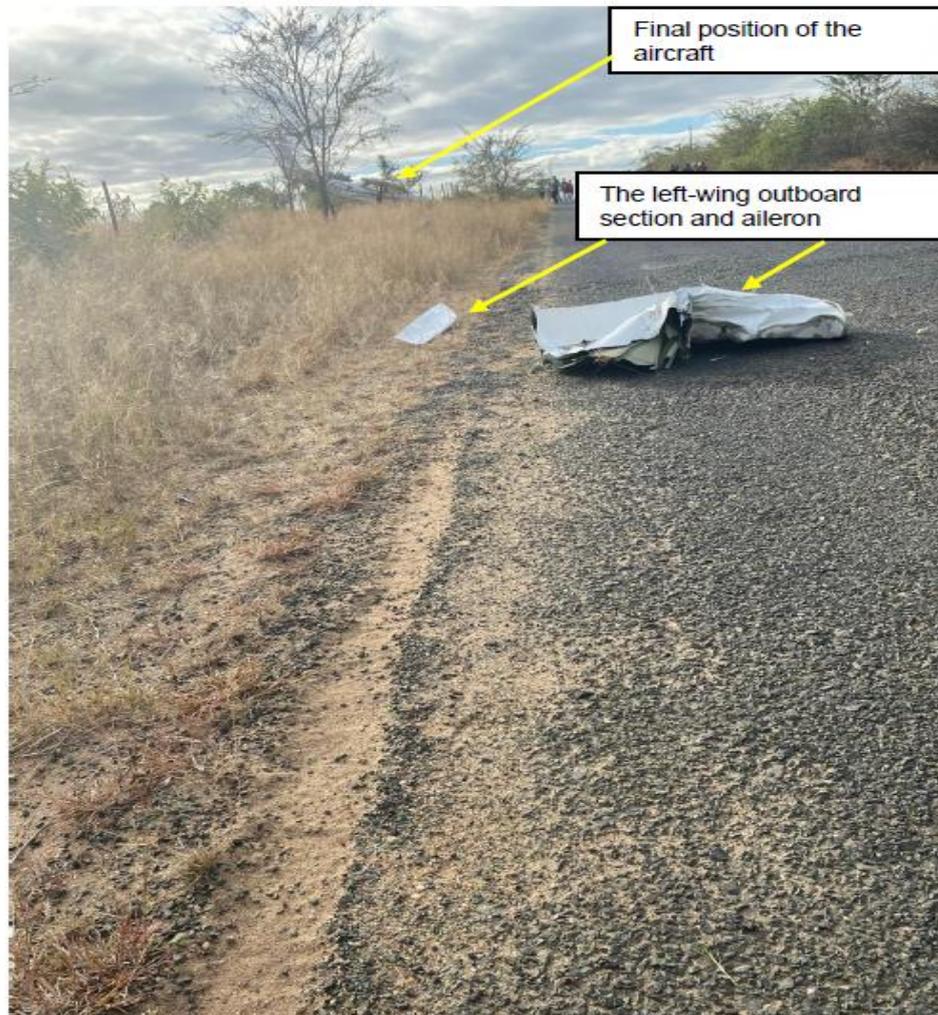
1.12.2. The detached outboard section of the left wing was located approximately 10 metres (m) from the final resting position of the aircraft, and the separated aileron was found about 9m away.

Figure 9: The final position of the aircraft with the left-wing outboard section and aileron that were severed by the trees. (Source: Pilot)

1.12.3. The nose landing gear strut collapsed during the accident sequence. The propeller exhibited bending and rotational scoring. The aircraft was substantially damaged.
