LIMITED OCCURRENCE INVESTIGATION REPORT – FINAL

Reference Number	CA18/2/3/10462						
Classification	Accident	Date	20 May 2024		Time	0803Z	
Type of Operation	Private (Part 91)						
Location							
Place of Departure	Alldays Game Pens, Limpopo Province		Place of Intended Landing	Game Farm near Alldays, Limpopo Province			
Place of Occurrence	Alldays Game Pens in Limpopo Province						
GPS Co-ordinates	Latitude	22°40'33.26" S	Longitude	029°05'39.13" E	Elevation	2 742 feet	
Aircraft Information							
Registration	ZS-HGS						
Make; Model; S/N	Robinson Helicopter Company, R22 Beta II (Serial Number: 4330)						
Damage to Aircraft	Substantial			Total Aircraft Hours	358.8		
Pilot-in-command							
Licence Type	Private Pilot Licence (PPL)		Gender	Male		Age	52
Licence Valid	Yes	Total Hours	6 400.1		Total Hours on Type	6 361.6	
Total Hours 90 Days	113.6		Total Flying on Type Past 90 Days	113.6			
People On-board	1 + 0	Injuries	0	Fatalities	0	Other (on ground)	0

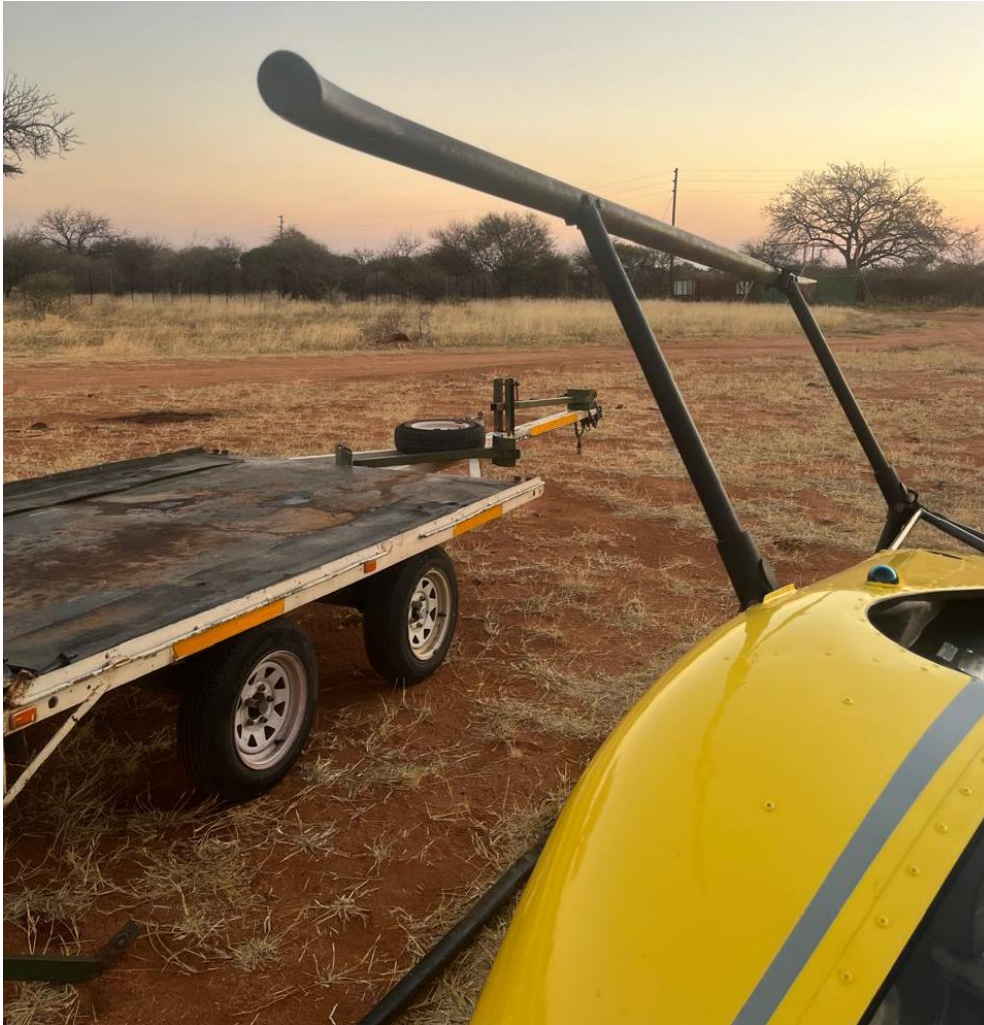
The helicopter sustained substantial damage to the fuselage, the main rotor blades and the tail boom which was severed by the main rotor blades. The front section of the left skid gear also broke off. The pilot vacated the helicopter unharmed.

Figure 1: The helicopter as it came to rest next to the trailer bed. (Source: Pilot)

The helicopter exceeded the critical roll angle on take-off and the main rotor blades struck the ground whereupon the helicopter rolled over to the left and crashed next to the trailer.

Contributing Factor(s)
None.
Safety Action
It is recommended that all potential hazards (such as tie-down brackets and associated equipment) are properly secured in a container and away from the trailer to reduce the risks associated with taking off from these types of platforms.
Safety Message and/or Safety Recommendation/s
None.
About this Report
<p><i>The decision to conduct a limited investigation is based on factors including whether the cause is known and the evidence supporting the cause is clear, the level of safety benefit likely to be obtained from an investigation, and that will determine the scope of an investigation. For this occurrence, a limited investigation has been conducted, and the Accident and Incident Investigations Division (AIID) has relied on the information submitted by the affected person/s and organisation/s to compile this limited report. The report has been compiled using information supplied in the initial notification, as well as from follow-up desktop inquiries to bring awareness of potential safety issues to the industry in respect of this occurrence, as well as possible safety action/s that the industry might want to consider in preventing a recurrence of a similar occurrence.</i></p> <p><i>All times given in this report are Co-ordinated Universal Time (UTC) and will be denoted by (Z). South African Standard Time is UTC plus 2 hours.</i></p>

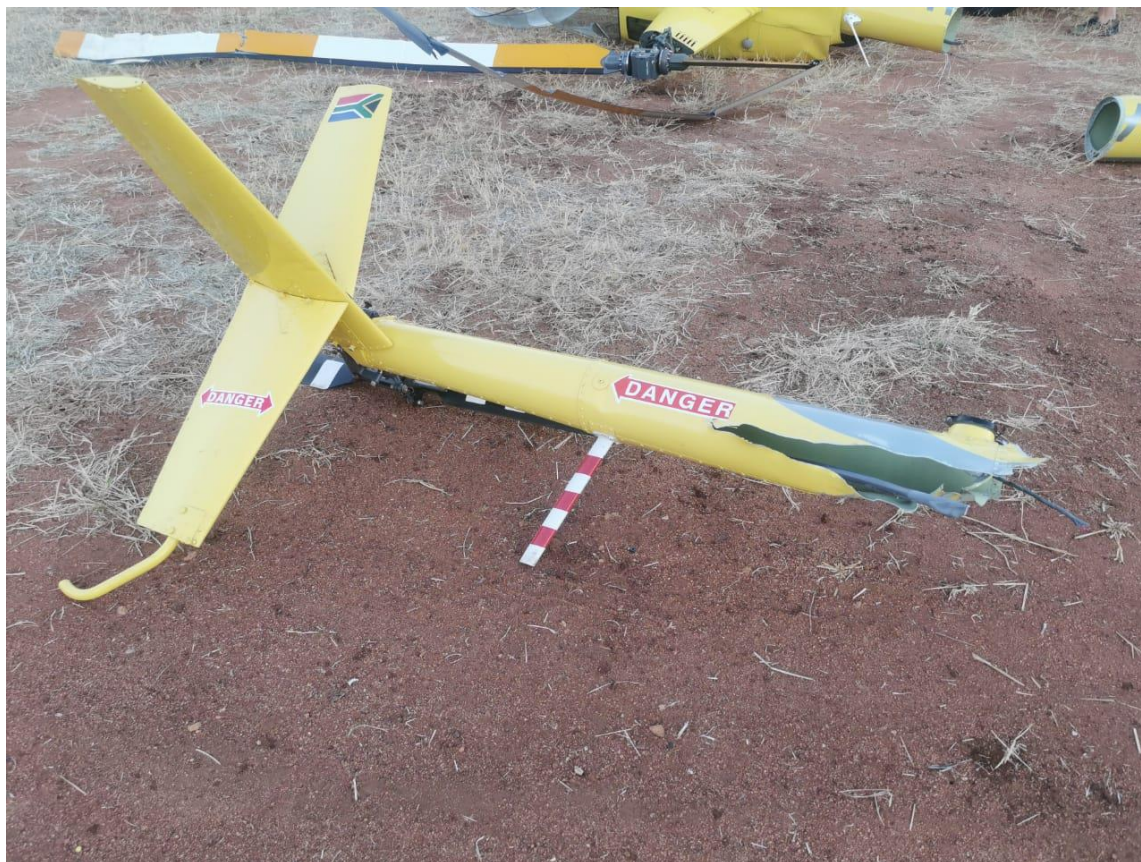
Figure 2: The tail boom was severed from the fuselage. (Source: Pilot)

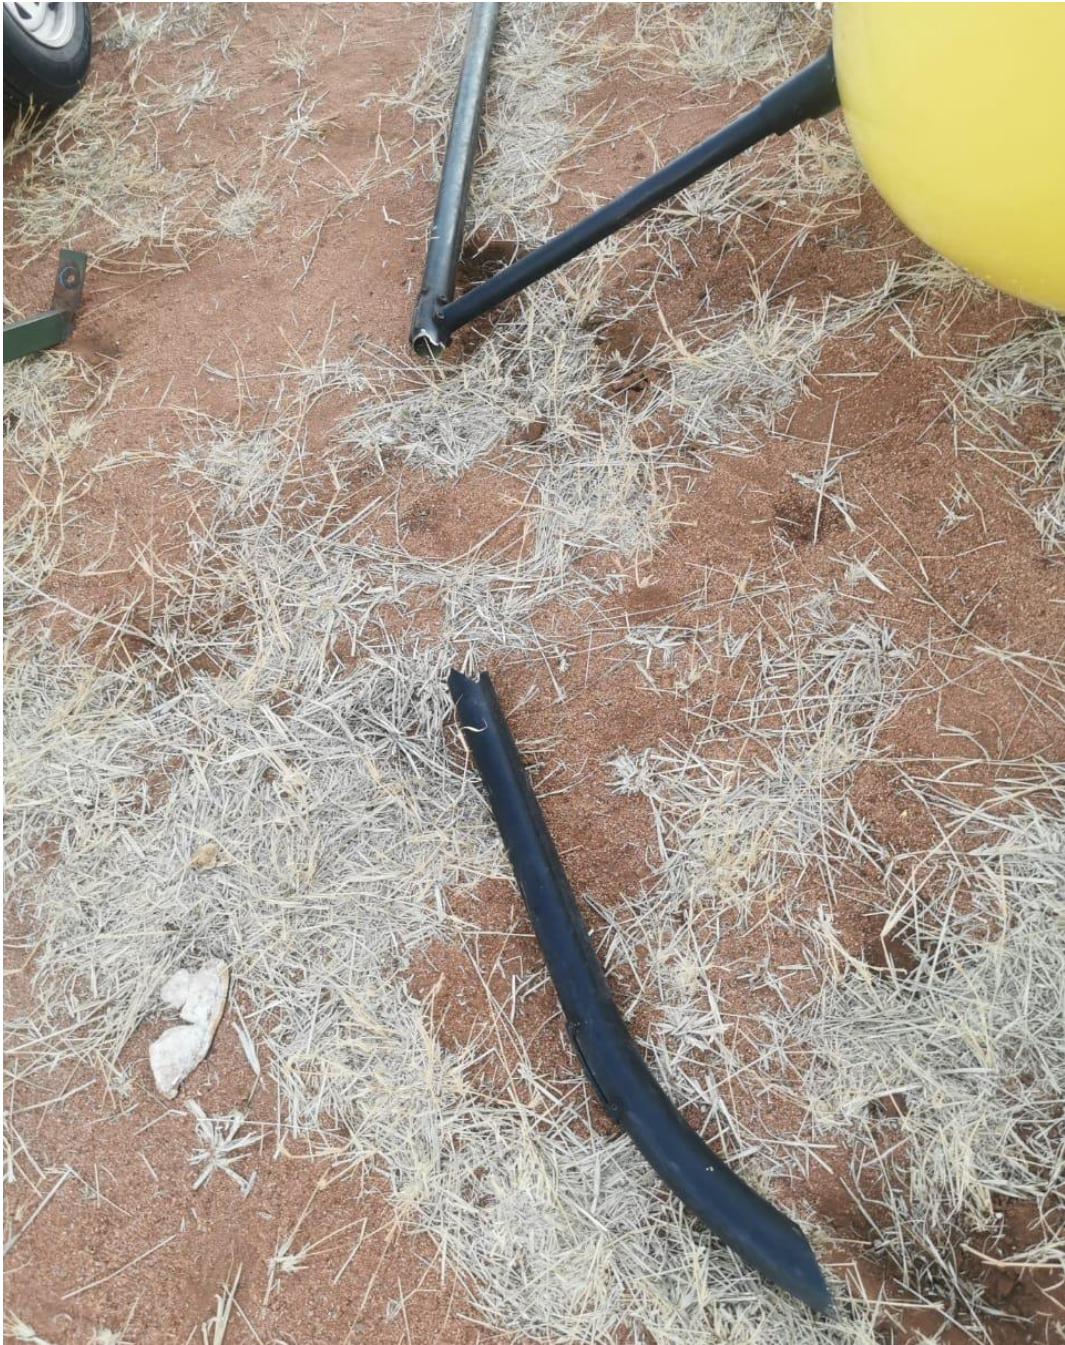
Figure 3: The left front section of the skid gear that broke off. (Source: Pilot)

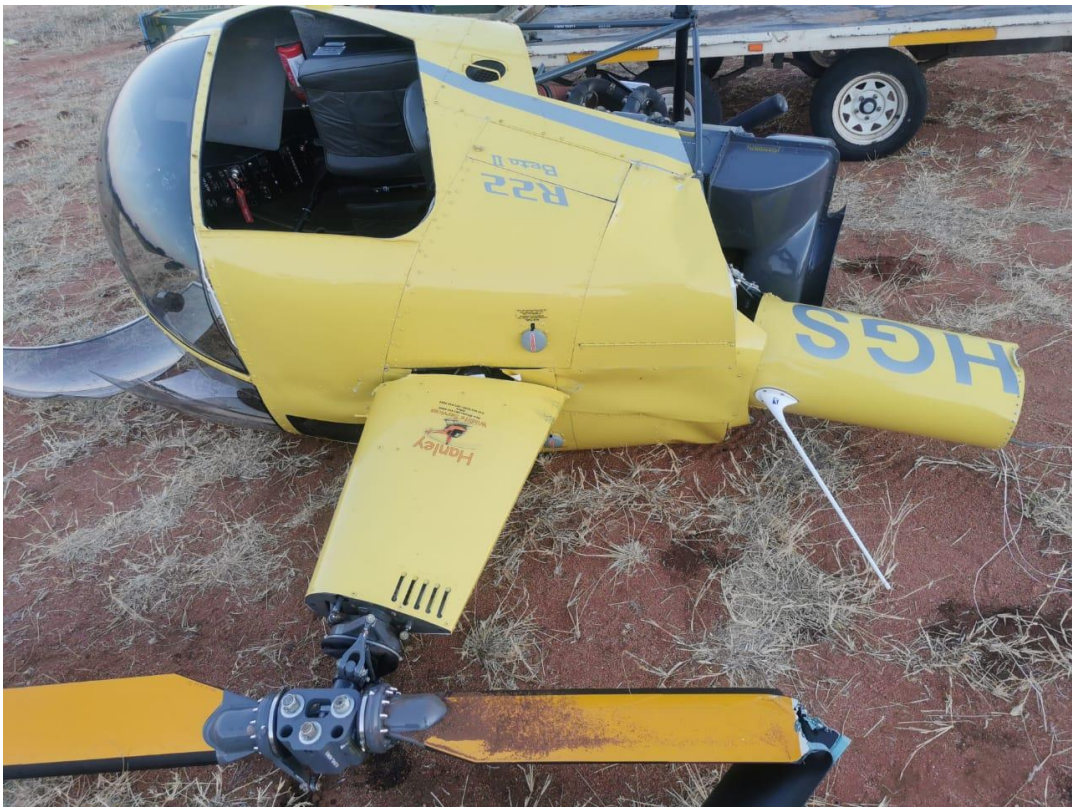
Figure 4: A view of the cabin area. (Source: Pilot)

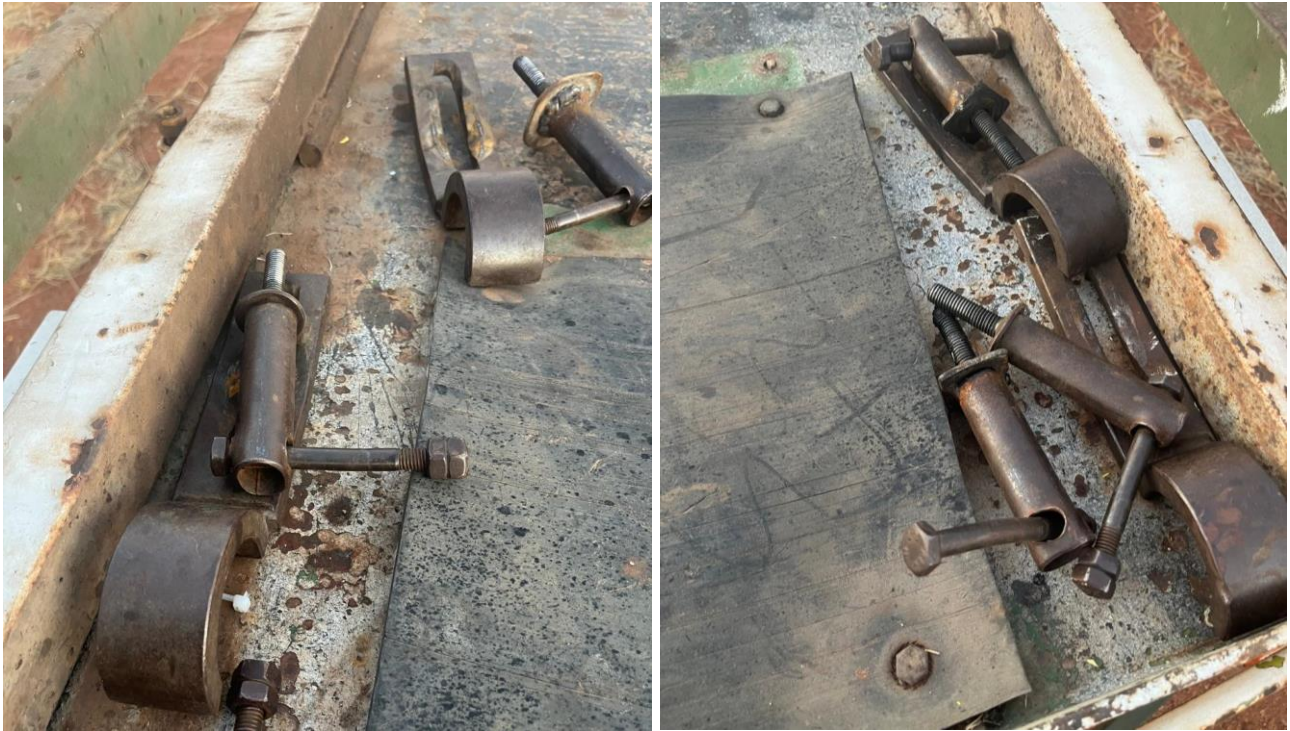
Figure 5: Some of the brackets used to secure the helicopter to the trailer. (Source: Pilot)

- 3.1 The trailer on which the helicopter was parked at the time of the accident is used to transport the helicopter by road. During an interview with the pilot, he stated that he built the trailer as it is not a production-built unit and because it is task-specific. As there are no design criteria, the layout of the trailer varies, depending on the person(s) who are designing it. On this specific trailer, there is no secure container to house the tie-down brackets and tools. The trailer featured a side wall frame which had the potential to act as a pivot point.

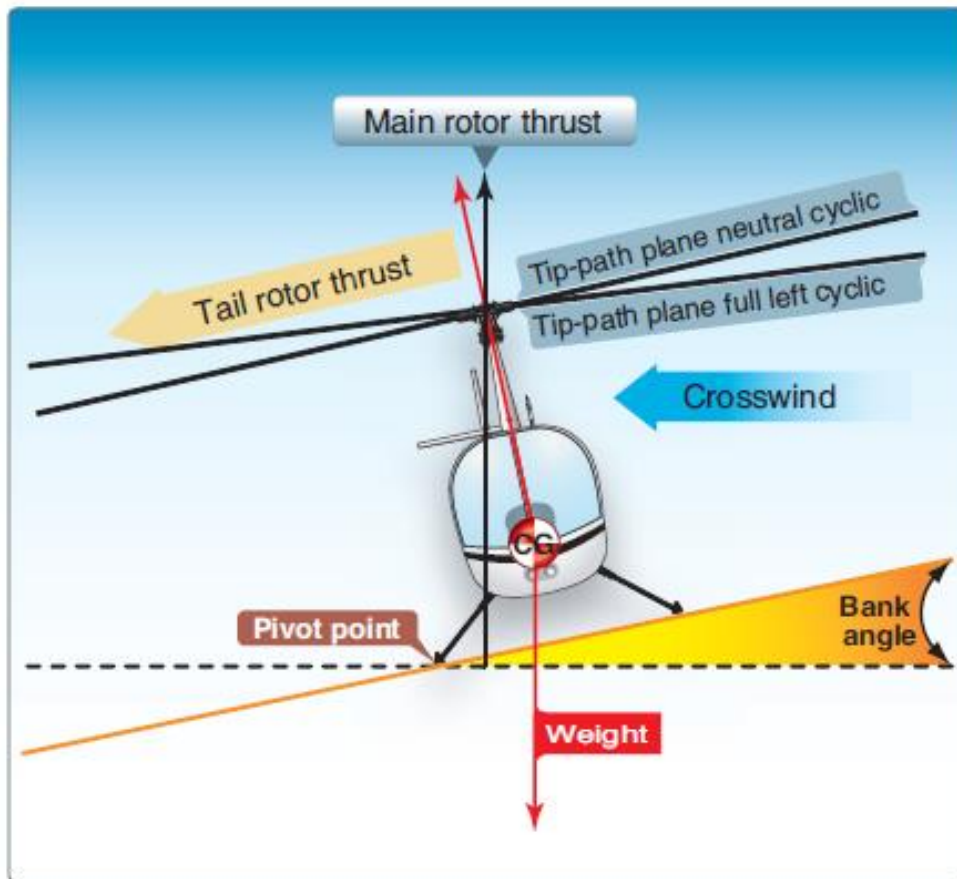
A helicopter is susceptible to a lateral rolling tendency, called dynamic rollover when the helicopter is in contact with the surface during take-offs or landings. For dynamic rollover to occur, some factor must first cause the helicopter to roll or pivot around a skid or landing gear wheel, until its critical rollover angle is reached. (5 - 8° depending on the helicopter, winds, and loading) Then, beyond this point, main rotor thrust continues the roll and recovery is impossible. After this angle is achieved, the cyclic does not have sufficient range of control to eliminate the thrust component and convert it to lift. If the critical rollover angle is exceeded, the helicopter rolls on its side regardless of the cyclic corrections made.

Dynamic rollover begins when the helicopter starts to pivot laterally around its skid or wheel. This can occur for a variety of reasons, including the failure to remove a tie-down or skid-securing device, or if the skid or wheel contacts a fixed object while hovering sideward, or if the gear is stuck in ice, soft asphalt, or mud. Dynamic rollover may also occur if you use an improper landing or take-off technique or while performing slope operations. Whatever the cause, if the gear or skid becomes a pivot point, dynamic rollover is possible if not using the proper corrective technique.

It is important to remember rotor blades have a limited range of movement. If the tilt or roll of the helicopter exceeds that range (5 - 8°), the controls (cyclic) can no longer command a vertical lift component and the thrust or lift becomes a lateral force that rolls the helicopter over. When limited rotor blade movement is coupled with the fact that most of a helicopter's weight is high in the airframe, another element of risk is added to an already slightly unstable centre of gravity. Pilots must remember that to remove thrust, the collective must be lowered as this is the only recovery technique available.

Illustration 1: Forces acting on a helicopter with right skid on the ground.
