**LIMITED OCCURRENCE INVESTIGATION REPORT – FINAL**

<b>Reference Number</b>	CA18/2/3/10463						
<b>Classification</b>	Accident	<b>Date</b>	19 June 2024	<b>Time</b>	1410Z		
<b>Type of Operation</b>	Training (Part 141)						
<b>Location</b>							
Place of Departure	Cape Town International Airport (FACT), Western Cape Province		Place of Intended Landing	Cape Town International Airport (FACT), Western Cape Province			
Place of Occurrence	Runway 19 at Cape Town International Airport (FACT)						
GPS Co-ordinates	Latitude	33° 58'17" S	Longitude	018° 36'15" E	Elevation	306ft	
<b>Aircraft Information</b>							
Registration	ZS-PIB						
Make; Model; S/N	Piper; PA-38-112 Tomahawk (Serial Number: 38-79A0322)						
Damage to Aircraft	Substantial		Total Aircraft Hours	176.4			
<b>Pilot-in-command</b>							
Licence Type	Student Pilot Licence (SPL)		Gender	Female		Age	21
Licence Valid	Yes	Total Hours	129.2		Total Hours on Type	87.3	
Total Hours 30 Days	15.8		Total Flying on Type Past 90 Days	15.8

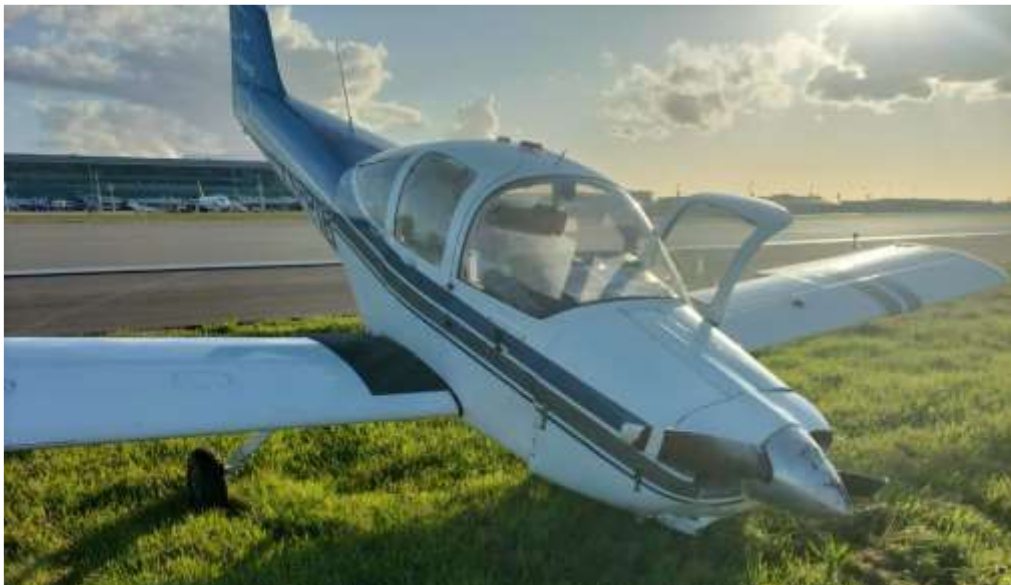
The aircraft sustained substantial damage to the nose gear strut, propeller blades, lower engine cowling and right-wing tip during the accident sequence.

**Figure 2:** The aircraft at the accident site. (Source: Pilot)

8.	The ATO (school) did not discontinue the SP's training as per Part 61.02.7 of CAR.	
9.	The SP lost directional control of the aircraft during the landing roll on Runway 19 and the aircraft veered off to the left of the runway.	
<b>Probable Cause</b>		
Loss of directional control during the landing roll which resulted in the aircraft veering off to the left of the runway.		
<b>Contributing Factors</b>		
None.

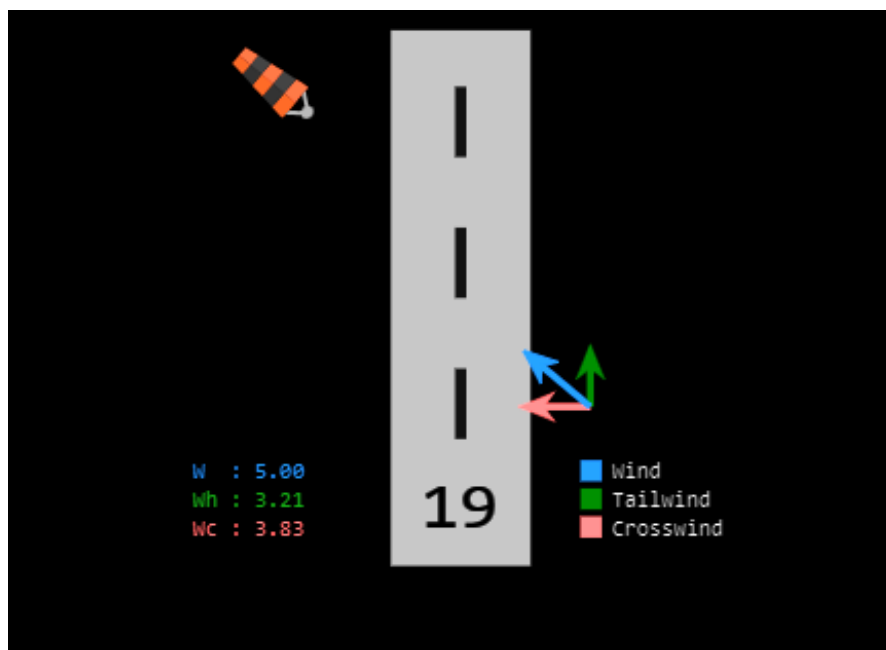
The crosswind component at the time of the flight was calculated to be 3.83 knots from the right. A Piper PA-38-112 Tomahawk aircraft has a maximum crosswind velocity of 15 knots, demonstrated at full flaps setting. Based on the above, the pilot would have no challenge maintaining the runway centreline during a 3.83 knots crosswind condition.

**Figure 3:** Crosswind component calculation. (Source: E6BX.com)
