LIMITED OCCURRENCE INVESTIGATION REPORT – FINAL

Reference Number		CA18/2/3/10464					
Classification	Accident	Date	15 June 2024			Time	1354Z
Type of Operation	Private (Part 94)						
Location							
Place of Departure	NB Safaris Airstrip in Sterkrivier, Limpopo Province		Place of Intended Landing	NB Safaris Airstrip in Sterkrivier, Limpopo Province			
Place of Occurrence	Approximately 12.5 metres (m) beyond the end of Runway 17 at NB Safaris Airstrip in Sterkrivier, Limpopo Province						
GPS Co-ordinates	Latitude	24°13'19.90" S	Longitude	028°49'12.90" E	Elevation	3891 feet	
Aircraft Information							
Registration	ZU-DSS						
Make; Model; S/N	Aeroprakt; A-22 Foxbat (Serial Number: 113)						
Damage to Aircraft	Substantial		Total Aircraft Hours	1 347			
Pilot-in-command							
Licence Type	Private Pilot Licence (PPL)		Gender	Female		Age	47
Licence Valid	Yes	Total Hours	1 635.3		Total Hours on Type	1 285.6	
Total Hours 30 Days	1.2		Total Flying on Type Past 90 Days	5.1

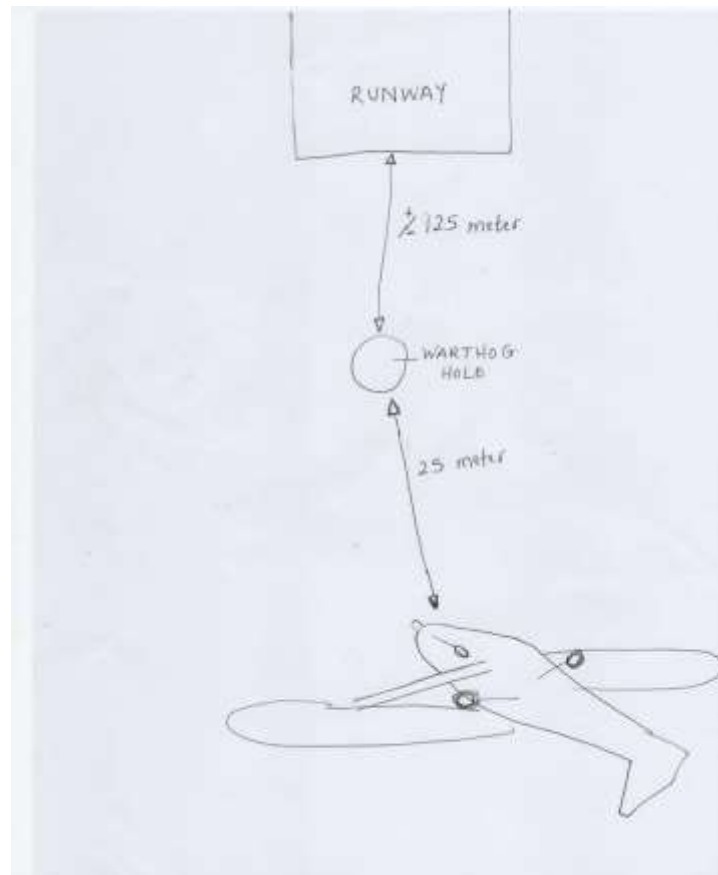
Figure 1: The sketch shows the sequence of events. (Source: Pilot)

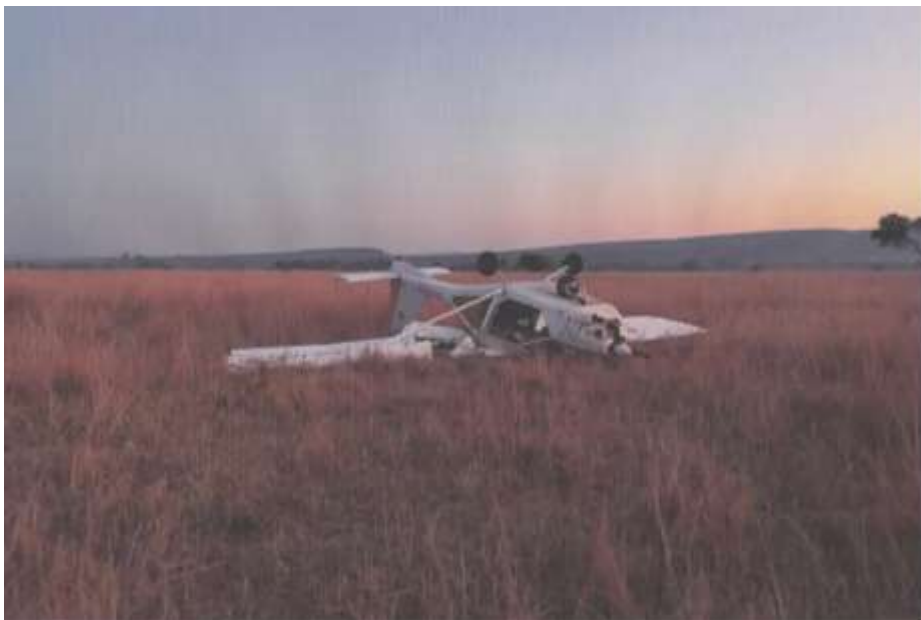
Figure 2: The aircraft at the accident site. (Source: Pilot)

The aircraft's airspeed was high on approach, and the aircraft touched down deep and overshot the runway; subsequently, the nose gear wheel rolled over a hole and the aircraft nosed over.

Safety message: In the interest of safety, pilots are advised to be vigilant during the critical phases of flight such as take-offs and landings.
