LIMITED OCCURRENCE INVESTIGATION REPORT – FINAL

Reference Number		CA18/2/3/10465					
Classification	Accident	Date	18 June 2024			Time	1545Z
Type of Operation	Private 94						
Location							
Place of Departure	New Tempe Aerodrome (FATP) Free State Province		Place of Intended Landing	New Tempe Aerodrome (FATP) Free State Province			
Place of Occurrence	On Runway 01 during landing at New Tempe Aerodrome (FATP)						
GPS Co-ordinates	Latitude	29° 2' 22.15" S	Longitude	026° 9' 33.01" E	Elevation	4 526ft	
Aircraft Information							
Registration	ZU-CUD						
Make; Model; S/N	Urban Air S.R.O; Samba UFM-10 (Serial Number: 29/10/2002)						
Damage to Aircraft	Substantial			Total Aircraft Hours	865.3		
Pilot-in-command							
Licence Type	National Pilot Licence (NPL)		Gender	Male		Age	82
Licence Valid	Yes	Total Hours	604.5		Total Hours on Type	62.5	
Total Hours 30 Days	2.6		Total Flying on Type Past 90 Days			2.6	
People On-board	1+0	Injuries	0	Fatalities	0	Other (on ground)	0

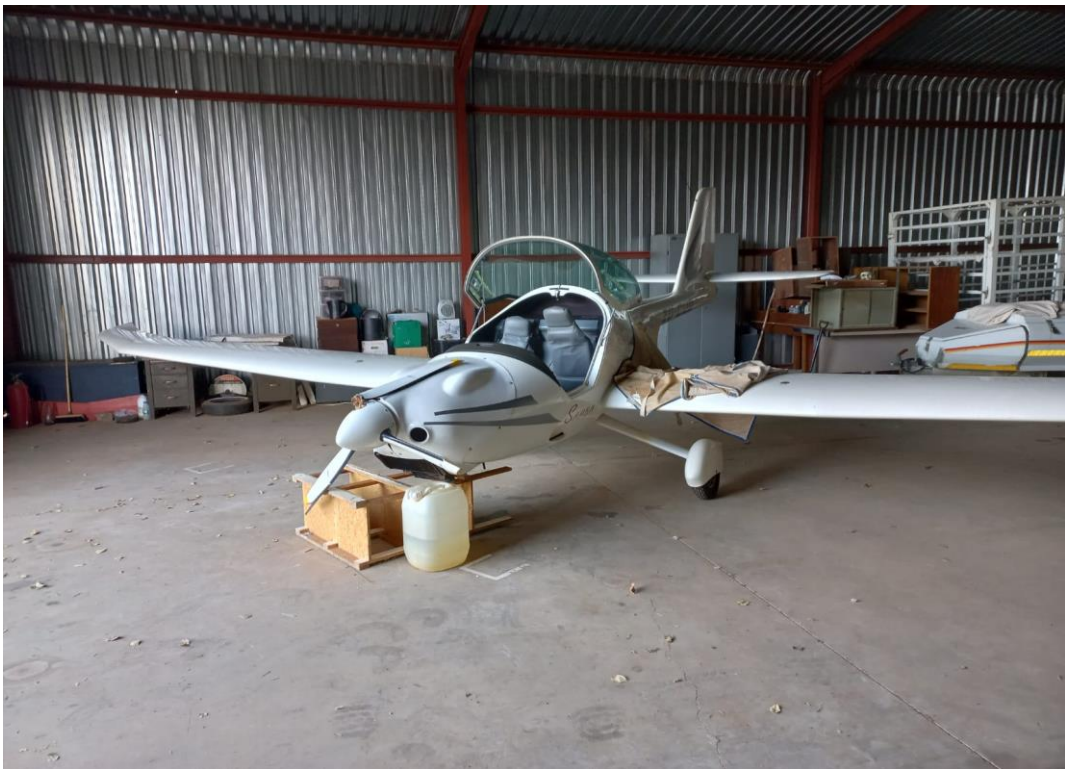
Figure 2: The damaged propeller after recovery. (Source: Pilot)

8. There was sufficient fuel on-board the aircraft during the flight.
9. The aircraft was too fast during landing which led to the aircraft ballooning, followed by a bounce that caused the nose gear to impact the runway hard and, thus, broke off.

The aircraft's airspeed was too high on approach which resulted in the aircraft ballooning and landing deep and hard on the runway with the nose landing gear first, which broke off.

Safety message: In the interest of safety, pilots are advised to be vigilant during the critical phases of flight such as landing and take-offs.
