**LIMITED OCCURRENCE INVESTIGATION REPORT – FINAL**

<b>Reference Number</b>	CA18/2/3/10466						
<b>Classification</b>	Accident	<b>Date</b>	22 June 2024		<b>Time</b>	0700Z	
<b>Type of Operation</b>	Training (Part 141)						
<b>Location</b>							
Place of Departure	Wonderboom Aerodrome (FAWB), Gauteng Province		Place of Intended Landing	Wonderboom Aerodrome (FAWB), Gauteng Province			
Place of Occurrence	On Runway 29 at Wonderboom Aerodrome (FAWB), Gauteng Province						
GPS Co-ordinates	Latitude	26°39'12" S	Longitude	028°13'12" E	Elevation	4 095 ft	
<b>Aircraft Information</b>							
Registration	ZS-CZU						
Make; Model; S/N	Piper Aircraft; PA-28-180 (Serial Number: 28-971)						
Damage to Aircraft	Minor			Total Aircraft Hours	3 804.28		
<b>Pilot-in-command</b>							
Licence Type	Student Pilot Licence (SPL)		Gender	Female		Age	20
Licence Valid	Yes	Total Hours	33		Total Hours on Type	33	
Total Hours Past 30 Days	4.8		Total Flying Hours on Type Past 90 Days	6.1

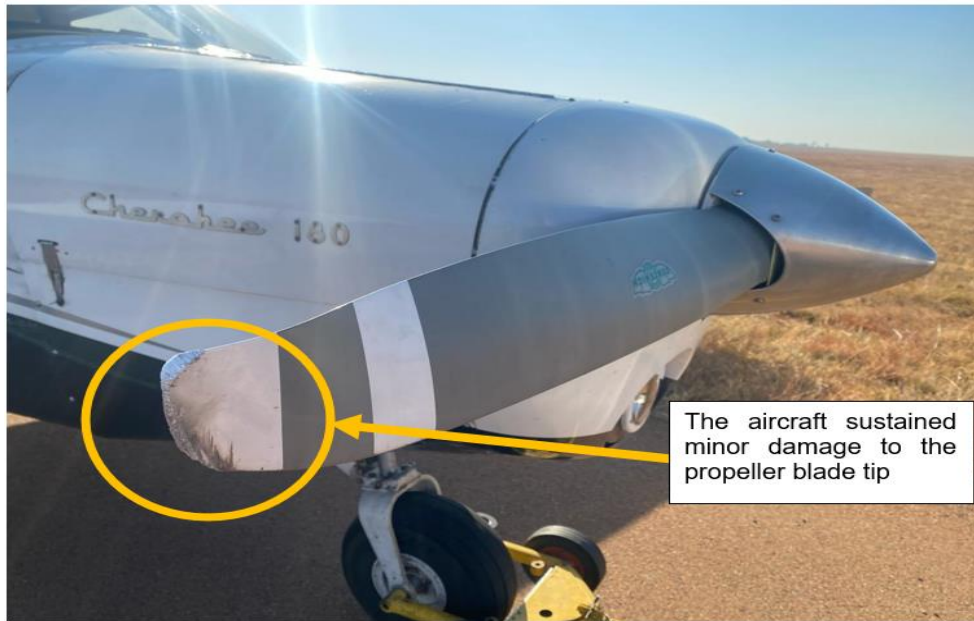
**Figure 1:** The damaged propeller blade. (Source: Operator)

At that point, the aircraft was still rolling at high speed, consequently, it banked to the right which resulted in the right-wing tip impacting the ground and the propeller striking the ground. The aircraft sustained minor damage. The student pilot was not injured.

The aircraft sustained minor damage to the propeller blade tip

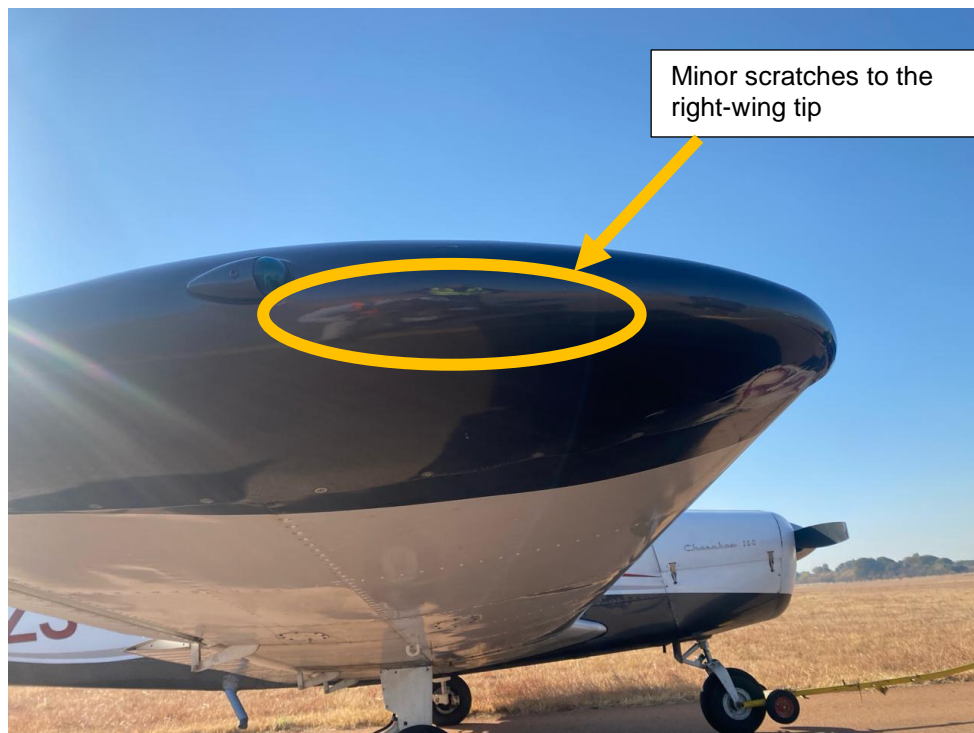
**Figure 2:** The right-wing tip with minor scratches. (Source: Operator)

Minor scratches to the right-wing tip
