LIMITED OCCURRENCE INVESTIGATION REPORT – FINAL

Reference Number	CA18/2/3/10467						
Classification	Accident	Date	23 June 2024		Time	1130Z	
Type of Operation	Private (Part 91)						
Location							
Place of Departure	Eva's Airfield in Hilton, KwaZulu-Natal Province		Place of Intended Landing		Margate Aerodrome (FAMG), KwaZulu-Natal Province		
Place of Occurrence	Eva's Airfield, approximately 11 nautical miles (nm) north-west of Pietermaritzburg Airport (FAPM), KwaZulu-Natal Province						
GPS Co-ordinates	Latitude	29° 29'35.0" S	Longitude	030° 16'24.0" E	Elevation	3 540ft	
Aircraft Information							
Registration	ZS-RUM						
Make; Model; S/N	Bell Textron: B206L-3 Long Ranger III; (Serial Number: 51357)						
Damage to Aircraft	Substantial			Total Aircraft Hours	6 091.30		
Pilot-in-command							
Licence Type	Private Pilot Licence (PPL) - Helicopter		Gender	Male		Age	63
Licence Valid	Yes	Total Hours	1 821.6		Total Hours on Type	1 269.0	
Total Hours 90 Days	12.6		Total Hours on Type Past 90 days		12.6

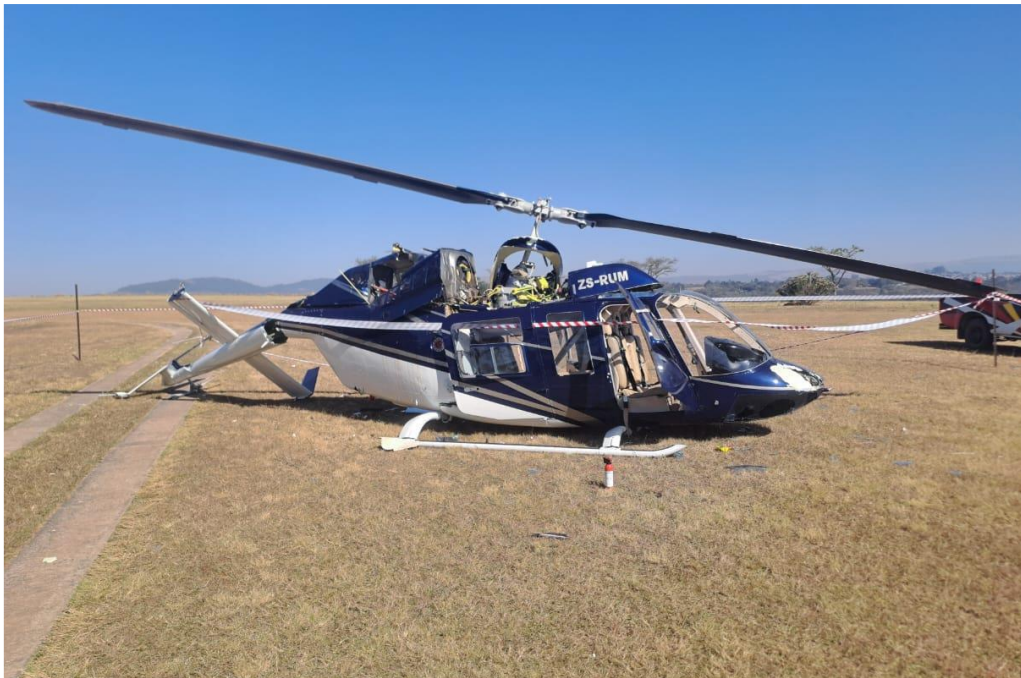
Figure 2: The helicopter at the accident site. (Source: Pilot)

2.6	The pilot lost control of the helicopter after the main rotor blades struck the tree branches during lift-off. This necessitated an emergency landing, which resulted in a hard impact to the ground and substantial structural damage to the helicopter.
Probable Cause(s)	
The main rotor blades struck the tree branches during lift-off and one of the blade tips broke, resulting in an imbalance of the rotor disc. Consequently, the pilot lost control and the helicopter impacted the ground hard on its skid landing gears which caused substantial structural damage to the helicopter.	
Contributing Factor(s)	
Inadequate situational awareness and hazard assessment.	
Safety Action(s)	
None.	
Safety Message and/or Safety Recommendation/s	
None.	
About this Report	
<p><i>The decision to conduct a limited investigation is based on factors, including whether the cause is known and the evidence supporting the cause is clear, the level of safety benefit likely to be obtained from an investigation, and that will determine the scope of an investigation. For this occurrence, a limited investigation has been conducted, and the Accident and Incident Investigations Division (AIID) has relied on the information submitted by the affected person/s and organisation/s to compile this limited report. The report has been compiled using information supplied in the initial notification, as well as from follow-up desktop inquiries to bring awareness of potential safety issues to the industry in respect of this occurrence, as well as possible safety action/s that the industry might want to consider in preventing a recurrence of a similar occurrence.</i></p> <p><i>All times given in this report are Co-ordinated Universal Time (UTC) and will be denoted by (Z). South African Standard Time is UTC plus 2 hours.</i></p>

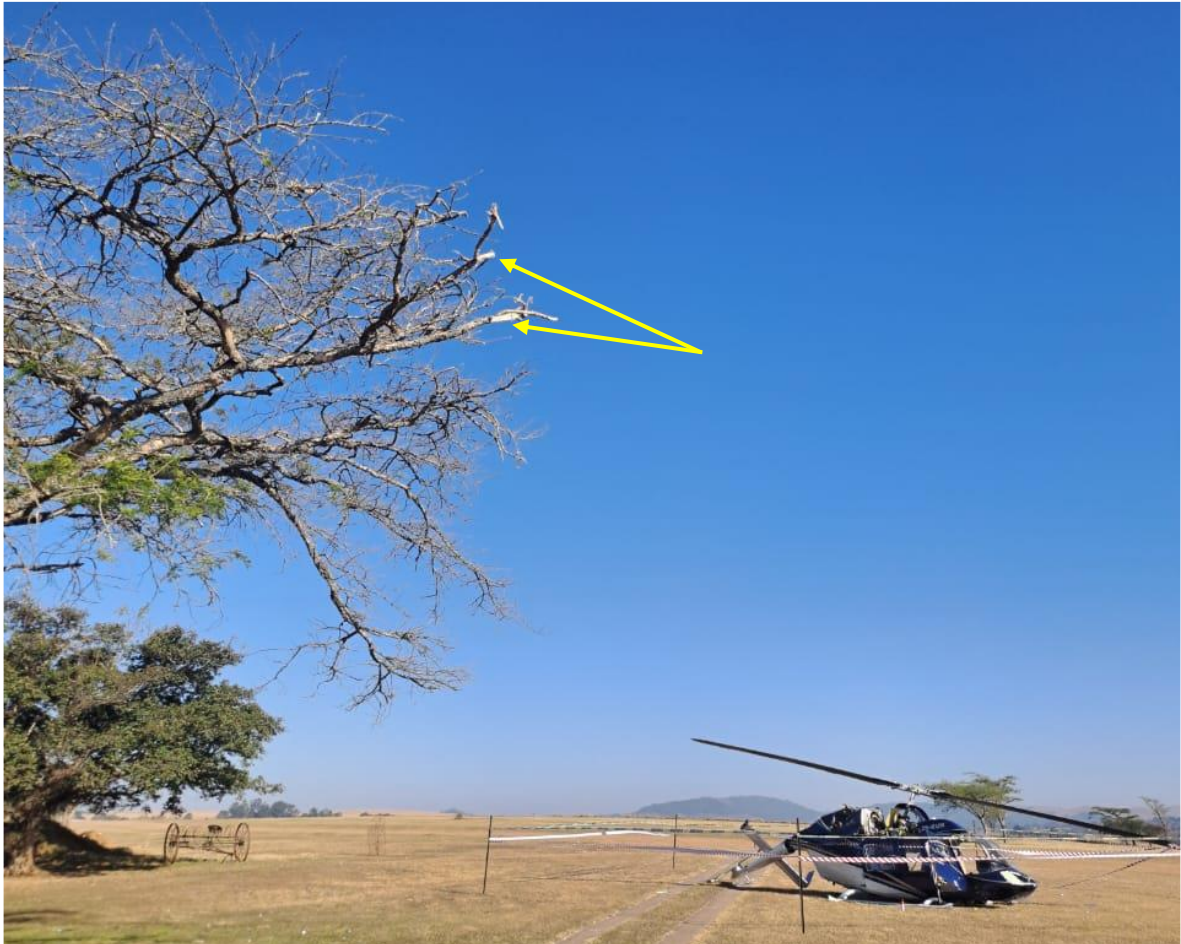
Figure 3: The helicopter and the tree branches struck by the main rotor blades. (Source: Pilot)

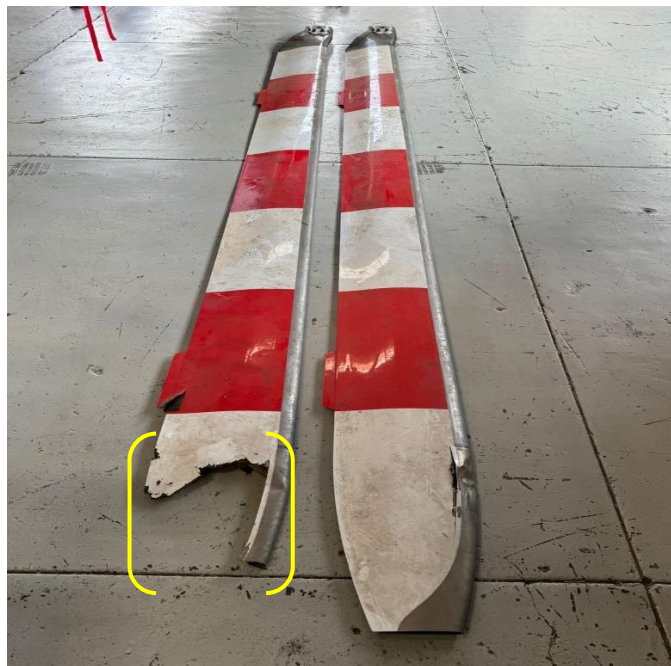
Figure 4: The severed main rotor blade tip. (Source: Pilot)
