LIMITED OCCURRENCE INVESTIGATION REPORT – FINAL

Reference Number	CA18/2/3/10468						
Classification	Accident	Date	2 July 2024		Time	0810Z	
Type of Operation	Private (Part 94)						
Location							
Place of Departure	Groutville Aerodrome, KwaZulu-Natal Province		Place of Intended Landing	Groutville Aerodrome, KwaZulu-Natal Province			
Place of Occurrence	In the Hlimbitwa River near Blythedale Beach in KwaZulu-Natal Province						
GPS Co-ordinates	Latitude	29°22'53.97" S	Longitude	031°19'54.95" E	Elevation	20 feet	
Aircraft Information							
Registration	ZU-CCJ						
Make; Model; S/N	Solo Wings; Windlass Aquilla (Serial Number: WA814)						
Damage to Aircraft	Substantial		Total Aircraft Hours	425.6			
Pilot-in-command							
Licence Type	National Pilot Licence		Gender	Male		Age	47
Licence Valid	Yes	Total Hours	97.9		Total Hours on Type	28.7	
Total Hours 90 Days	10.3		Total Hours on Type Past 90 Days	10.3			
People On-board	1 + 1	Injuries	0	Fatalities	0	Other (on ground)	0

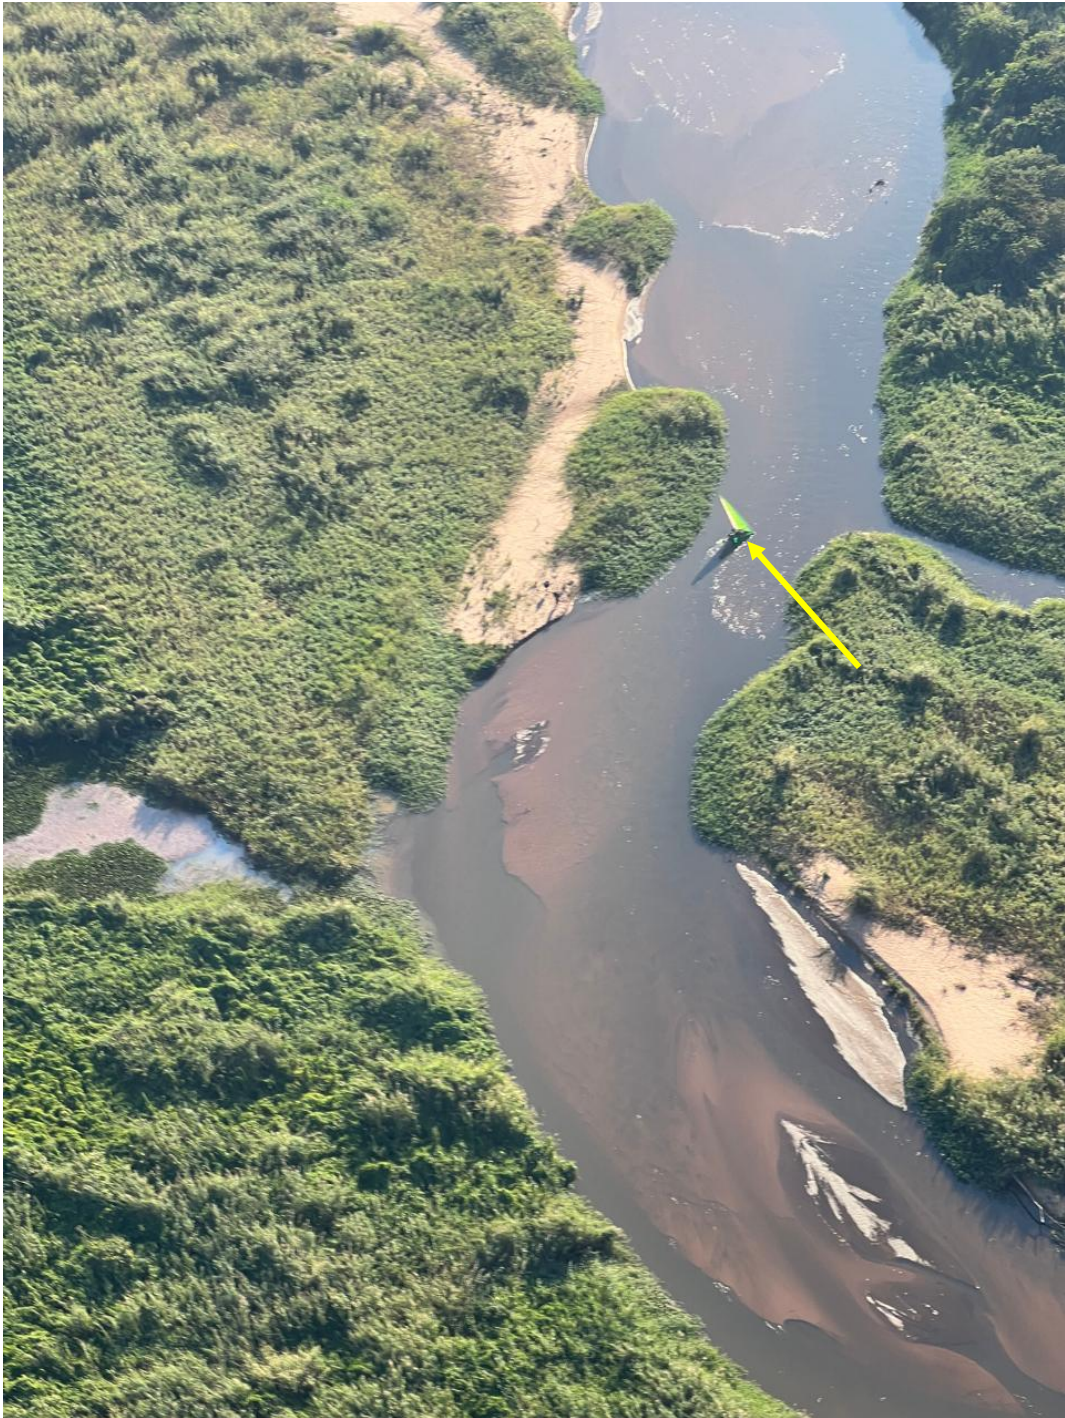
Figure 3: An aerial view of the microlight aircraft in the river.

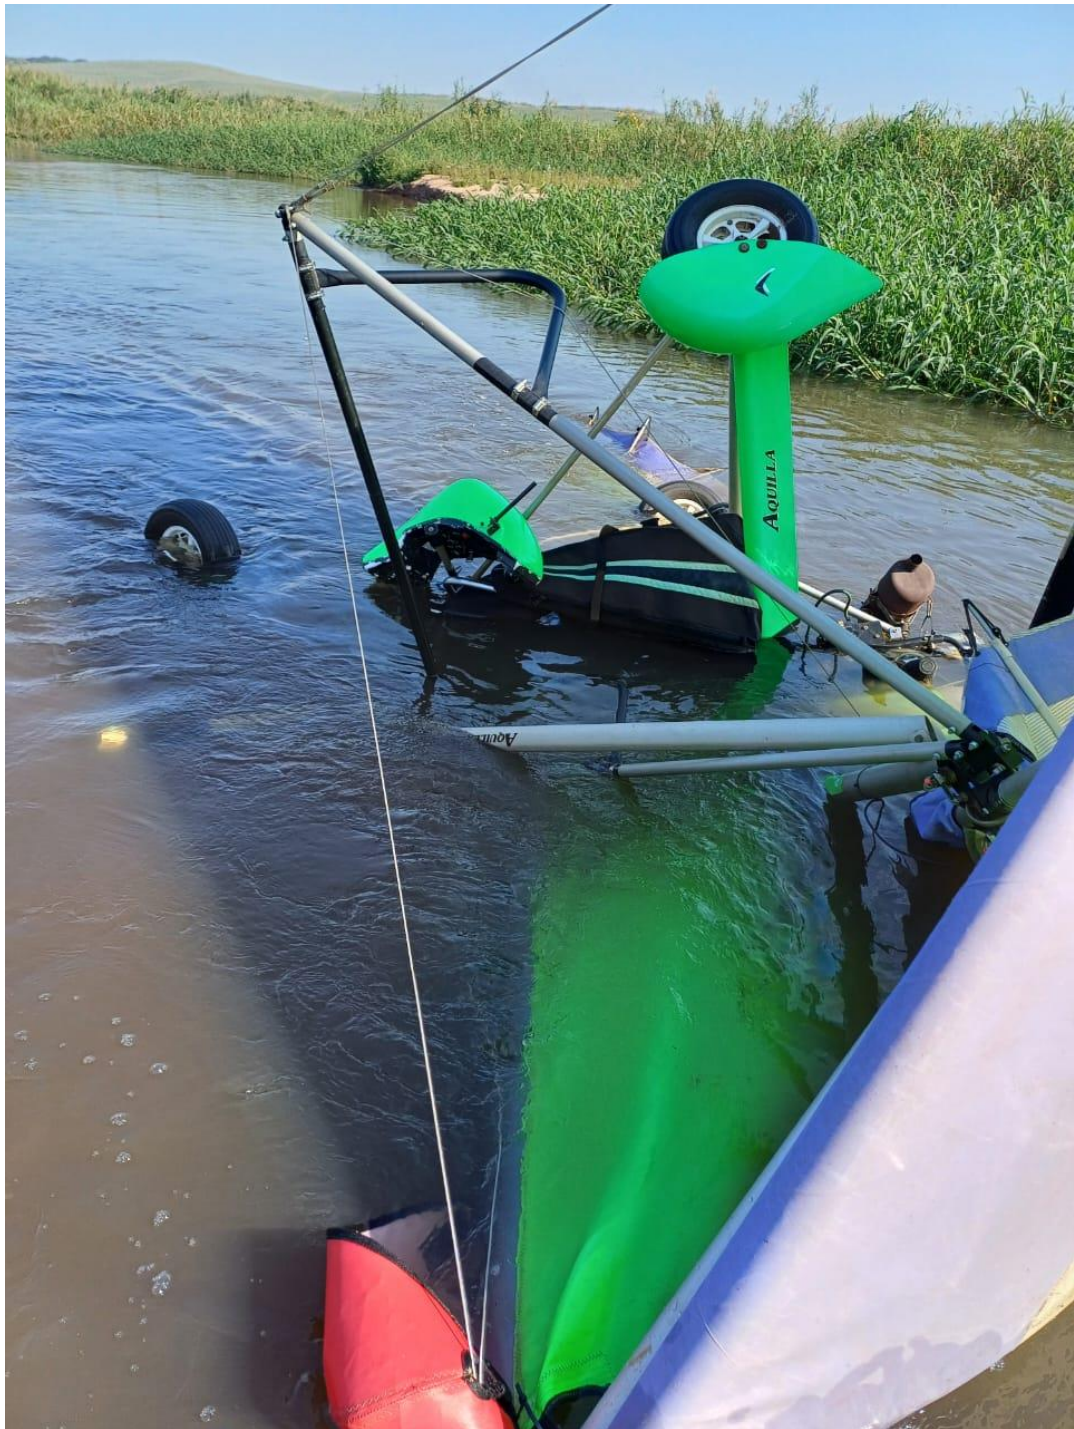
The pilot noticed that fuel was leaking into the river, and he initiated an immediate recovery. The microlight aircraft sustained substantial structural damage.

Figure 4: The microlight aircraft in the river after the accident. (Source: Pilot)

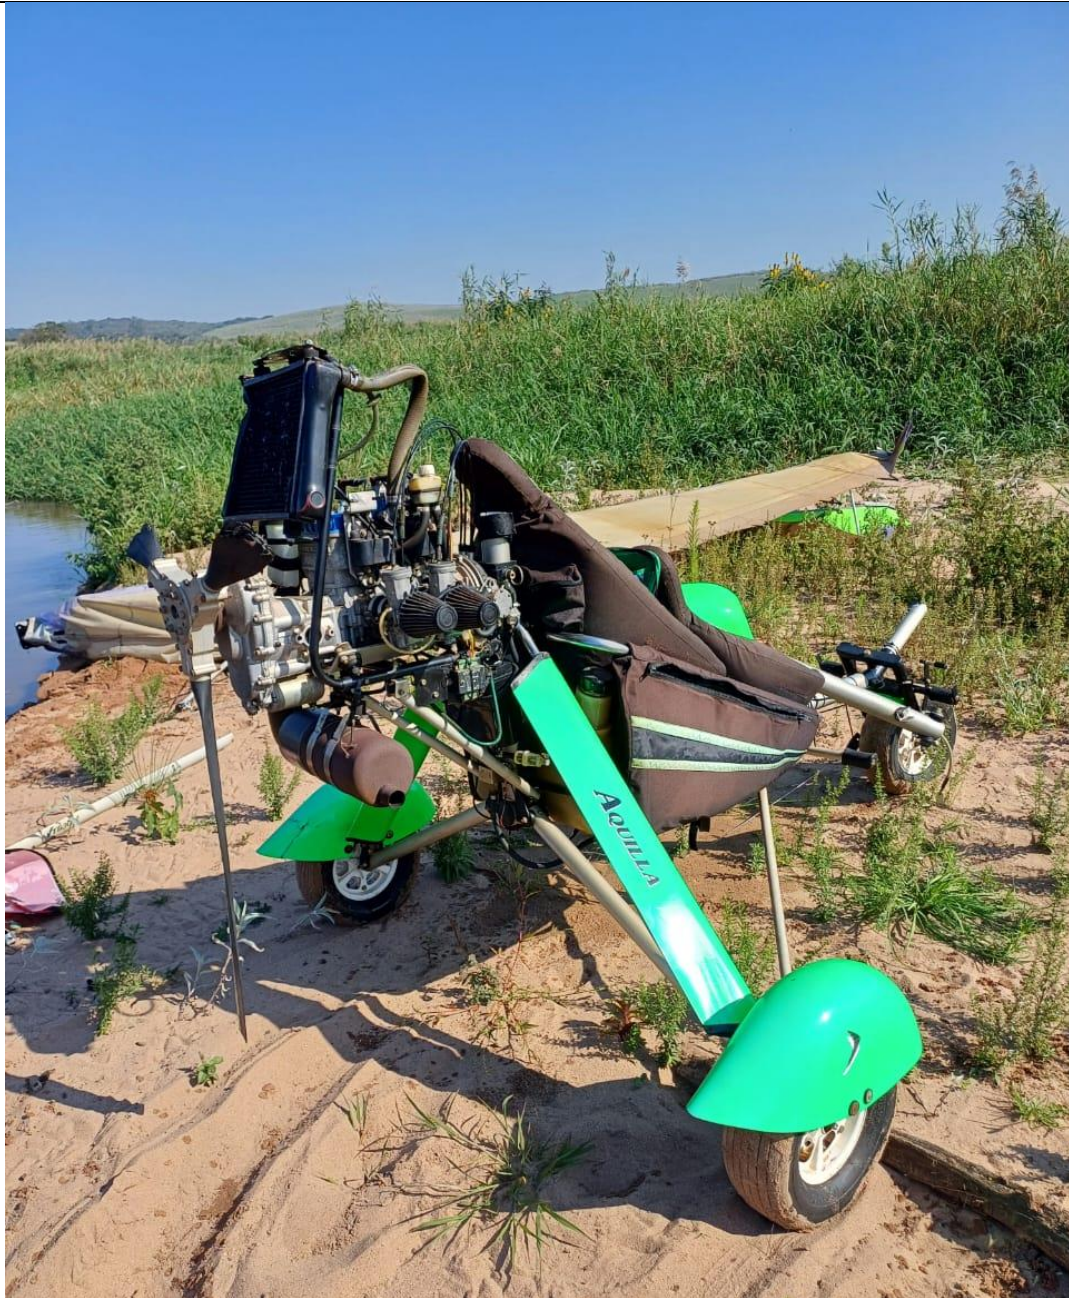
Figure 5: Two of the three propeller blades were severed. (Source: Pilot)
