LIMITED OCCURRENCE INVESTIGATION REPORT – FINAL

Reference Number		CA18/2/3/10469									
Classification		Accident		Date		02 July 2024	Time		1000Z		
Type of Operation		Training (Part 141)									
Location											
Place of Departure		Rand Airport (FAGM), Gauteng Province		Place of Intended Landing			Rand Airport (FAGM), Gauteng Province				
Place of Occurrence		Open field outside Klipriver Airfield in Meyerton, Gauteng Province									
GPS Co-ordinates		Latitude		26°27'8.95"S		Longitude		28° 6'11.83"E	Elevation		4 765ft
Aircraft Information											
Registration		ZS-FKL									
Make; Model; S/N		Bellanca; Citabria 7CKAB (Serial Number: 88)									
Damage to Aircraft		Substantial			Total Aircraft Hours		3 399.8				
Pilot-in-command											
Licence Type		Commercial Pilot Licence (CPL)		Gender		Male		Age	59		
Licence Valid		Yes	Total Hours		2072.8		Total Hours on Type		238.9		
Total Hours 30 Days		4.8			Total Flying on Type Past 90 Days			13.4

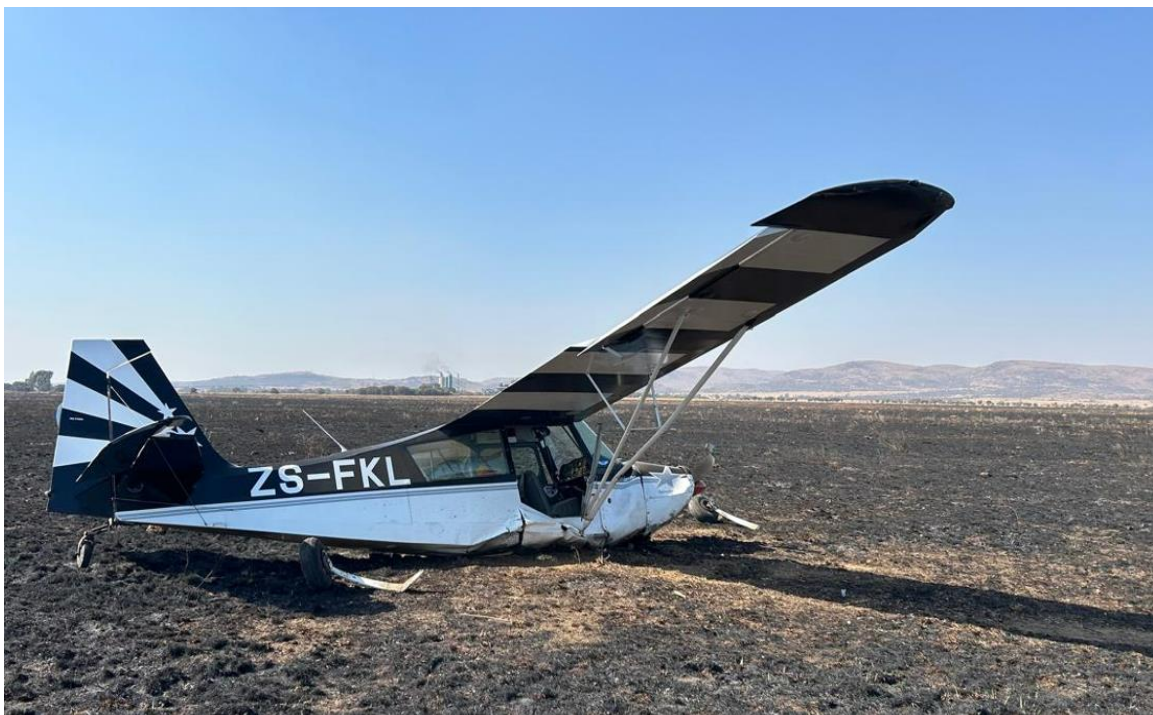
landing. The FI chose an open field north of Runway 02 to conduct the forced landing, however, there were anthills on the field. To avoid the anthills, the FI slightly turned the aircraft to the right, but it touched down with its right-wing first, followed by the right main gear and then the left main gear. The landing gear detached, and the propeller blades struck the ground.

The aircraft skidded on its belly and came to a stop a few metres from where the landing gear had detached, with the left-wing tip touching the ground. The aircraft was substantially damaged; however, the occupants were not injured.

Figure 1: The aircraft at the accident site. (Source: Operator)

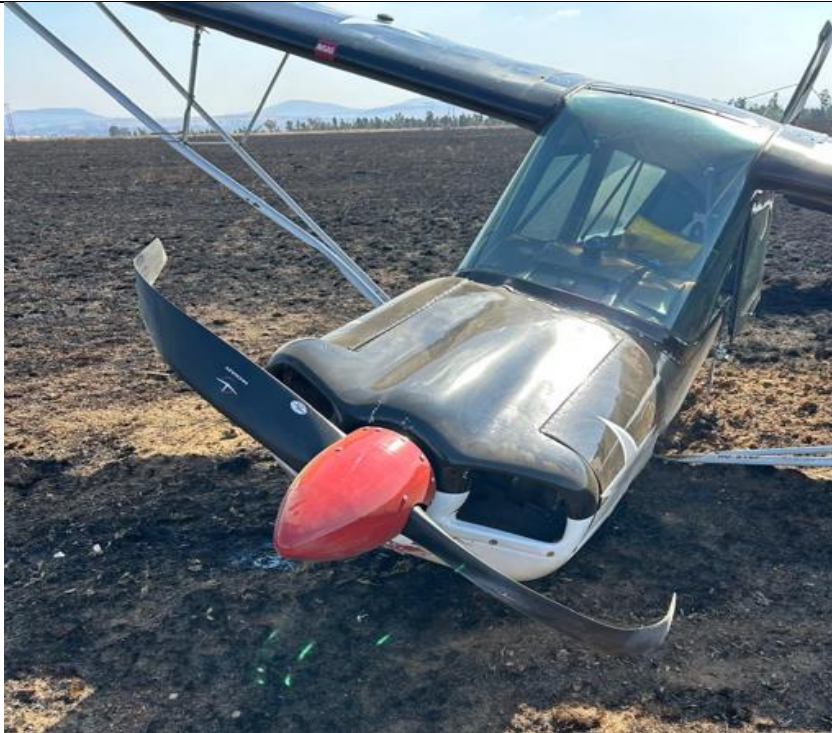
Figure 2: Front view of the aircraft with the damaged propeller blades. (Source: Operator)

Unsuccessful forced landing after a loss of thrust due to severe vibrations caused by the damaged propeller blades.

Improper landing technique that led to a propeller strike.
