**LIMITED OCCURRENCE INVESTIGATION REPORT – FINAL**

<b>Reference Number</b>	CA18/2/3/10470						
<b>Classification</b>	Accident		<b>Date</b>	06 July 2024		<b>Time</b>	1100Z
<b>Type of Operation</b>	Private (Part 91)						
<b>Location</b>							
Place of Departure	Mossel Bay Airport (FAMO), Western Cape Province		Place of Intended Landing		Mossel Bay Airport (FAMO), Western Cape Province		
Place of Occurrence	On the right of Runway 10 at Mossel Bay Airport (FAMO), Western Cape Province						
GPS Co-ordinates	Latitude	34° 9'36.66"S	Longitude	22° 3'7.29" E	Elevation	531.2 ft	
<b>Aircraft Information</b>							
Registration	ZS-OHB						
Make; Model; S/N	Beechcraft; King Air B90 (Serial Number: LJ-431)						
Damage to Aircraft	Substantial			Total Aircraft Hours	11265.9		
<b>Pilot-in-command</b>							
Licence Type	Private Pilot Licence (PPL) Aeroplane		Gender	Female		Age	61
Licence Valid	Yes	Total Hours	2828		Total Hours on Type	40.8	
Total Hours 30 Days	18.3		Total Flying on Type Past 90 Days		5.2

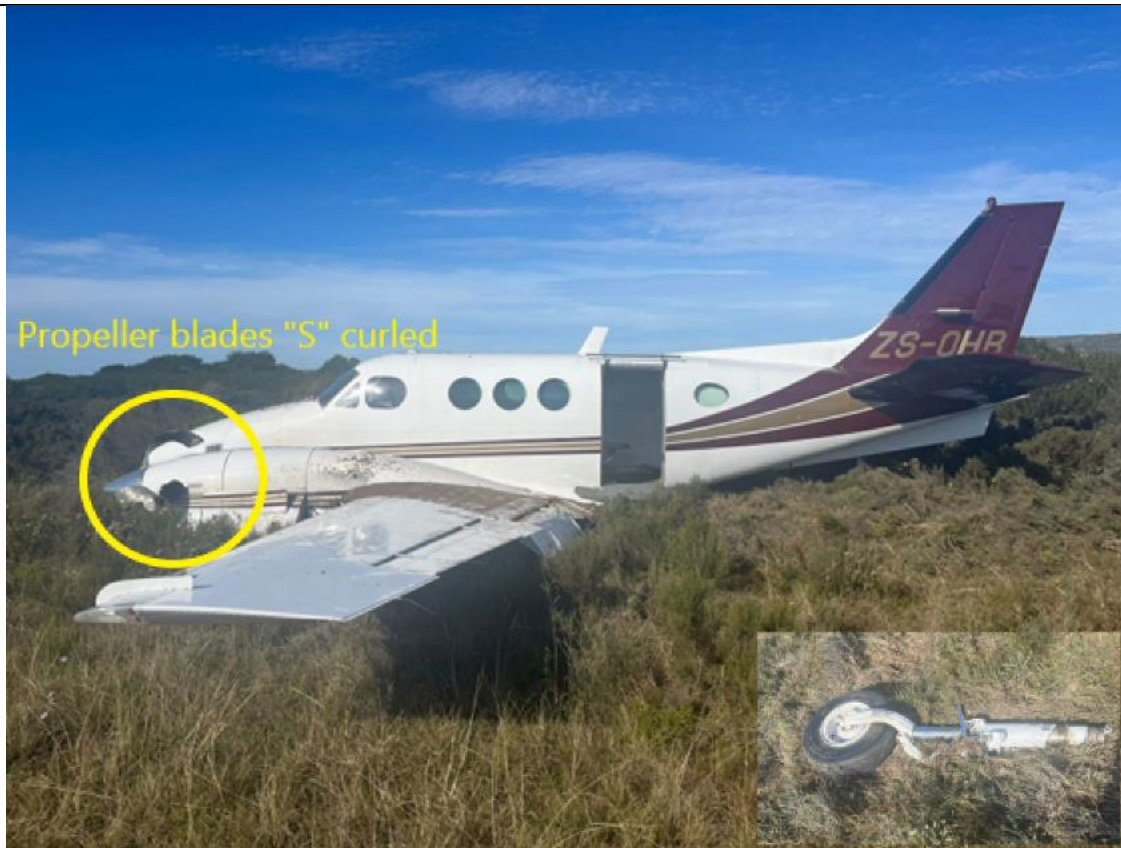
**Figure 1:** The aircraft came to rest facing north. Inset: The nose wheel gear that broke off. (Source: Owner)

On final approach, the aircraft's indicated air speed was between 75 and 80 kts with full flaps down; the wind speed was approximately 160° at 04 kts. The pilot reduced power below the required setting and the aircraft stalled before it touched down hard on the runway. The landing gears were severed and, thus, the aircraft skidded before it came to a stop in the bush next to the runway.

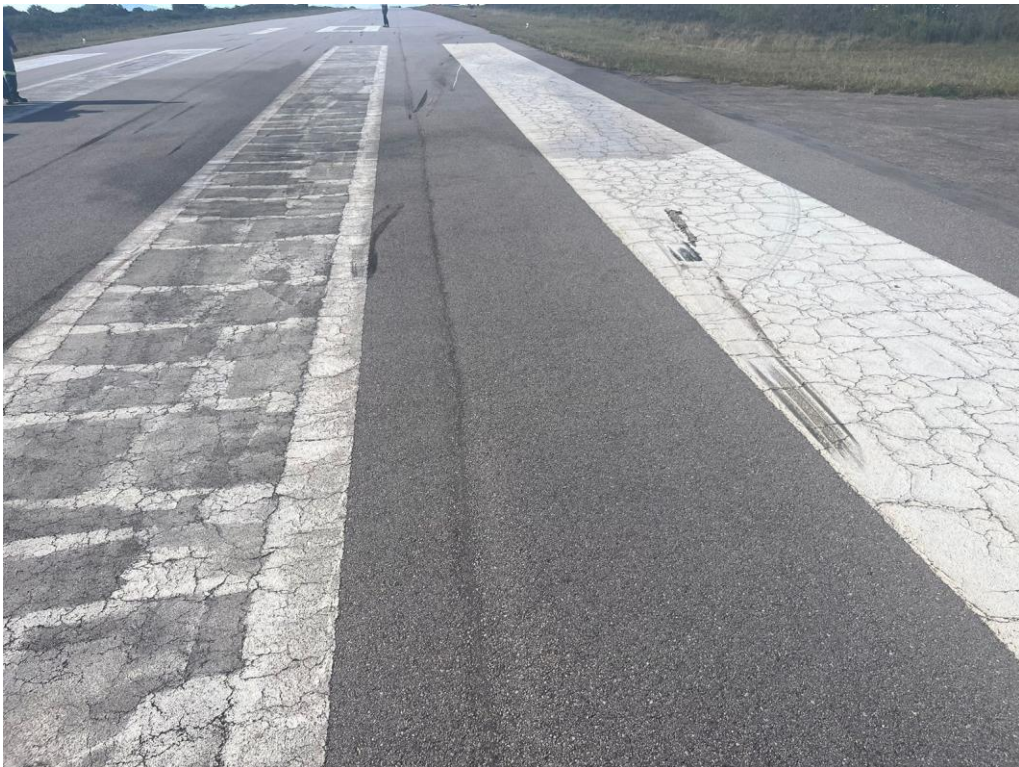
**Figure 2:** The accident aircraft skid marks on Runway 10 at FAMO. (Source: Owner)

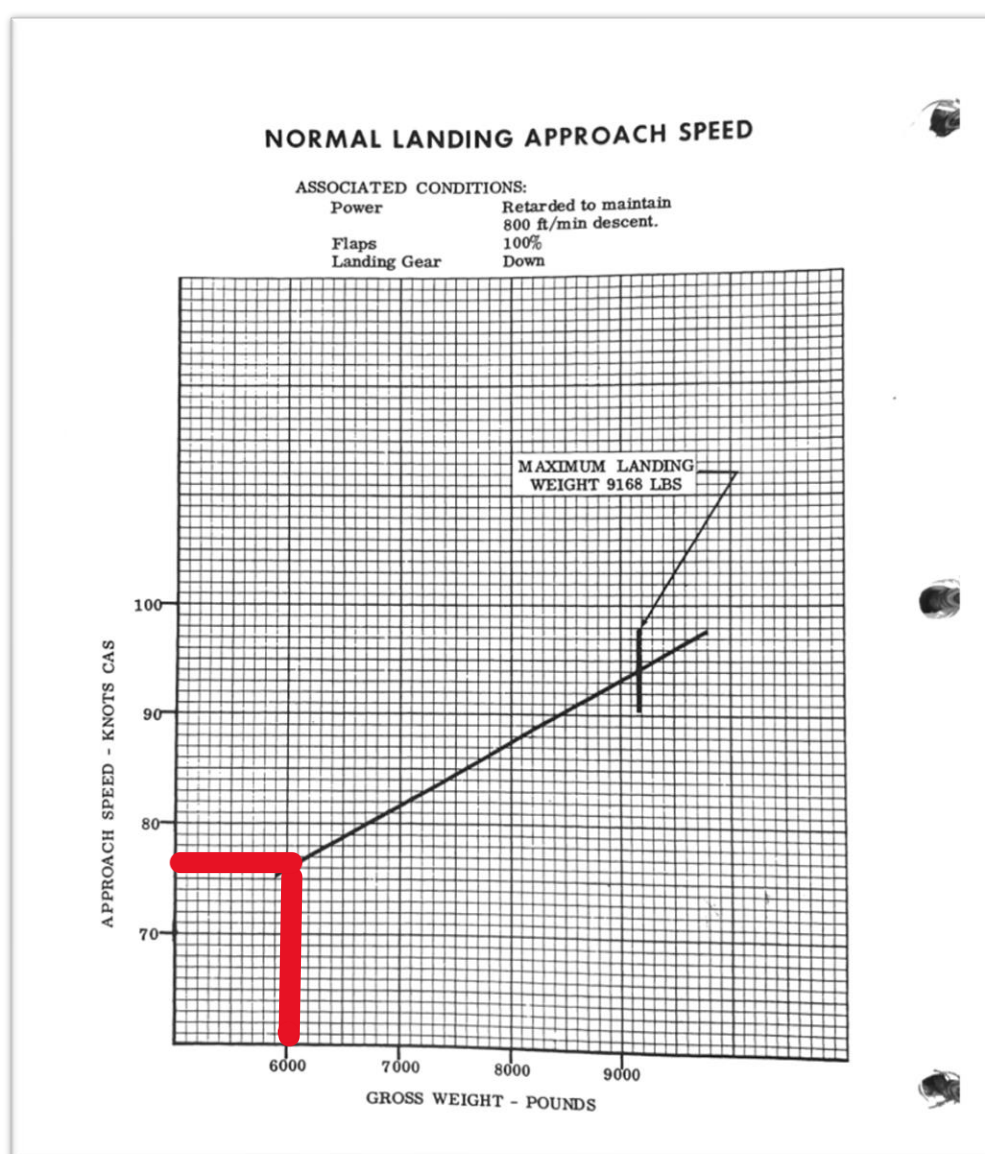
**Figure 4:** The approach speed changes with weight. At 6000 lb it is 76 knots. (Source: Operator)
