AIRCRAFT ACCIDENT REPORT AND EXECUTIVE SUMMARY

Reference:		CA18/2/3/10471	
Aircraft Registration	ZU-IEZ	Date of Accident	15 July 2024		Time of Accident	0700Z	
Type of Aircraft	Bat Hawk			Type of Operation	Private (Part 94)		
Pilot-in-command Licence Type	National Pilot Licence (NPL)		Age	65	Licence Valid	Yes	
Pilot-in-command Flying Experience	Total Flying Hours			101.2	Hours on Type	10.3	
Last Point of Departure	Bundu Inn Airfield, Gauteng Province						
Next Point of Intended Landing	Wonderboom Aerodrome (FAWB), Gauteng Province						
Damage to Aircraft	Substantial						
Location of the accident site with reference to easily defined geographical points (GPS readings if possible)							
At GPS co-ordinates: 25°39'02.9" South 028°02' 48.7" East, at an elevation of 4 265 feet (ft)							
Meteorological Information	Surface wind:180° 5 kts; temperature: 08°C; dew point: -2°C; CAVOK						
Number of People On-board	1 + 1	Number of People Injured	1	Number of People Killed	0	Other (On Ground)	0

Probable Cause/s and/or Contributory Factors							
It is probable that the engine stoppage in-flight was caused by serious carburettor icing conditions.							
SRP Date	8 April 2025		Publication

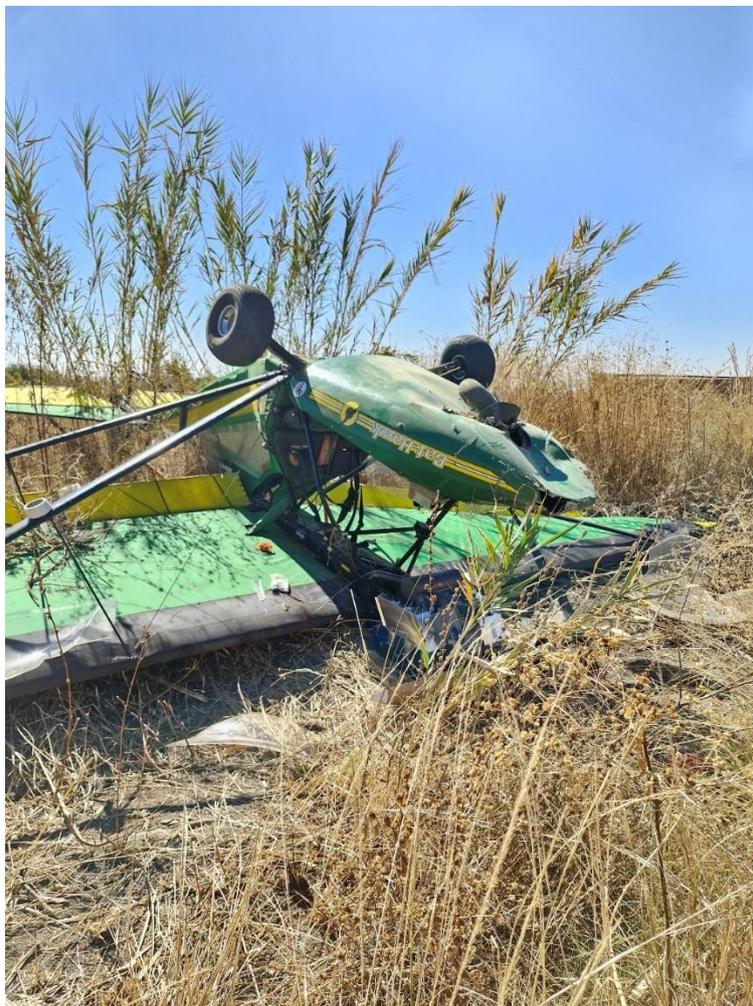
1.3.1. The aircraft sustained substantial damage.

Figure 2: The aircraft post-accident. (Source: Pilot)

1.12.1 During the forced landing, the aircraft impacted a tree and the nose wheel hit a rock; as a result, the aircraft nosed over and came to rest in an inverted position. The accident occurred approximately 0.6 nm north-east of Bundu Inn Airfield. The aircraft's windshield was found shattered and pieces of it were scattered near the nose section. The nose gear was found bent backward. Both wings were damaged.

3.2.6 After touching down and during the landing roll, the aircraft impacted a tree and the nose gear hit a rock; the aircraft nosed over and skidded before it stopped in an inverted position.

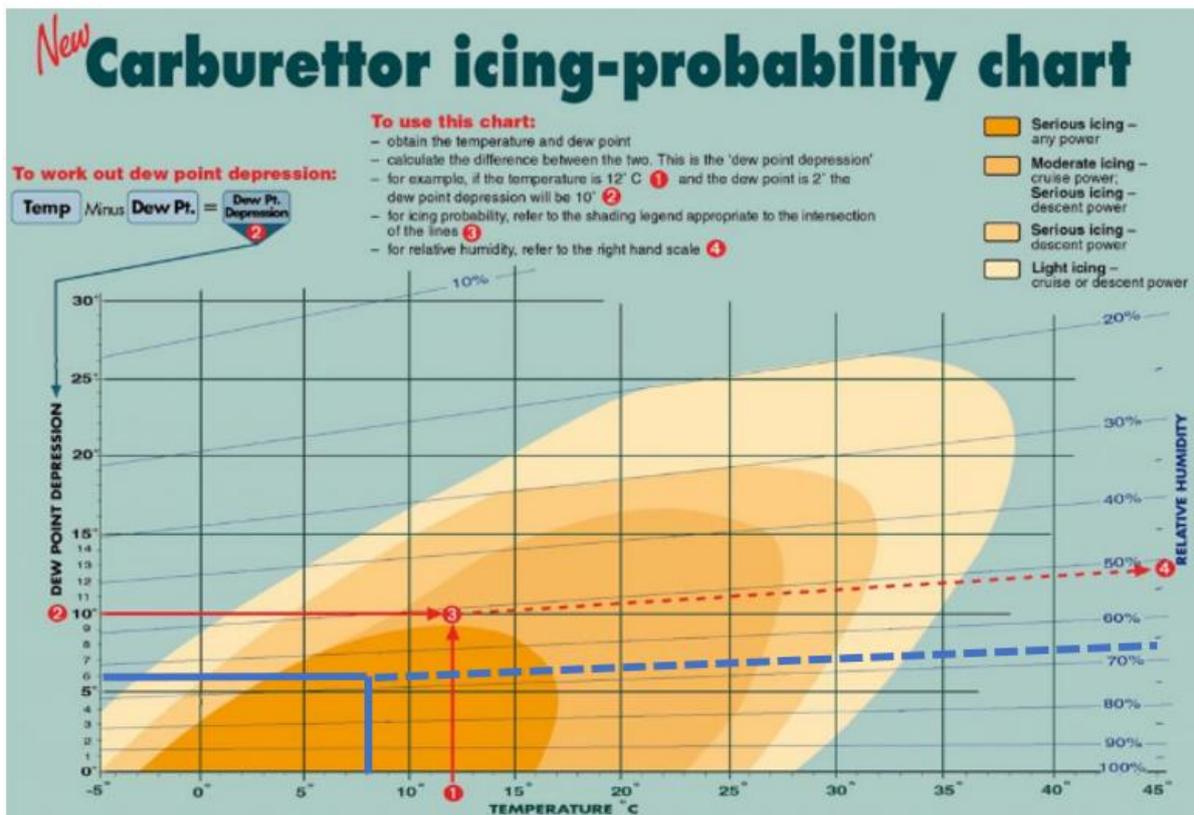
1.7.2 The carburettor icing chart below indicates a dew point depression of 6°C at a temperature of 8°C, which gives the relative humidity of 68% and a serious icing probability at any power setting.

Figure 3: Carburettor icing probability chart.

- 2.2.4 The carburettor icing chart indicated that with the dew point depression of 6°C at 8°C temperature, there would be a relative humidity of 68% and a serious icing probability at any power setting; thus, the weather was a factor which may have resulted in the engine stoppage in-flight.

3.3.1 It is probable that the engine stoppage in-flight was caused by serious carburettor icing conditions.

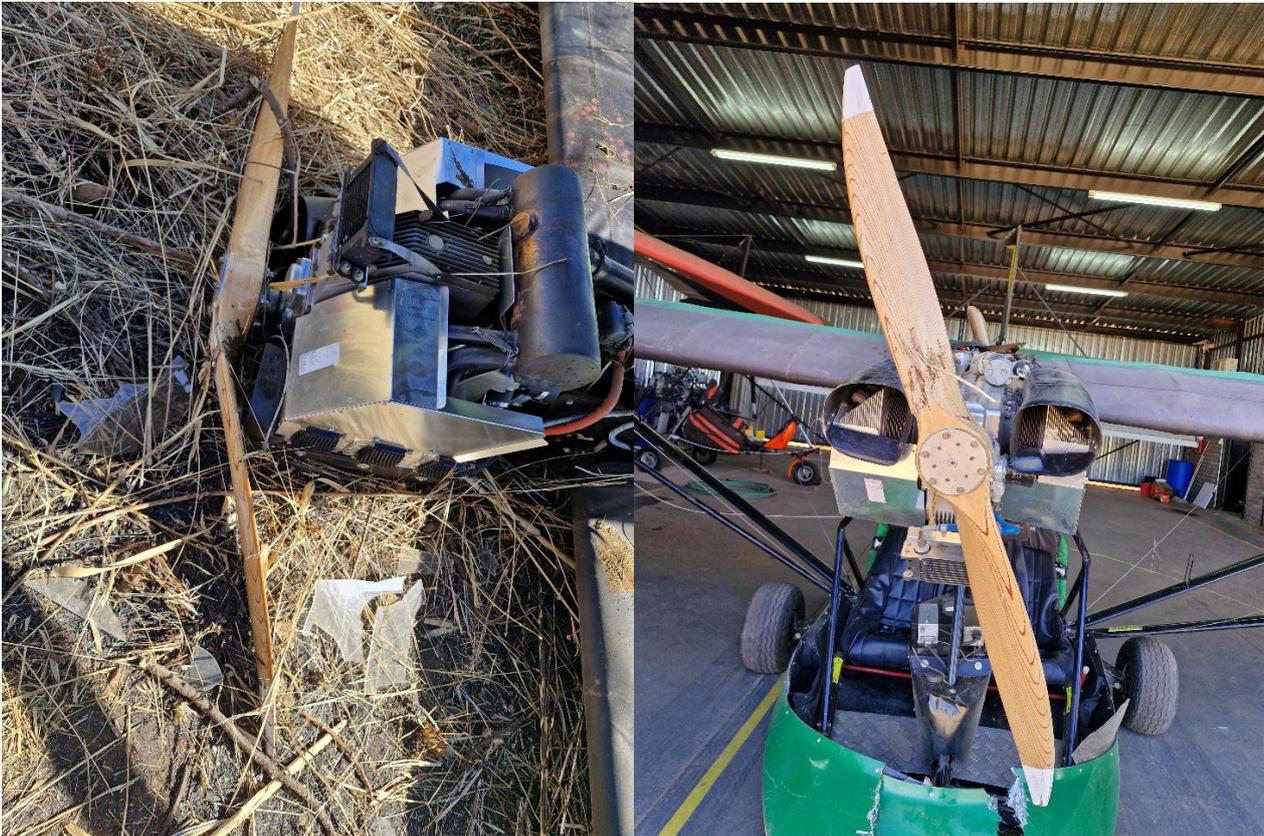
Figures 4 and 5: The damaged propeller blades.

1.16.1 The engine was removed from the aircraft and transported to an approved person (AP) facility at Silver Creek Airfield, North West province. One of the propeller blades was found broken and the other was intact; this indicated that the engine was not operating at time of the impact. The general inspection of the engine revealed that the engine was in good
