LIMITED OCCURRENCE INVESTIGATION REPORT – FINAL

Reference Number	CA18/2/3/10472						
Classification	Accident	Date	15 July 2024		Time	1334Z	
Type of Operation	Private (Part 94)						
Location							
Place of Departure	Tedderfield Aerodrome (FATA), Gauteng Province			Place of Intended Landing	Rand Aerodrome (FAGM), Gauteng Province		
Place of Occurrence	About 2 kilometres (km) west of Runway 29 threshold at Tedderfield Aerodrome (FATA)						
GPS Co-ordinates	Latitude	29°39'03.06" S	Longitude	28°2'48.48" E	Elevation	5 200ft	
Aircraft Information							
Registration	ZU-PBL						
Make; Model; S/N	Sling Aircraft; Sling 4 TSI (Serial Number: 329s)						
Damage to Aircraft	Substantial			Total Aircraft Hours	465.4		
Pilot-in-command							
Licence Type	Private Pilot Licence (PPL)		Gender	Male		Age	44
Licence Valid	Yes	Total Hours	278.5		Total Hours on Type	147.8	
Total Hours 30 Days	6.5		Total Flying on Type Past 90 days	25.2			
People On-board	1+1	Injuries	0	Fatalities	0	Other (on ground)	0

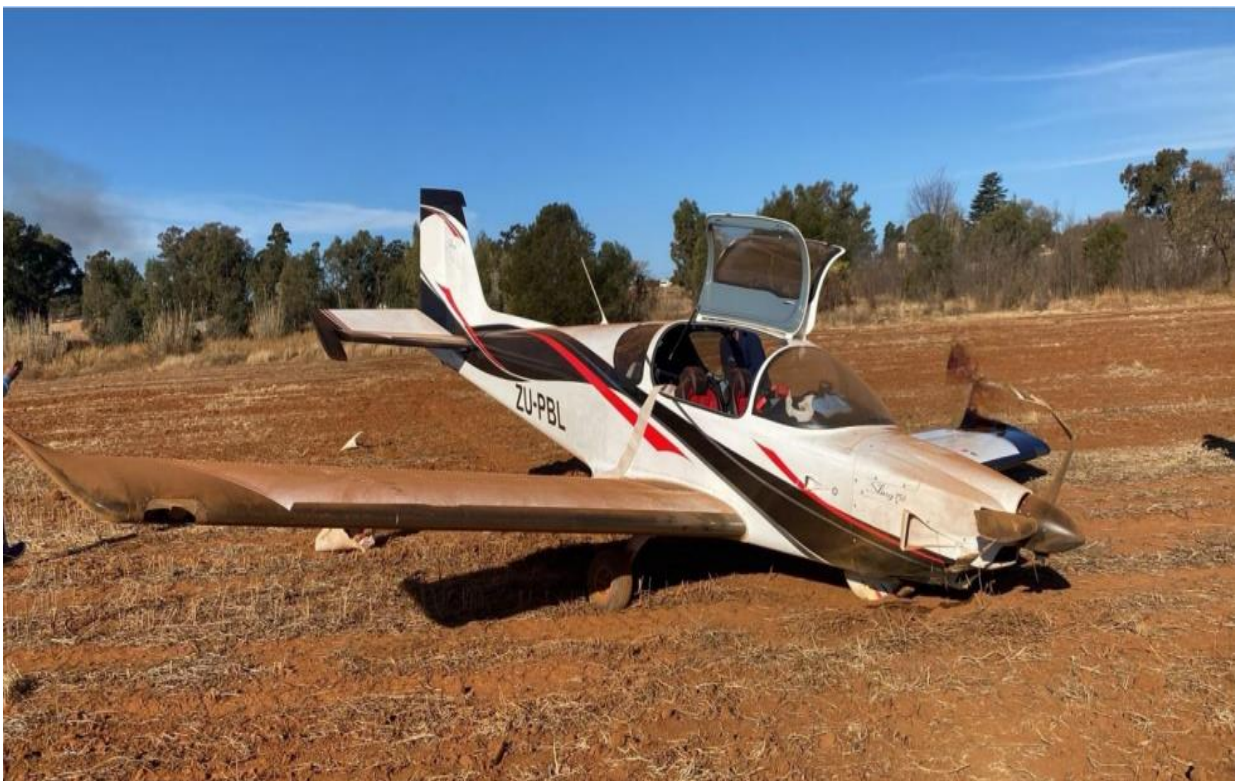
to perform a forced landing on an open space near an informal settlement. The aircraft sustained substantial damage, and the pilot and the passenger vacated the aircraft unharmed.

Figure 3: The aircraft at the accident site. (Source: Pilot)

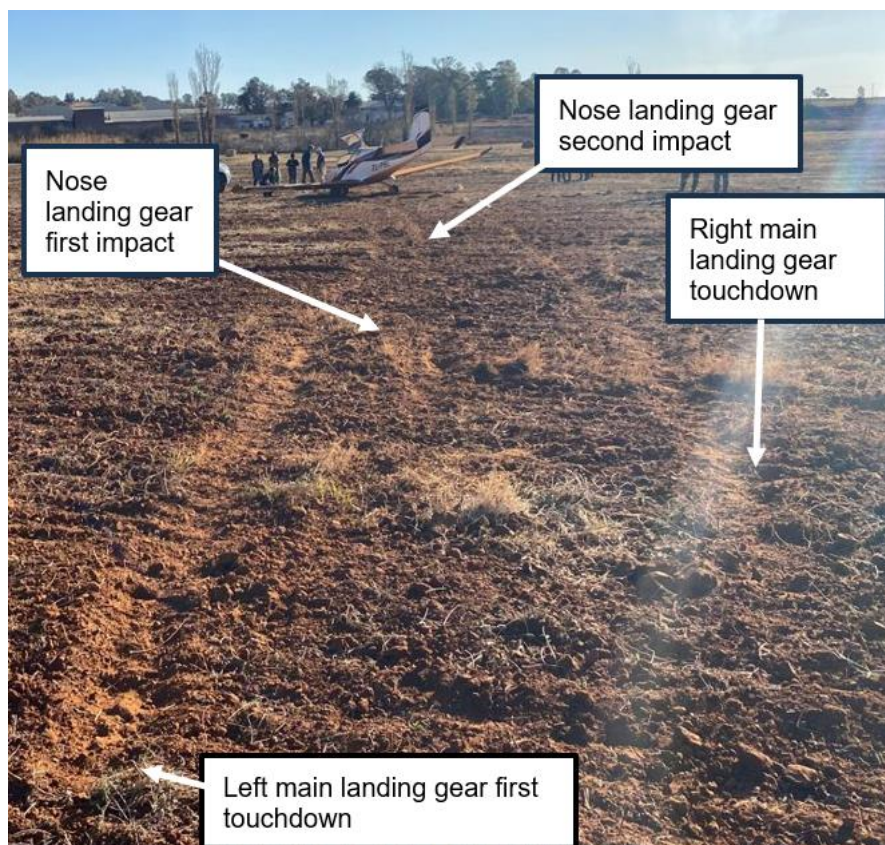
Marks on the ground at the accident site indicated that the aircraft first impacted the ground with its left main landing gear, followed by the right main landing gear. A few metres (m) further, the nose gear contacted the ground and bounced back into the air. Upon the second impact, the nose gear collapsed which caused the propeller blades to contact the ground; as a result, they bent backwards. The aircraft skidded on its nose section for about 5m before it stopped approximately 90 degrees to the left from the first point of impact.

Figure 4: Marks on the ground during the touch down.

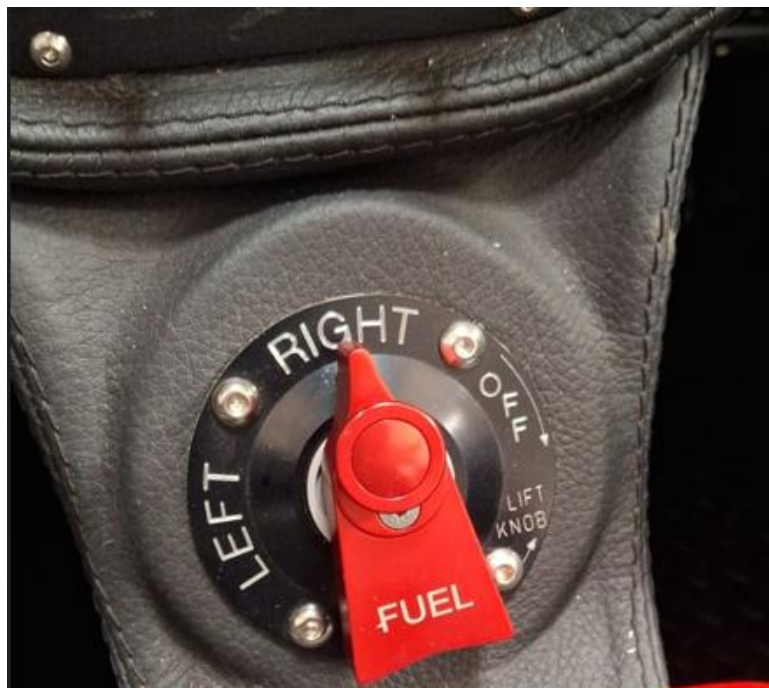
The aircraft was equipped with dual Electronic Flight Information System (EFIS) and dual control sticks which allowed for it to be flown from either the left or right side. Fuel supply could also be selected from either the left or right tank. The pilot had selected the right tank (see Figure 6) for the flight and was seated on the right seat.

Figure 6: Fuel selection.

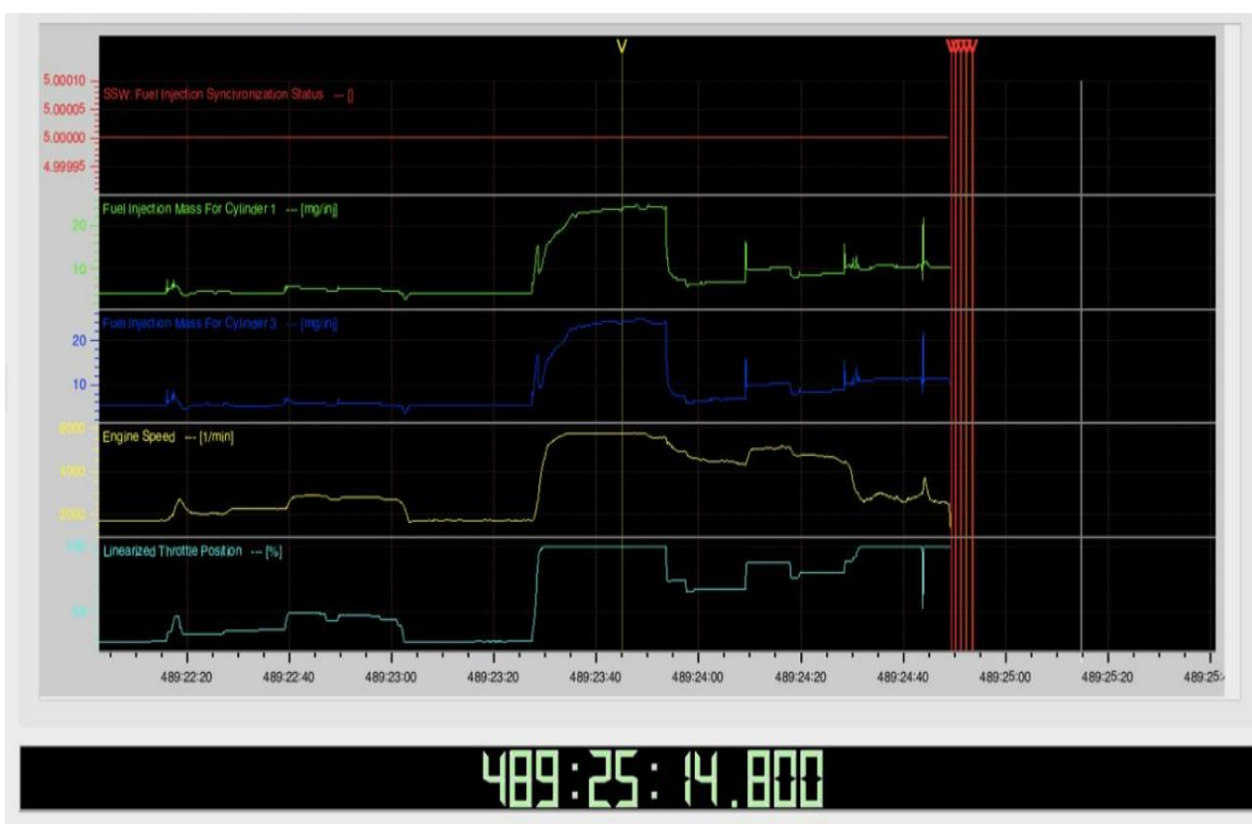
- The fuel synchronisation showed 0, indicating one tank was selected.
- The fuel flow showed that it was constant during the take-off roll, approximately 2 minutes after take-off, the fuel supply fluctuated (engine surged) and cut off.

During the take-off roll, the engine revolutions per minute (RPM) gradually increased from an initial 2000 RPM. However, shortly after take-off, the engine RPM began to fluctuate, indicating possible instability in engine performance. Eventually, the RPM dropped to zero, signalling a complete engine stoppage. The data showed that the power lever was set to 99%, indicating full power at the moment when the fuel supply cut off.

Graph 1: The downloaded parameters. (Source: Manufacturer)

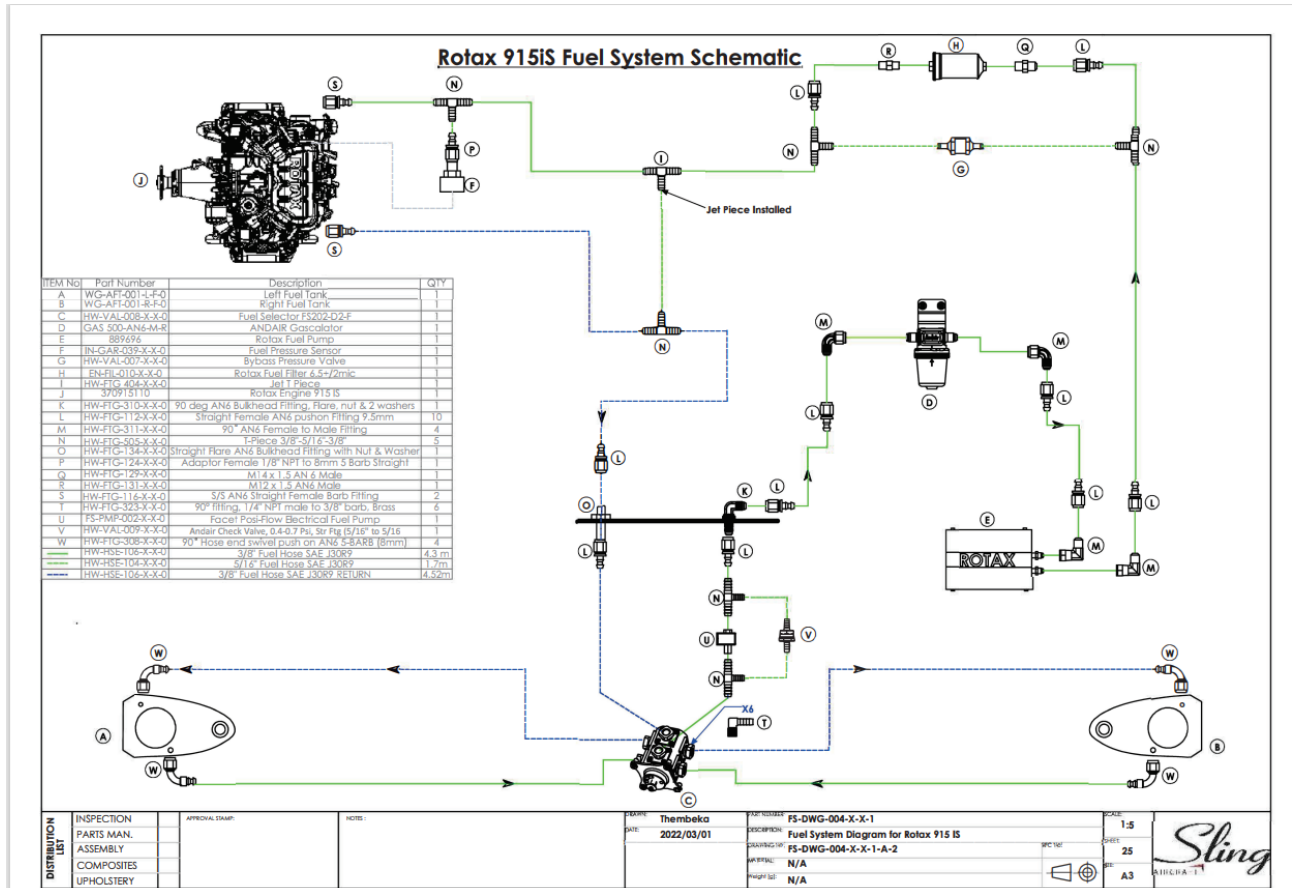
The fuel lift pipe in each tank is situated adjacent to the lower inside wall of the tank. The aircraft should at no time be subjected to a sustained side slip towards a near-empty fuel tank. (i.e. wing

with near-empty tank down) as, despite the baffling, this may lead to fuel running towards the outer edge of the tank and exposing the fuel lift pipe to suck air, thereby starving the engine of fuel and leading to an engine failure. This poses a particular threat when at low altitude, typically prior to landing.

Illustration 1: Schematic diagram of the fuel system. (Source: POH)

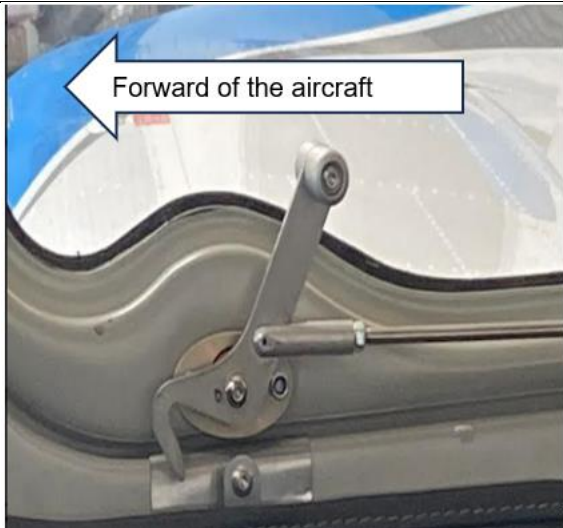
- 1) During take-off, the improperly latched door made it possible for the airflow to push the outer handle backward which caused the door to open (see Figures 7 and 8).

Figure 7: Improperly latched interior door handle.

- The right-side door was not properly latched, and it opened in-flight.
- Excessive roll angle beyond the limit specified in the POH.

In the interest of safety, pilots must ensure that doors are properly latched after taxi and line-up on the runway prior to take-off.

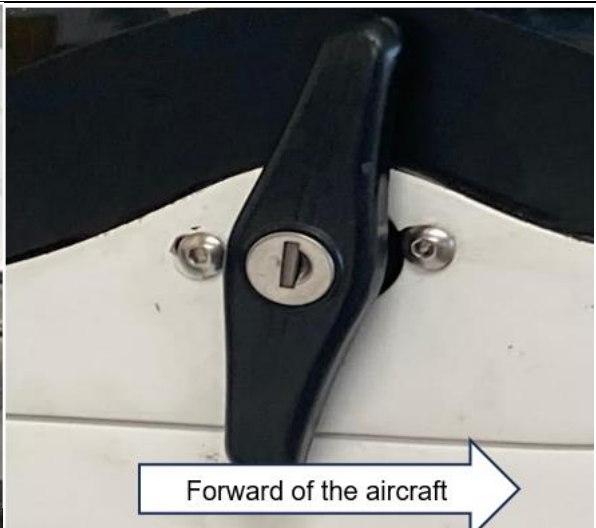
Figure 8: Improperly latched exterior door handle.
