LIMITED OCCURRENCE INVESTIGATION REPORT – FINAL

Reference Number	CA18/2/3/10474							
Classification	Accident			Date	1 August 2024		Time	1515Z
Type of Operation	Private (Part 91) – Game Capture							
Location								
Place of Departure	Alpha Farm in Jakkalsfontein, Free State Province			Place of Intended Landing	Alpha Farm in Jakkalsfontein, Free State Province			
Place of Occurrence	Alpha Farm in Jakkalsfontein, approximately 45 nautical miles (NM) south-west of Bram Fischer International Airport (FABL), Free State Province							
GPS Co-ordinates	Latitude	29°42'49" S	Longitude	025°38'33" E	Elevation	4 340ft		
Helicopter Information								
Registration	ZS-HEM							
Make; Model; S/N	Schweizer Helicopter Corporation; 269C (Serial Number: 1201014)							
Damage to Helicopter	Substantial			Total Helicopter Hours	1 589.6			
Pilot-in-command								
Licence Type	Private Pilot Licence (PPL)		Gender	Male		Age	30	
Licence Valid	Yes	Total Hours	1020.4		Total Hours on Type	1 020.4

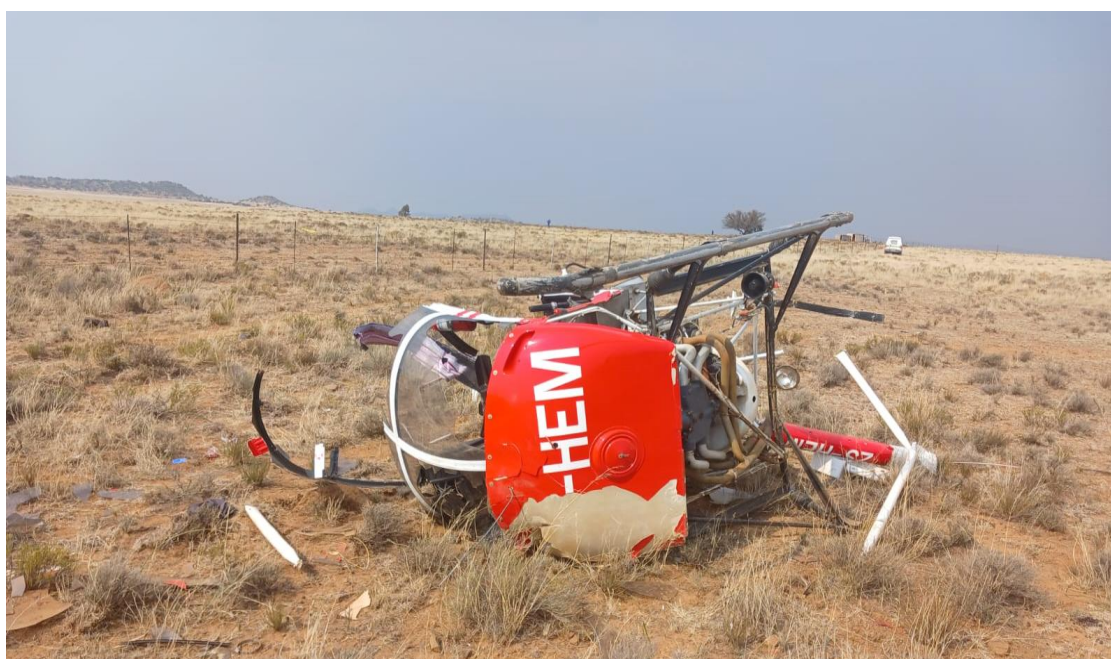
The investigation revealed that the helicopter was operated close to the ground. The pilot's focus was on the springboks that were deviating from going into the boma. The pilot then transitioned the helicopter backwards, but the tail rotor blades struck an anthill (and the rotor blades were severed). As a result, the pilot lost control of the helicopter and it rolled to the right and crashed next to the fence. The helicopter rested on its right side; it was destroyed during the accident sequence.

Figure 1: The final resting position of the helicopter. (Source: SAPS)

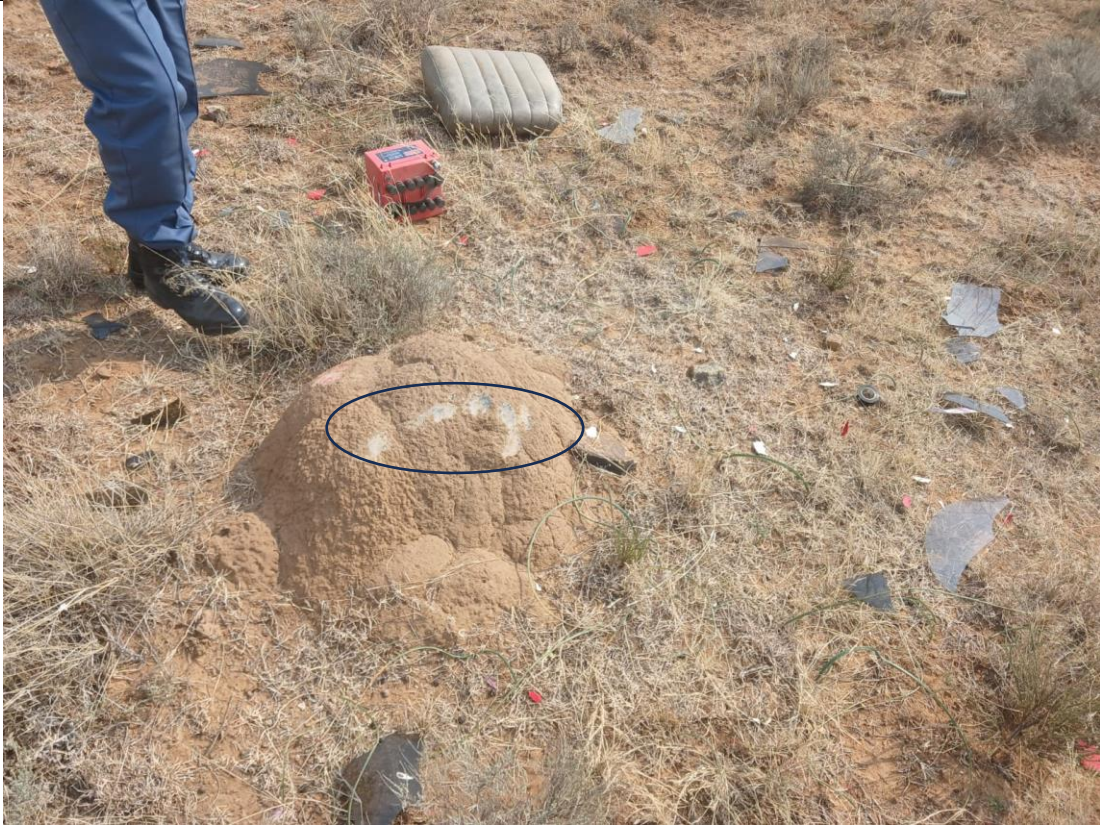
Figure 2: The tail rotor blades marks on the anthill. (Source: SAPS)

Probable Cause(s)
The helicopter's tail rotor blades struck an anthill whilst the helicopter was operated close to the ground. As a result, the tail boom was severed and the pilot lost control; the helicopter rolled to the right and crashed.
Contributing Factor(s)
Loss of situational awareness of the ground's proximity.
Safety Action(s)
None.
Safety Message and/or Safety Recommendation/s
None.
About this Report

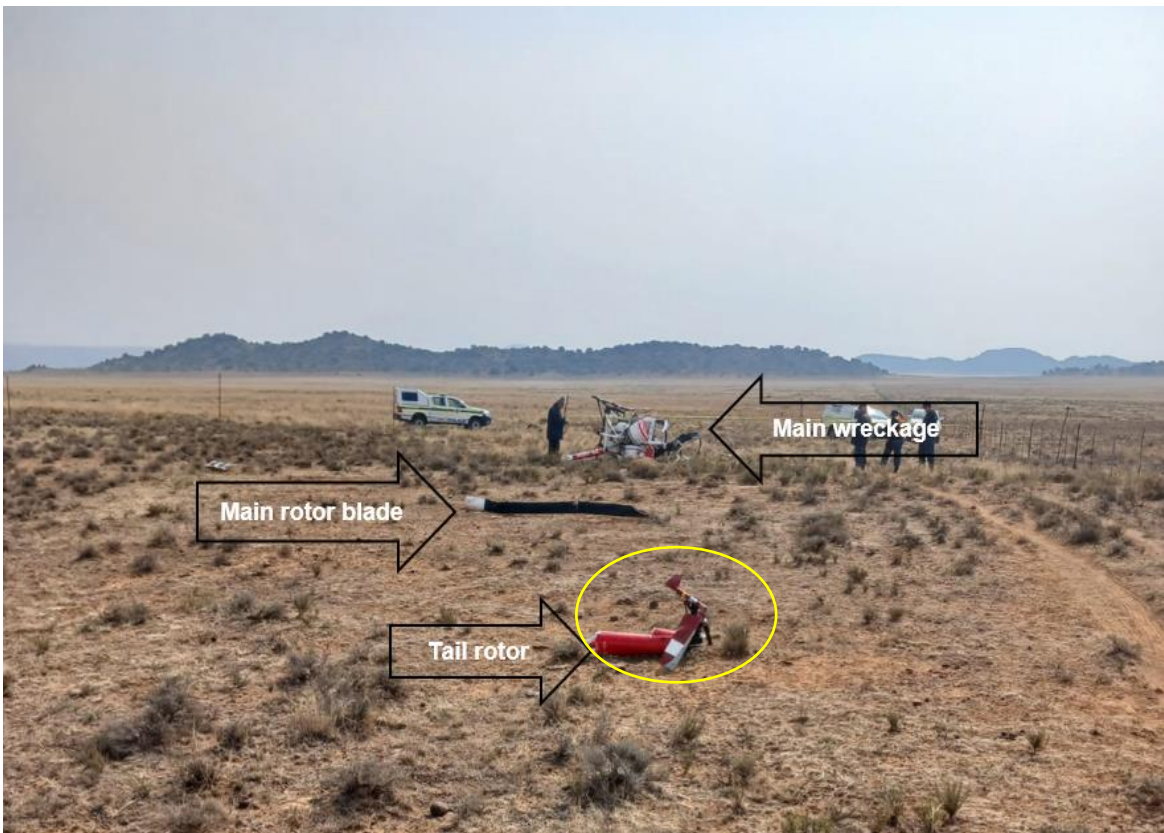
Figure 3: The accident scene depicting the wreckage, main rotor blade and tail rotor post-accident. (Source: SAPS)
