LIMITED OCCURRENCE INVESTIGATION REPORT

Reference Number	CA18/2/3/10475				
Classification	Accident	Date	6 August 2024	Time	0730Z
Type of Operation	Training (Part 141)				
Location					
Place of Departure	Cape Winelands Aerodrome, (FAWN) Western Cape Province	Place of Intended Landing	Cape Winelands Aerodrome, (FAWN) Western Cape Province		
Place of Occurrence	On Runway 05 at Cape Winelands Aerodrome, Western Cape Province				
GPS Co-ordinates	Latitude	33°46'18.70" S	Longitude	018°44'23.34" E	Elevation 414 ft
Aircraft Information					
Registration	ZS-PUW				
Make; Model; S/N	Cessna 150 (Serial Number: 150-59992)				
Damage to Helicopter	Substantial	Total Aircraft Hours	4882.46		
Pilot-in-command					
Licence Type	Student Pilot Licence (SPL)	Gender	Male	Age	26
Licence Valid	Yes	Total Hours	44.2	Total Hours on Type	44.2
Total Hours Past 30 Days	3.4		Total Flying Hours on Type Past 90 Days	29.1	
People On-board	1 + 0	Injuries	0	Fatalities	0
				Other (on ground)	0

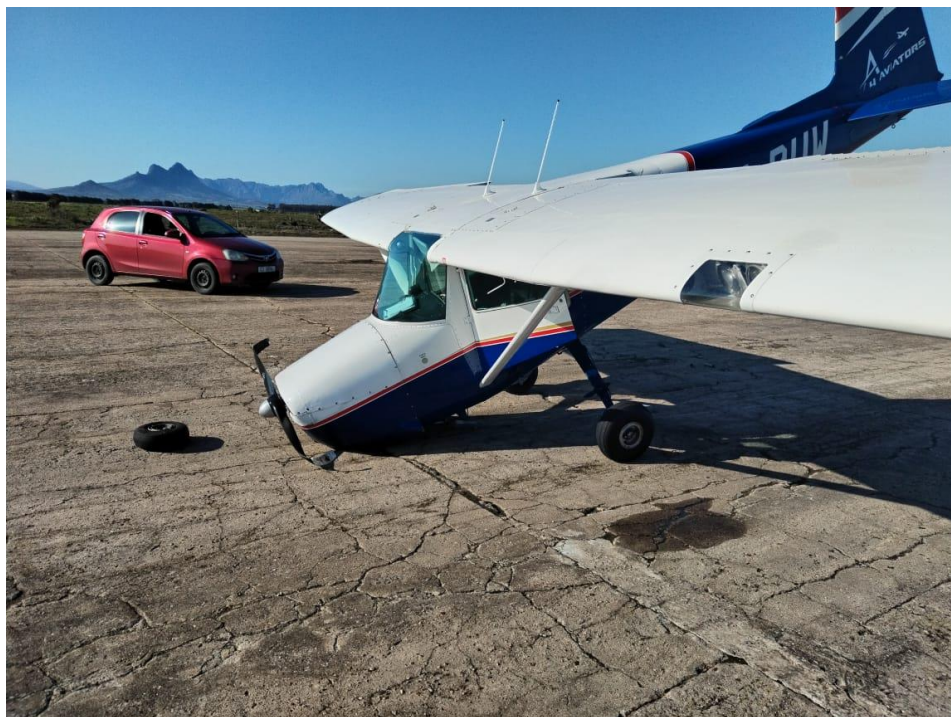
down at 60 kts, the aircraft bounced before it impacted hard on the runway with the nose gear. As a result, the nose gear broke off and the propeller impacted the runway surface. The student pilot did not attempt to execute a go-around. He was not injured during the accident sequence. The aircraft sustained damage to the nose landing gear and the propeller.

Figure 2: The aircraft post-accident. (Source: Operator)

7. The student pilot delayed flaring during landing and the nosewheel struck the runway hard and bounced. Subsequently, the nose gear collapsed, and the wheel separated from the aircraft which led to the propeller also striking the runway.

Probable Cause
The aircraft landed hard due to the delayed flare which resulted in a bounce. This was followed by the collapse of the nose gear and the subsequent wheel separation.
Contributing Factor
None.
Safety Action(s)
None.
Safety Message
None.
About this Report
<p><i>The decision to conduct a limited investigation is based on factors including whether the cause is known and the evidence supporting the cause is clear, the level of safety benefit likely to be obtained from an investigation and that will determine the scope of an investigation. For this occurrence, a limited investigation has been conducted, and the Accident and Incident Investigations Division (AIID) has relied on the information submitted by the affected person/s and organisation/s to compile this limited report. The report has been compiled using information supplied in the initial notification, as well as from follow-up desktop inquiries to bring awareness of potential safety issues to the industry in respect of this occurrence, as well as possible safety action/s that the industry might want to consider in preventing a recurrence of a similar occurrence.</i></p> <p><i>All times given in this report are Co-ordinated Universal Time (UTC) and will be denoted by (Z). South African Standard Time is UTC plus 2 hours.</i></p>
