LIMITED OCCURRENCE INVESTIGATION REPORT – FINAL

Reference Number	CA18/2/3/10477						
Classification	Accident	Date	9 August 2024	Time	0920Z		
Type of Operation	Private (Part 94)						
Location							
Place of Departure	Grand Central Aerodrome (FAGC), Gauteng Province		Place of Intended Landing	Grand Central Aerodrome (FAGC), Gauteng Province			
Place of Occurrence	To the left of Runway 35 at FAGC						
GPS Co-ordinates	Latitude	25°59'20.51" S	Longitude	028°08'29.39" E	Elevation	5 327 feet	
Aircraft Information							
Registration	ZU-CNI						
Make; Model; S/N	Shadow Lite CC; Jabiru SP (Serial Number: 502)						
Damage to Aircraft	Minor		Total Aircraft Hours	1 053.1			
Pilot-in-command							
Licence Type	Private Pilot Licence		Gender	Male		Age	46
Licence Valid	Yes	Total Hours	358.3		Total Hours on Type	111.2	
Total Hours 90 Days	35.6		Total Hours on Type Past 90 Days	14.4			
People On-board	1 + 0	Injuries	0	Fatalities	0	Other (on ground)	0
What Happened

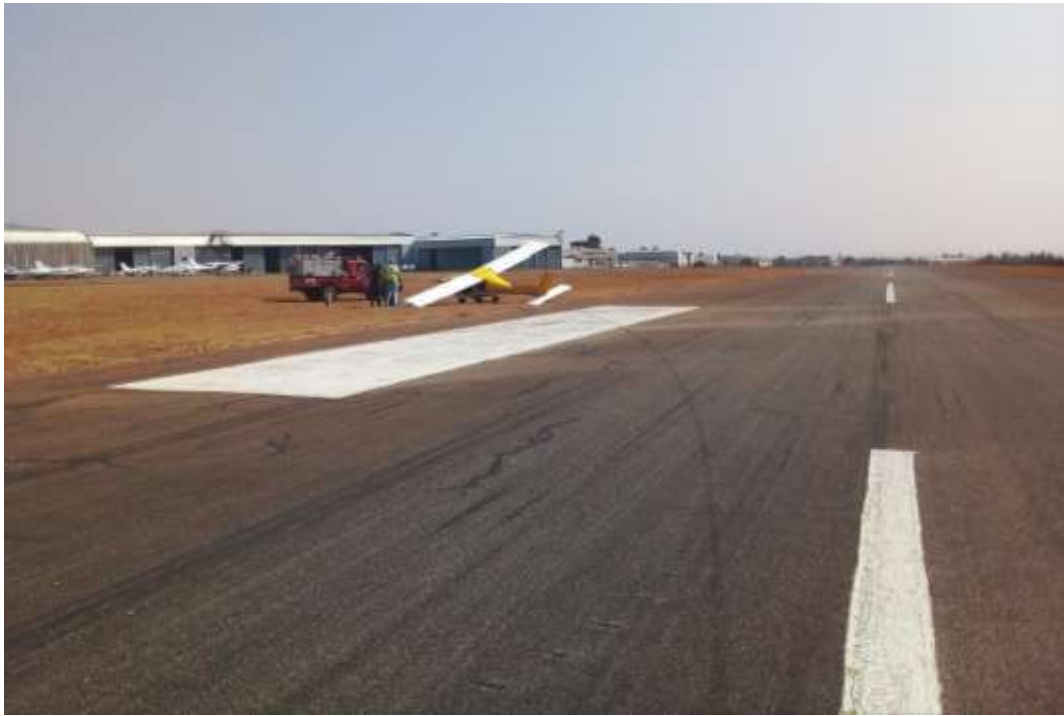
Figure 2: The left main tyre markings on the runway. (Source: Pilot)

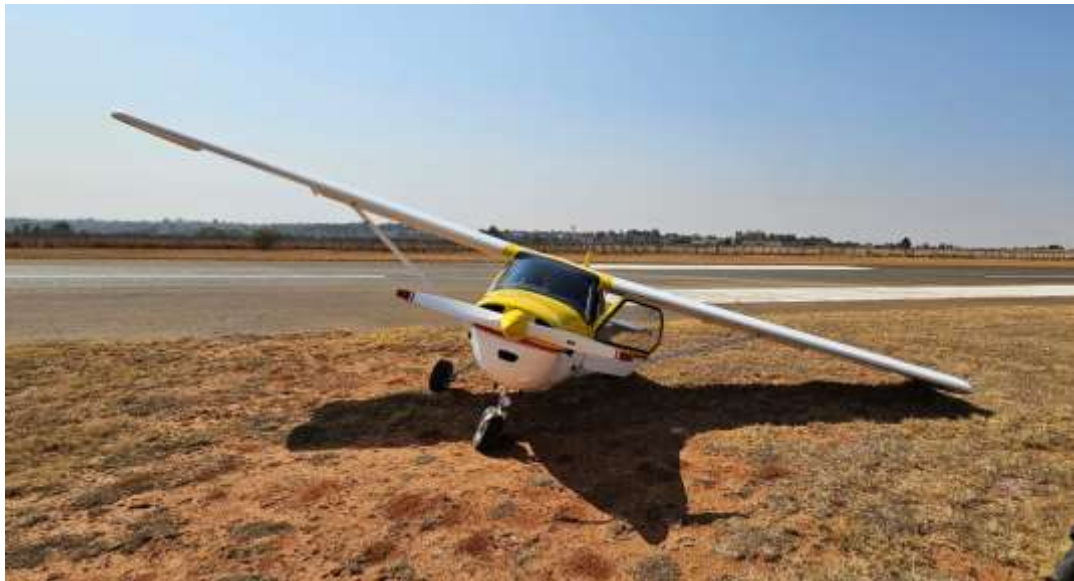
Figure 3: The aircraft as it came to rest next to the runway. (Source: Pilot)

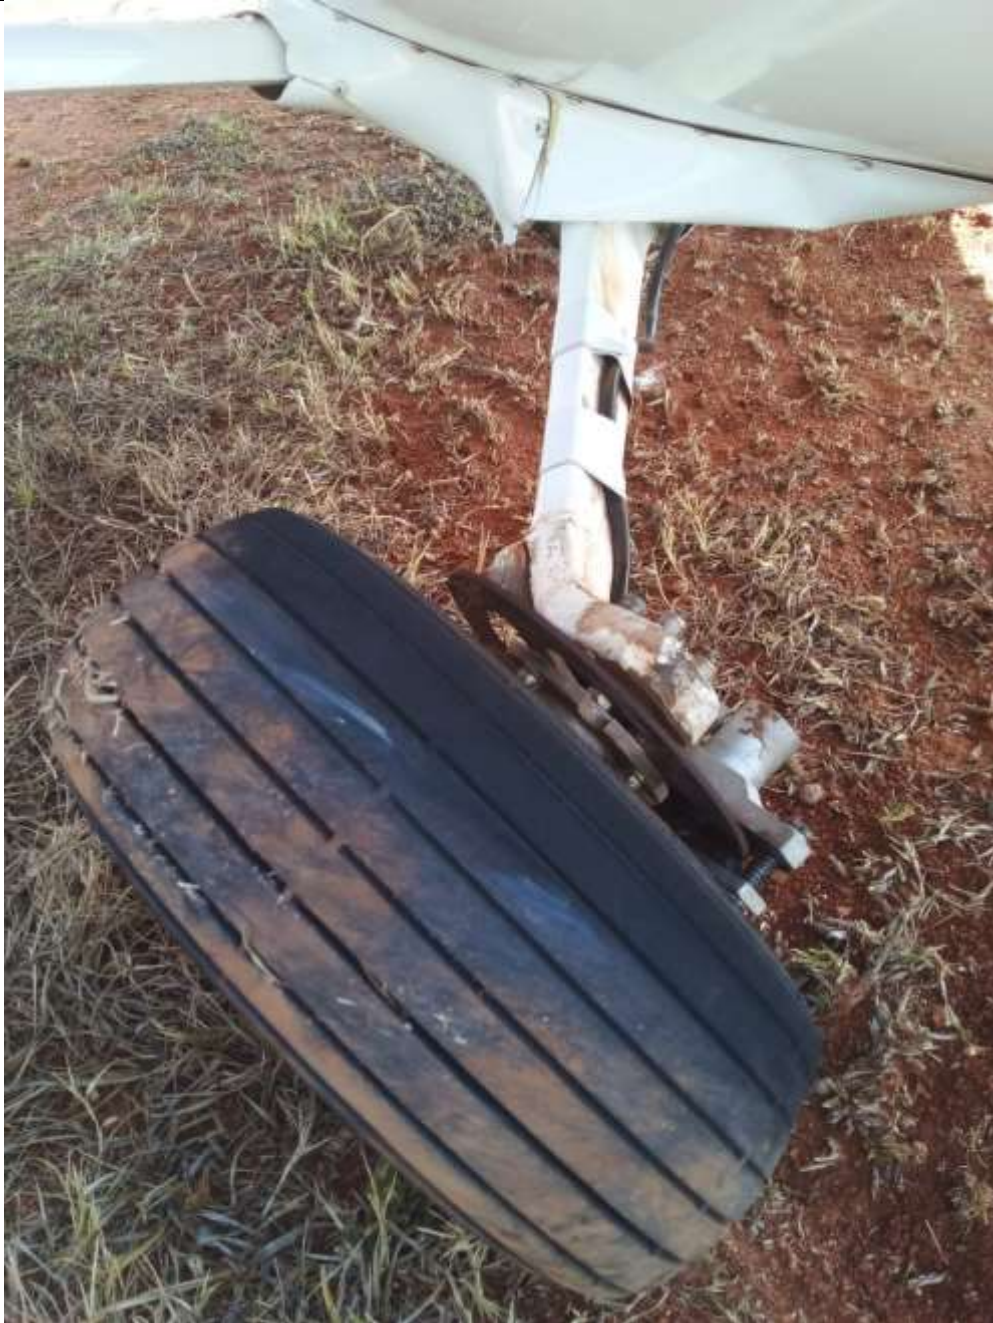
Figure 4: The left main landing gear leaf spring strut that folded backwards. (Source: Pilot)

The aircraft was recovered to the aircraft maintenance organisation (AMO) facility where the aircraft was inspected by the investigator from the Accident and Incident Investigations Division (AIID). It was found that the left main landing gear outer support bracket with part number 6002094-8 (see Figure 5, item 7) had fractured during landing, which caused the left leaf spring landing gear strut to fold backwards (as shown in Figure 4). The aircraft did not sustain any other damage.

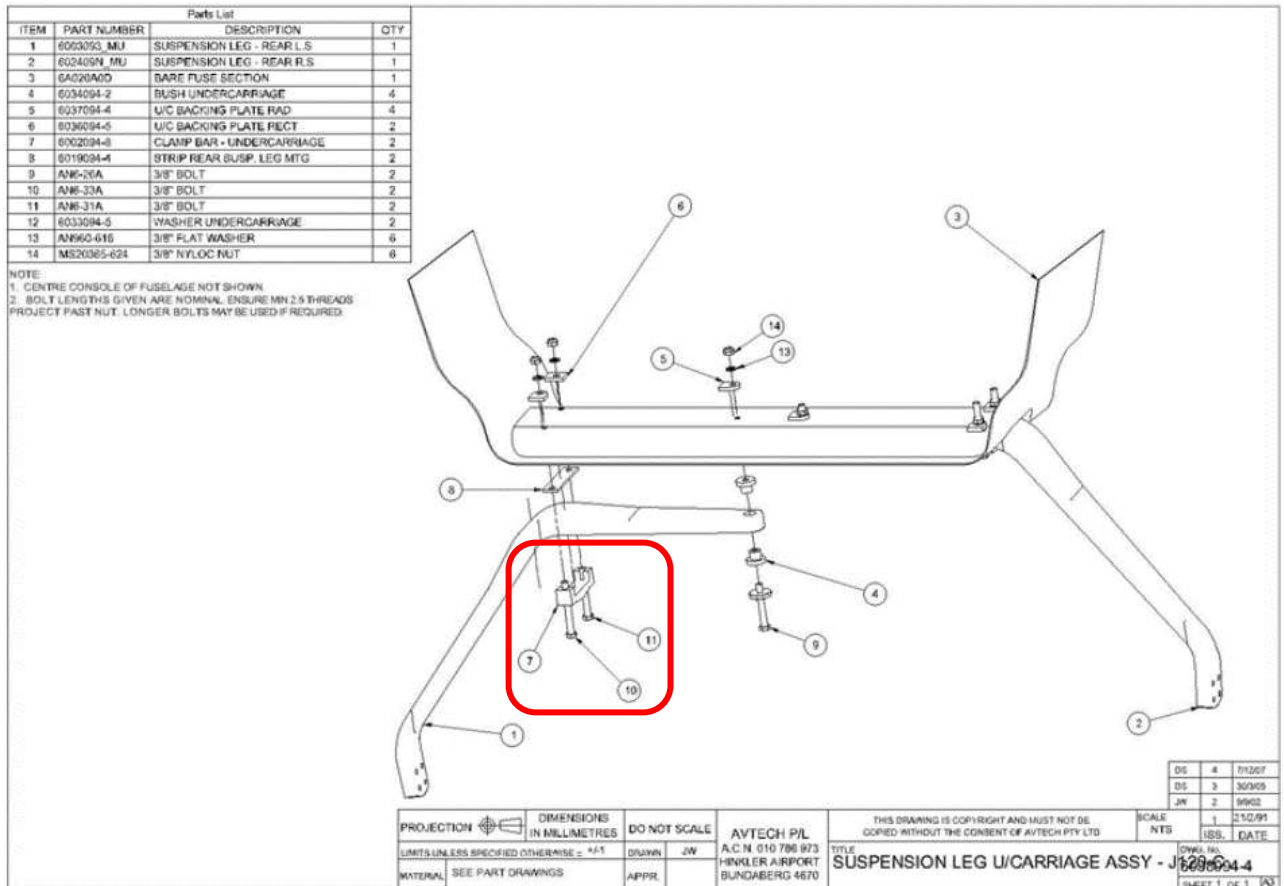
Figure 5: The main undercarriage with the failed bracket, item 7 depicted in the red window.

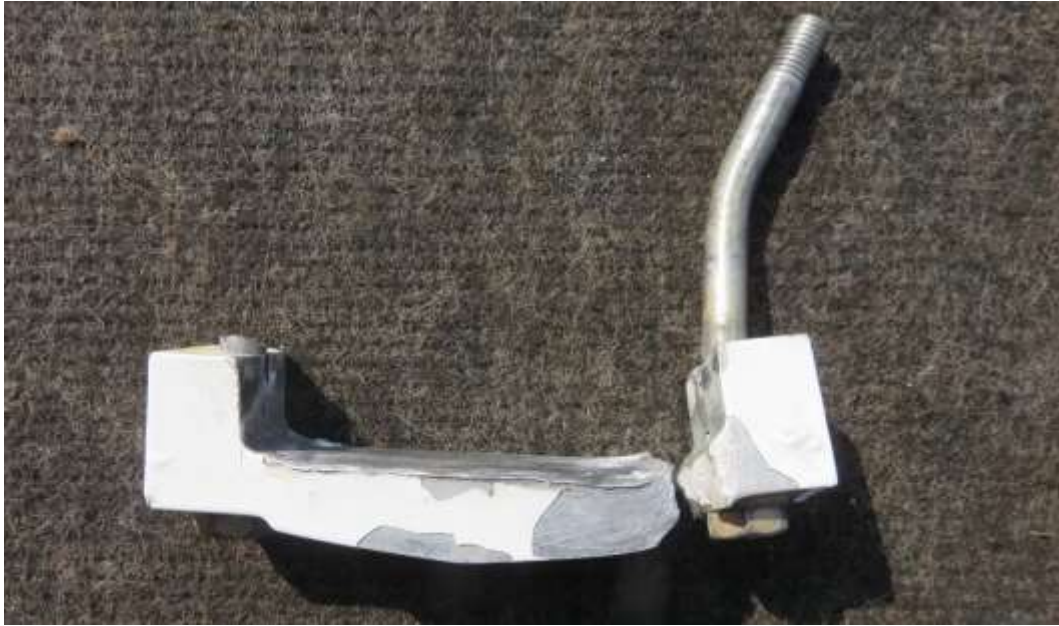
Figure 6: The fractured bracket.

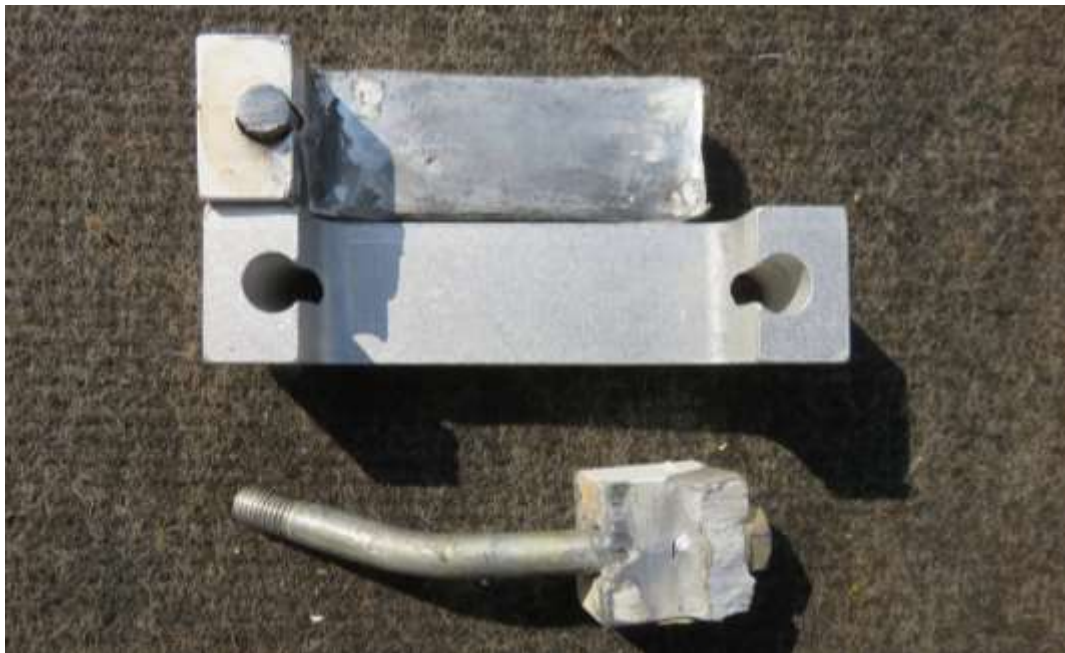
Figure 7: The picture depicts the fractured bracket and a new bracket.

2.7	This aircraft was involved in a previous accident on 14 June 2010 when it veered off the runway during landing at a private aerodrome in Buffelspoort near Rustenburg; the aircraft entered a ditch and nosed over. The allocated reference number CA18/2/3/8796 to this accident.
Probable Cause(s)	
The left main gear leaf spring strut folded backwards during the landing roll when the outer support gear strut bracket failed due to fatigue. This caused the aircraft to veer off to the left of the runway.	
Contributing Factor(s)	
None.	
Safety Action(s)	
None.	
Safety Message and/or Safety Recommendation/s	
It is recommended that the Director of Civil Aviation issue a Mandatory Advisory Notice (MAN) that calls for the replacement of all old main gear leaf spring strut outer brackets on the Jabiru SP series of aircraft with the newer version (shown in Figure 7 of this report) which requires thicker bolts to secure the brackets.

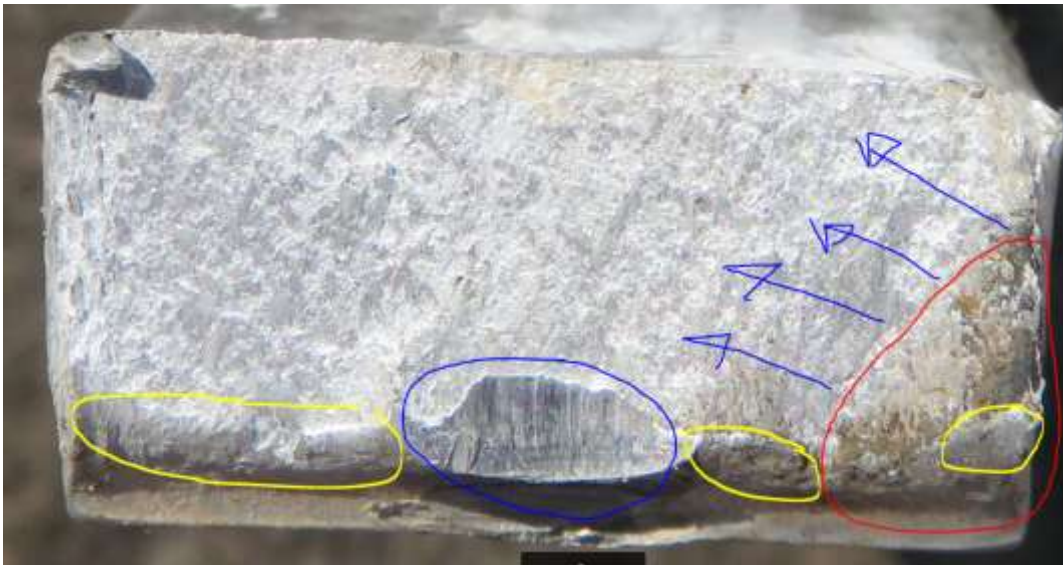
1. Fractured surface (Figure 8): There seems to be a clear zone that has been exposed to the environment for a period (red circle).
2. Fractured surface (Figure 8): There also seem to be indications of fatigue beach-marks (blue arrows) suggesting a fracture progression direction.

3. Mechanical smearing indicated by the yellow circles (in Figure 8) suggested that the fracture existed for some time.
4. The primary fracture mode seems to be fatigue and not a single overload.
5. The extent of mechanical wear at the leaf spring/bracket interface suggested the following.
 - (i) The aircraft was subjected to a high number of take-offs and landings.
 - (ii) Incorrect torque of the bracket bolts (items 10 and 11 of Figure 5) during fitment.
 - (iii) The level of wear also supports the notion that the bracket was exposed to exceedingly high loads during operation, thus, initiating the fracture.

Figure 8: Fractures on the bracket surface.

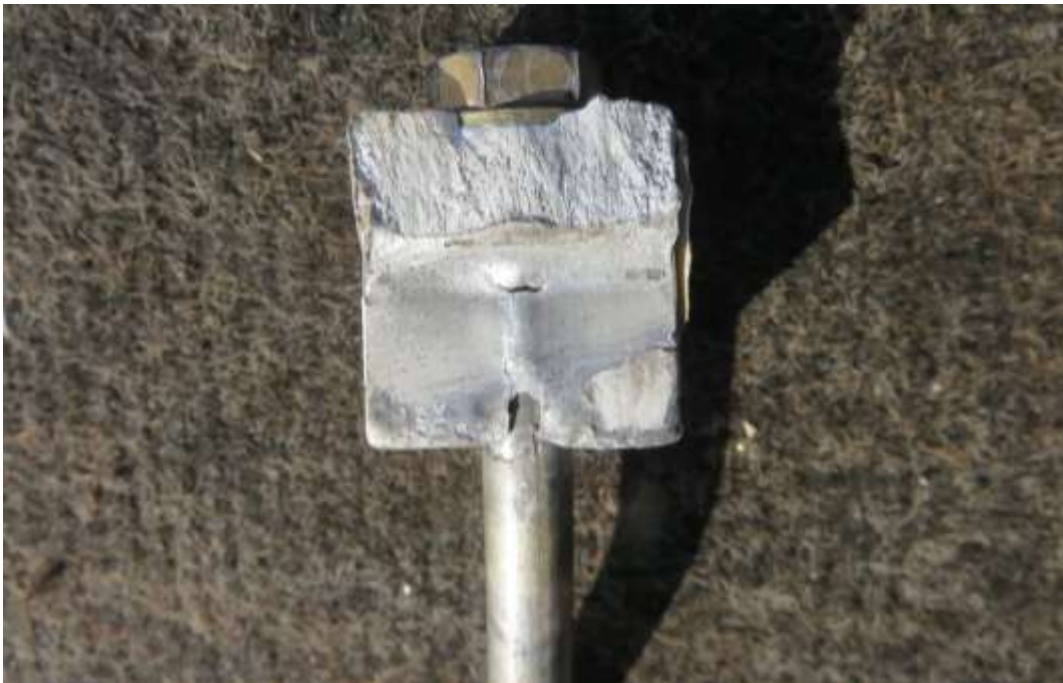
Figure 9: The bracket a with fractured surface.
