**LIMITED OCCURRENCE INVESTIGATION REPORT – FINAL**

<b>Reference Number</b>	CA18/2/3/10478						
<b>Classification</b>	Accident		<b>Date</b>	15 August 2024		<b>Time</b>	1050Z
<b>Type of Operation</b>	Training (Part 141)						
<b>Location</b>							
Place of Departure	Lanseria International Airport (FALA), Gauteng Province		Place of Intended Landing		Lanseria International Airport (FALA), Gauteng Province		
Place of Occurrence	Runway 25 at Lanseria International Airport (FALA)						
GPS Co-ordinates	Latitude	25°55'55.00"S	Longitude	27°56'6.74"East	Elevation	4 298 ft	
<b>Aircraft Information</b>							
Registration	ZU-FVU						
Make; Model; S/N	Sling Aircraft Factory, Sling 2 (Serial Number: 063)						
Damage to Aircraft	Minor		Total Aircraft Hours		465.4		
<b>Pilot-in-command</b>							
Licence Type	Student Pilot Licence (SPL)		Gender	Female		Age	21
Licence Valid	Yes	Total Hours	70		Total Hours on Type	63.2	
Total Hours 30 Days	2.2		Total Flying on Type Past 90 Days		7.8

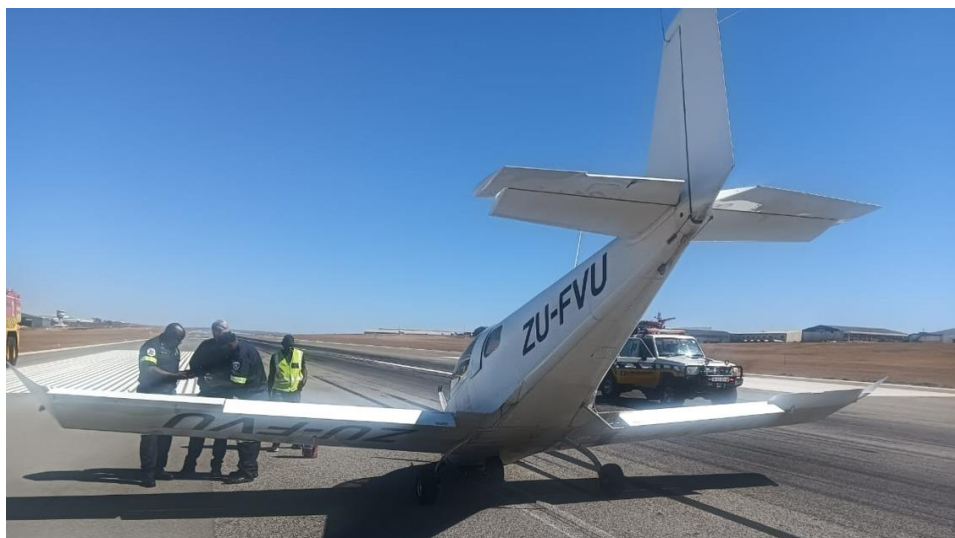
<b>People On-board</b>	1+0	<b>Injuries</b>	0	<b>Fatalities</b>	0	<b>Other (on ground)</b>	0
<b>What Happened</b>							
<p>On Thursday, 15 August 2024, a student pilot (SP) on-board a Sling 2 aircraft with registration ZU-FVU was on a training flight from Lanseria International Airport (FALA) in Gauteng province, with the intention to land back at same airport. The flight was conducted under visual meteorological conditions (VMC) by day and under the provisions of Part 141 of the Civil Aviation Regulations (CAR) 2011 as amended.</p> <p>The SP stated that she took off to Magaliesburg general flying area (GFA) for an hour-building flight. The flight from FALA to the GFA was uneventful. Upon her return to FALA, the air traffic control (ATC) officer could not clear her to immediately join the circuit due to the congested airspace at the time. The SP was instructed to orbit before joining the circuit. After a while, the SP was directed to join a circuit and to land on Runway 25. The SP stated that the approach speed was approximately 75 knots (kts) with the flaps extended to 40 degrees; the main wheels touched down on the runway and the aircraft bounced. During the second touchdown, the aircraft landed with the nose wheel first and the nose gear strut collapsed; consequently, the propeller blades struck the runway surface. The aircraft sustained minor damage. The SP vacated the aircraft unharmed.</p>

**Figure 2:** The aircraft as it came to a stop. (Source: ARFF)

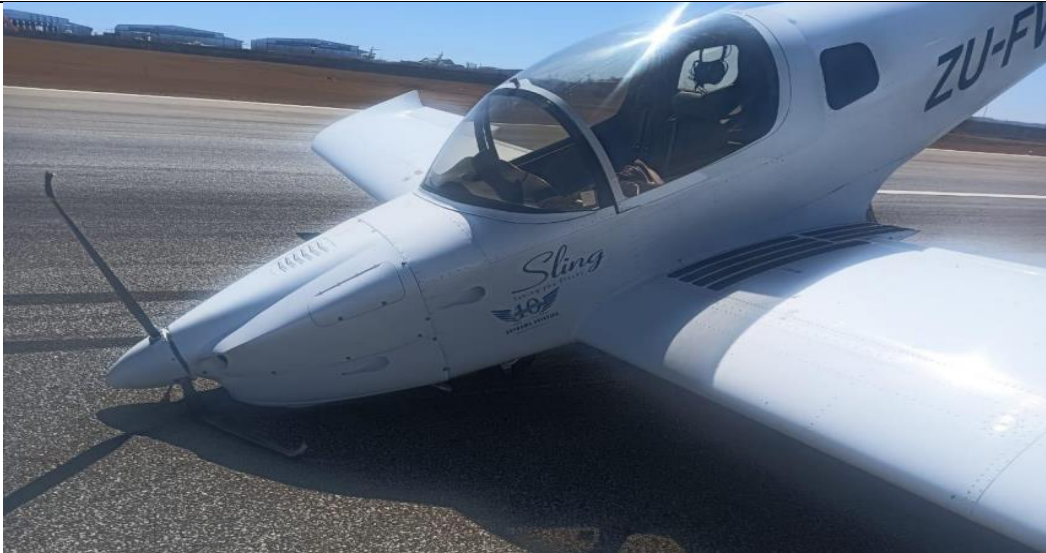
**Figure 3:** The damaged propeller. (Source: ARFF)

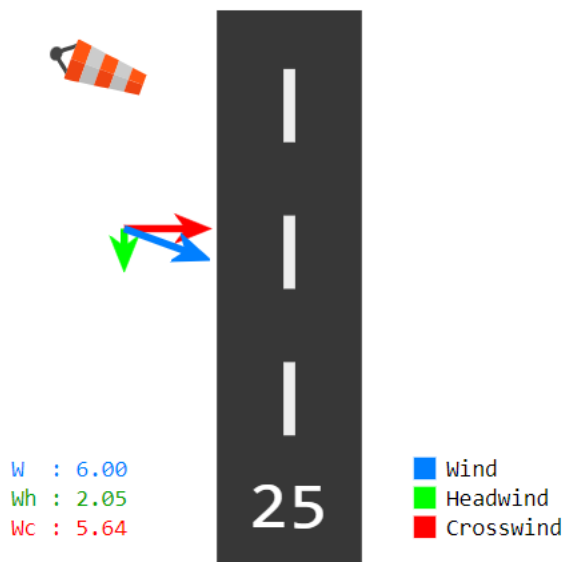
**Figure 4:** The crosswind component as per the weather report. (Source: <https://e6bx.com>)

- The weather profile indicates a constant wind speed and direction at the surface with no low-level wind shear turbulence.
- The crosswind component for the Sling 2 is 15 knots (kts). The crosswind component refers to the maximum crosswind velocity an aircraft can effectively withstand during take-off and landing.
