LIMITED OCCURRENCE INVESTIGATION REPORT – FINAL

Reference Number		CA18/2/3/10479						
Classification		Accident		Date		18 August 2024	Time	0950Z
Type of Operation		Private (Part 91)						
Location								
Place of Departure		Margate Airport (FAMG), KwaZulu-Natal Province		Place of Intended Landing		Virginia Airport (FAVG), KwaZulu-Natal Province		
Place of Occurrence		On the grass near the hangar at FAMG						
GPS Co-ordinates		Latitude	30° 51' 34.98" S	Longitude	030° 20' 33.43" E	Elevation	480 ft	
Aircraft Information								
Registration		ZS-EGZ						
Make; Model; S/N		Cessna Aircraft Company; C150F (Serial Number:150-63463)						
Damage to Aircraft		Substantial		Total Aircraft Hours		8 528.55		
Pilot-in-command								
Licence Type		Private Pilot Licence (PPL)		Gender		Male	Age	26
Licence Valid		Yes	Total Hours		185.4	Total Hours on Type		47.6
Total Hours 30 days		6.7		Total Flying on Type Past 90 days		25.9		
People On-board		1+0	Injuries	0	Fatalities	0	Other (on ground)	0

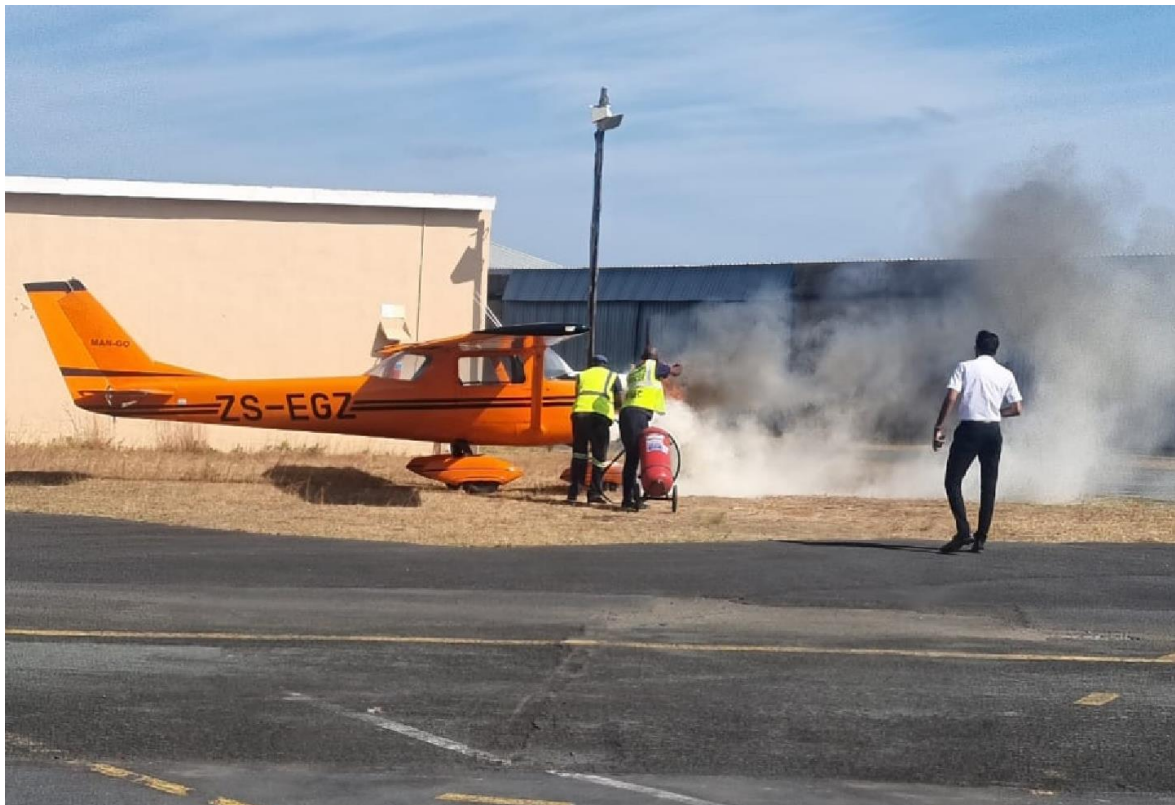
Figure 2: The aircraft at the time the firefighters extinguished the fire. (Source: Pilot)

The aircraft's engine was flooded with fuel during the priming procedure which led to fuel overflowing. A subsequent hot start procedure without clearing the flooded engine led to the eruption of the fire.

Safety message: Pilot's must remember to use the fire extinguisher (safety equipment) when a fire erupts.

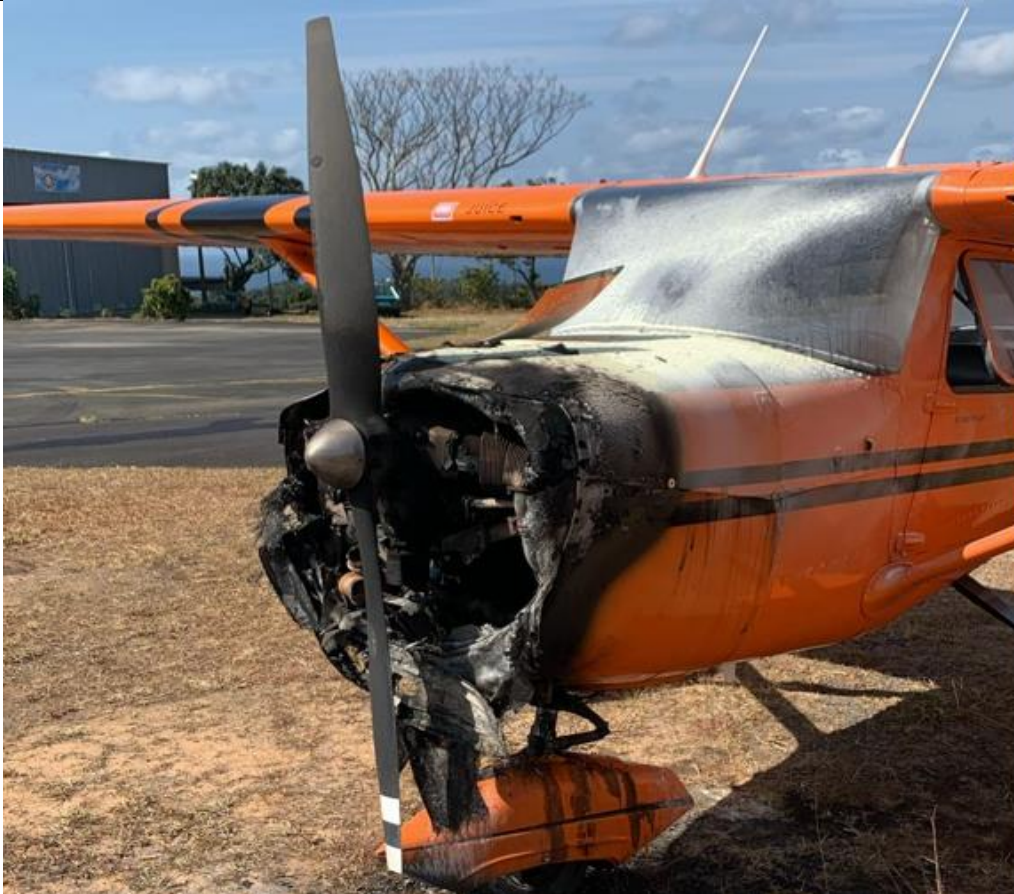
Figure 3: Damage in the engine section. (Source: Pilot)

7. The POH outlines that to clear the excess fuel from the combustion chambers, the following procedure should be conducted: The pilot should set the mixture control to full lean position, open the throttle fully, and crank the engine through several revolutions with the starter. This procedure should be repeated without additional priming. The pilot did not follow the recommended procedure for clearing a flooded engine as outlined in the POH, which might have prevented or mitigated the start of the fire and the severity of the damage. The excess fuel from flooding came into contact with the engine's hot section and ignited, which caused the fire.

8. The fire damage was exacerbated by failure to use the on-board fire extinguisher.

- Ensure that pilots are familiar with and follow the complete engine start and recovery procedures as detailed in the POH. Emphasise the importance of adjusting the mixture control and throttle settings in the event of over-priming.

- Conduct recurrent training on handling engine flooding and the proper use of on-board fire extinguishers. Simulate scenarios involving over-priming and engine fires to reinforce quick and effective response measures.
- Ensure pre-flight briefings include protocols for handling engine issues and the availability of emergency equipment. Post-incident procedures should include checking the functionality of on-board fire extinguishers.
- Encourage the immediate use of fire extinguishers in the event of on-board fires, even if external help is available. Train pilots to use on-board fire extinguishers effectively before evacuating the aircraft.
