**LIMITED OCCURRENCE INVESTIGATION REPORT – FINAL**

| <b>Reference Number</b> | CA18/2/3/1048 | | | | | | |
| <b>Registration</b> | ZU-SPS | | | | | | |
| <b>Make; Model; S/N</b> | Thunderbird MKII (Serial Number: TDE-71) | | | | | | |

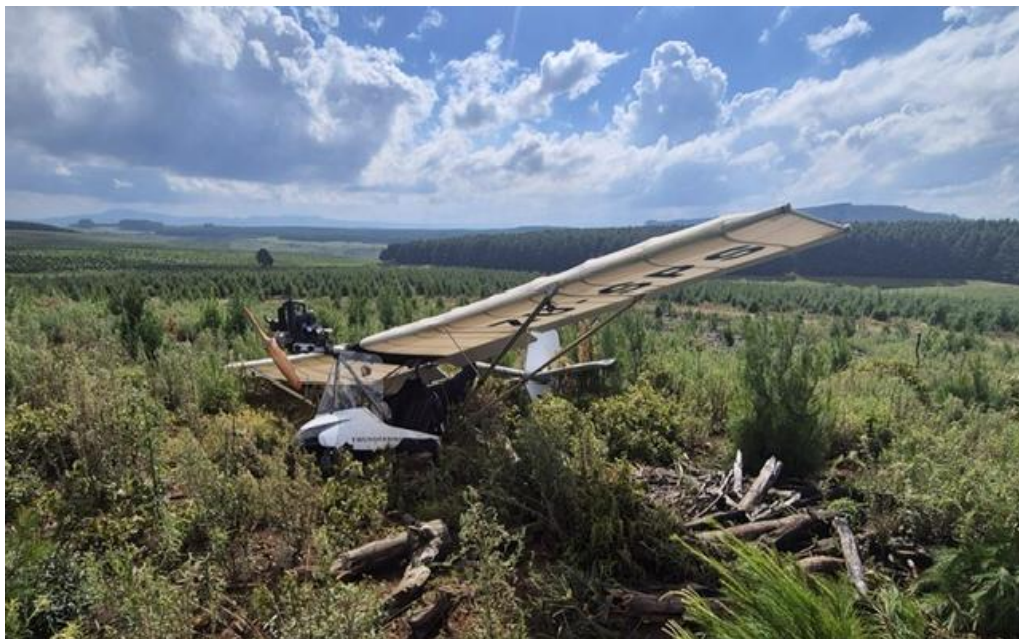
The pilot turned on the auxiliary fuel as he thought the engine was receiving insufficient fuel to restore the RPM, however, the issue could not be resolved. The pilot elected to perform a forced landing on a farm. After the aircraft had come to a stop, the pilot switched off the master switch and fuel supply before he vacated the aircraft; he was not injured. The aircraft sustained substantial damage during the forced landing.

**Figure 2:** The aircraft at the accident site. (Source: Pilot)

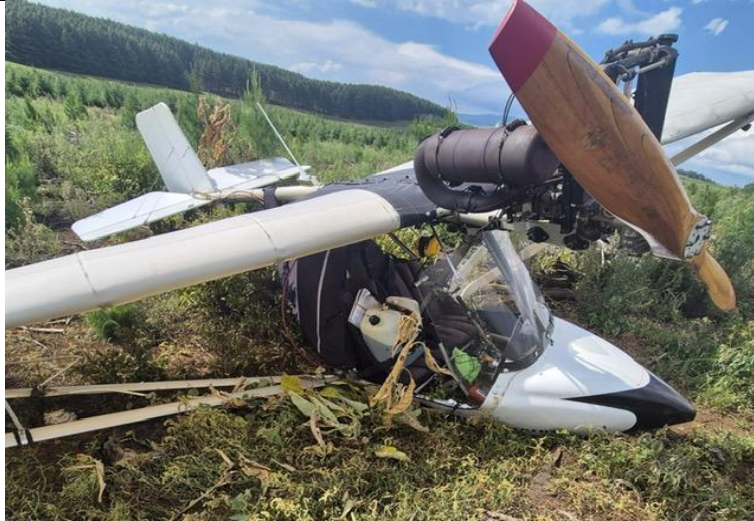
The wreckage was examined by the approved person (AP) at the accident site. The propeller was undamaged which was consistent with the engine not delivering power (see Figure 3). The engine controls were properly fitted to the carburettors. The engine was removed from the airframe and transported to the AP's facility at Brakpan Aerodrome (FABB) in Gauteng province for further investigation. A sample of the fuel from the fuel filters was tested; it contained water and contaminants of an unknown origin. The filters were clogged and had restricted the flow of fuel to the engine (fuel starvation) which resulted in loss of power. Fuel in the filters was consistent with Octane 95 Unleaded fuel mixed with two-stroke oil. The pilot stated that the fuel into the tank was purchased from an automotive filling station in Margate on 29 January 2025.

**Figure 3:** Closer view of the aircraft showing the undamaged propeller. (Source: AP)

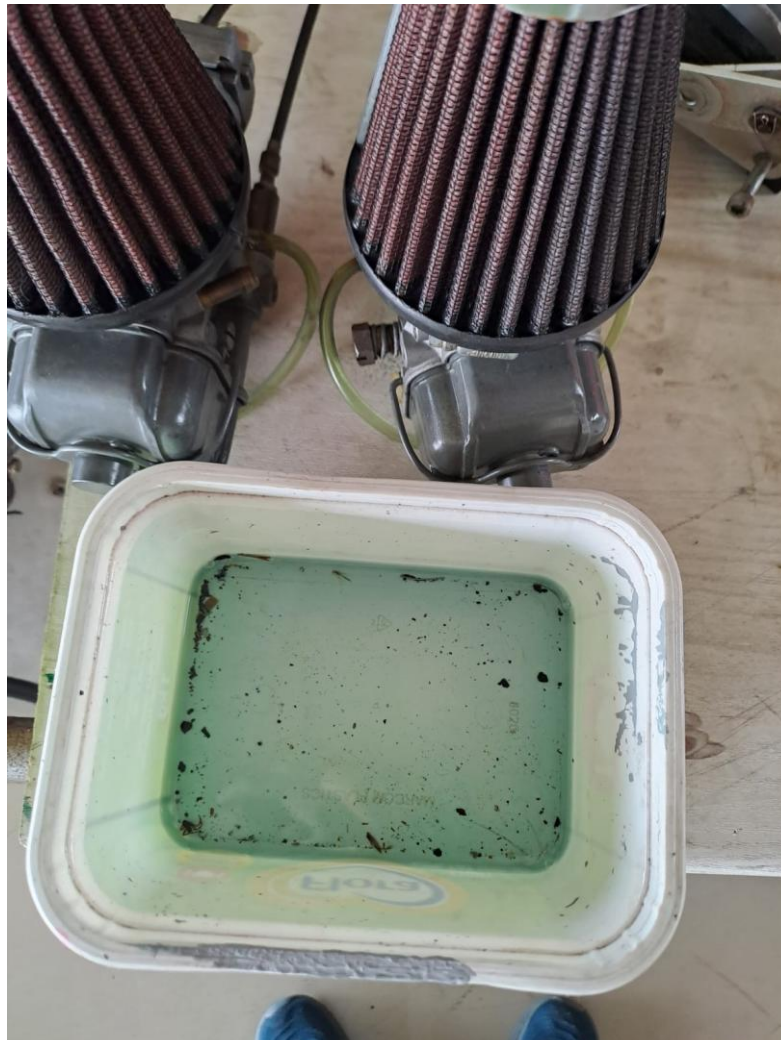
**Figure 4:** The filters and contaminated fuel. (Source: AP)

| Findings | |
|---|---|
| Engine loss of power caused by contaminated fuel; subsequently, an unsuccessful forced landing was conducted on a farm. | |
| Inadequate pre-flight inspection. | |
