**LIMITED OCCURRENCE INVESTIGATION REPORT – FINAL**

| <b>Reference Number</b> | CA18/2/3/10480 | | | | | | |
| Registration | ZU-CKU | | | | | | |
| Make; Model; S/N | Shadow Lite CC; Jabiru SP (Serial Number: 421) | | | | | | |

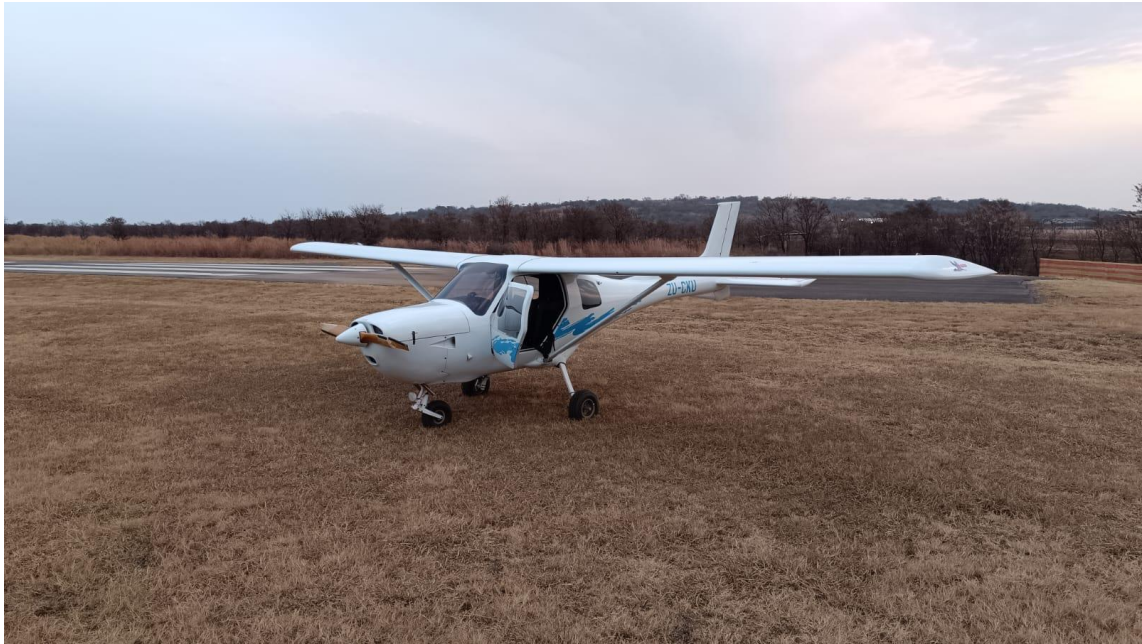
**Figure 1:** The aircraft stopped after rolling over the ditch. (Source: Owner)

| It is likely that the pilot engaged (pressed) the rudder pedals when he should have engaged the hand brake to bring the aircraft to a stop. |

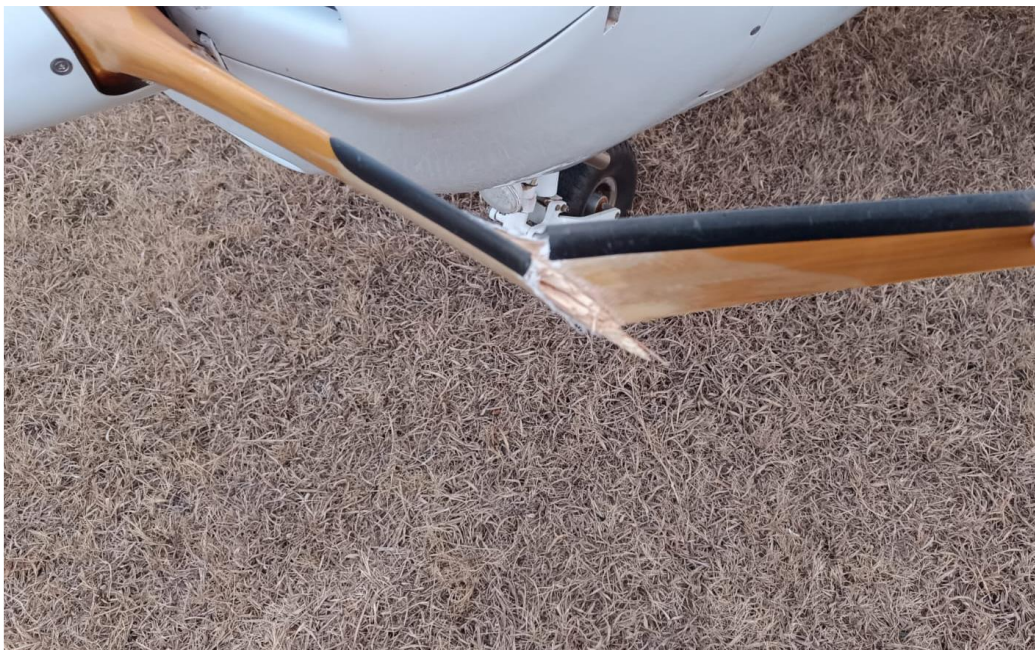
**Figure 2:** The damaged propeller blade. (Source: Owner)

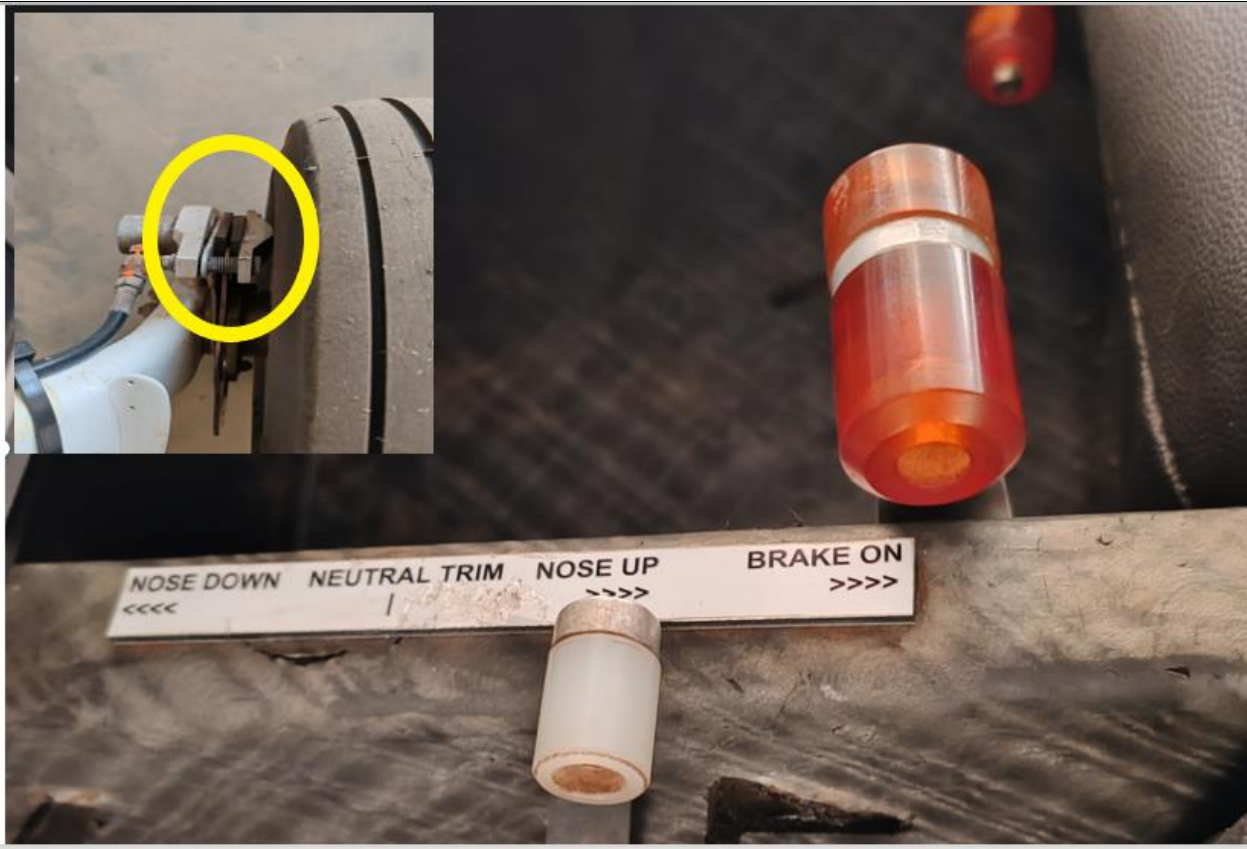
**Figure 3:** The hand brake (orange handle). Inset shows brake pads in an acceptable state. (Source: Owner)

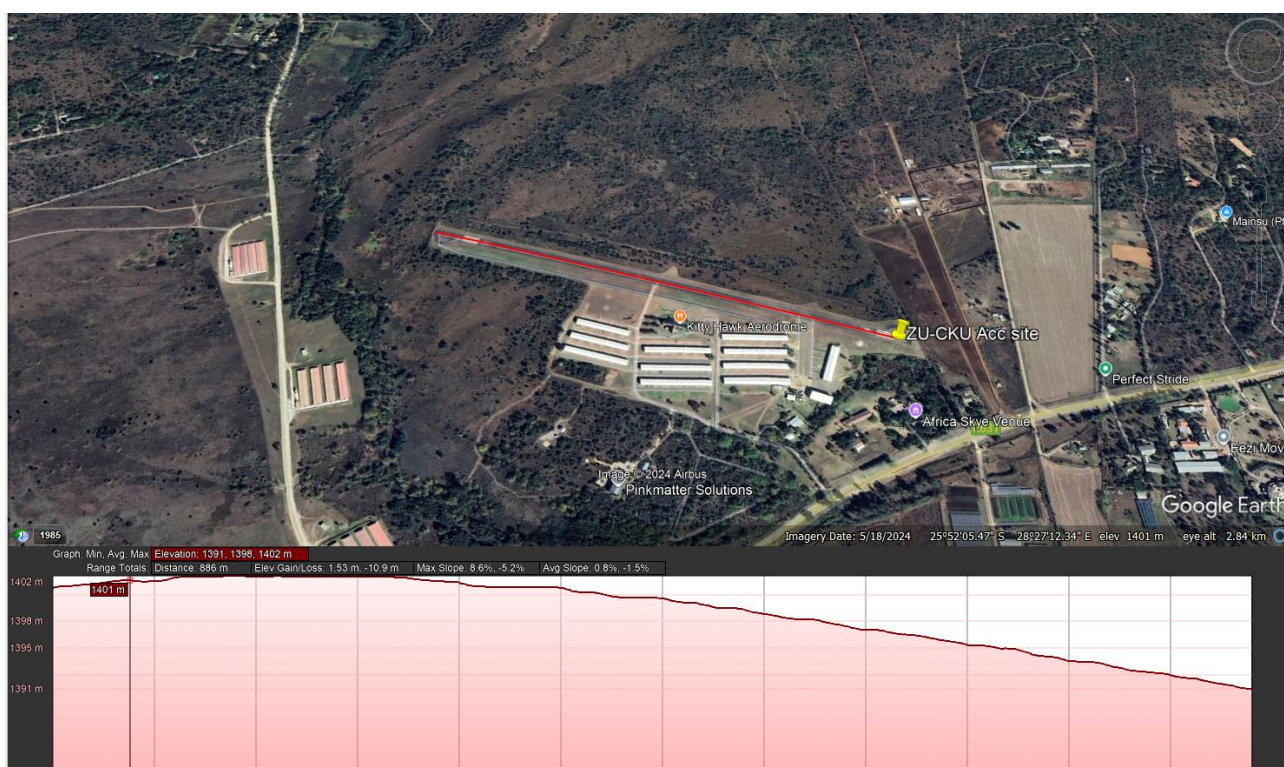
dry on the day of the flight. RWY 01, which is 900 metres (m) long, has a downward slope of approximately 32 feet (ft) from the middle to the end.

**Figure 4:** Runway 01 indicates a downhill profile of 32 feet from top to bottom. (Source: Google Earth)
