**LIMITED OCCURRENCE INVESTIGATION REPORT**

<b>Reference Number</b>	CA18/2/3/10481						
<b>Classification</b>	Accident	<b>Date</b>	17 August 2024	<b>Time</b>	0810Z		
<b>Type of Operation</b>	Operation of Non-type Certificated Aircraft (Part 94)						
<b>Location</b>							
Place of Departure	Howick Airfield (FAHC), KwaZulu-Natal Province		Place of Intended Landing	Howick Airfield (FAHC), KwaZulu-Natal Province			
Place of Occurrence	On Runway 34 at Howick Airfield (FAHC)						
GPS Co-ordinates	Latitude	29°33'11.32" S	Longitude	30°12'36.86" E	Elevation	3 529 feet	
<b>Aircraft Information</b>							
Registration	ZU-IOU						
Make; Model; S/N	Bushbaby Explorer (Serial Number: 152-02-22exp)						
Damage to Aircraft	Substantial			Total Aircraft Hours	8.3		
<b>Pilot-in-command</b>							
Licence Type	National Pilot Licence (NPL)		Gender	Male		Age	64
Licence Valid	Yes	Total Hours	1300		Total Hours on Type	120	
Total Hours Past 30 Days	2.9		Total Flying Hours on Type Past 90 Days			30

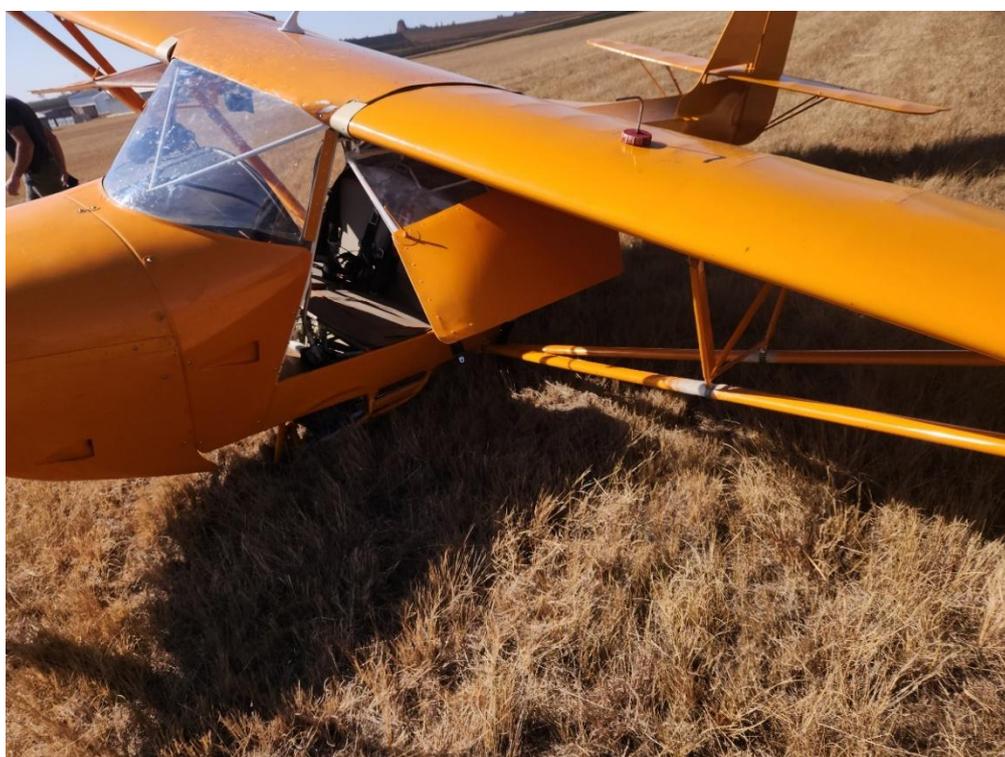
<b>People On-board</b>	1 + 0	<b>Injuries</b>	0	<b>Fatalities</b>	0	<b>Other (on ground)</b>	0
<b>What Happened</b>							
<p>On Saturday, 17 August 2024, a pilot on-board a Bushbaby Explorer with registration ZU-IOU took off on a proving flight from Howick Airport (FAHC) in KwaZulu-Natal province with the intention to land back at the same airport. The flight was conducted under visual meteorological conditions (VMC) by day and under the provisions of Part 94 of the Civil Aviation Regulations (CAR) 2011 as amended.</p> <p>According to the pilot, he conducted a pre-flight inspection of the aircraft and did not find anomalies. The aircraft had 80 litres of fuel in the tank. The take-off and the flight were uneventful; however, upon the aircraft's return to the airstrip for a full-stop landing on Runway 16 at 55 knots and with flaps set at 15 degrees, the pilot applied brakes after touchdown and the aircraft ground-looped and veered off to the left of the runway. After the aircraft had come to a stop, the pilot disembarked from it; he then noticed that the left main landing gear wheel had collapsed backward during the accident sequence. He further noticed that the brake calliper attachment bolts had sheared, which caused the calliper to rotate with wheel hub and lock it (the wheel); hence, the subsequent sideways movement of the aircraft towards the left of the runway. This also led to the failure of the left main landing gear (inward collapse); the undercarriage was also damaged. The pilot was not injured.</p>

**Figure 2:** The aircraft as it came to rest after the accident. (Source: Pilot)

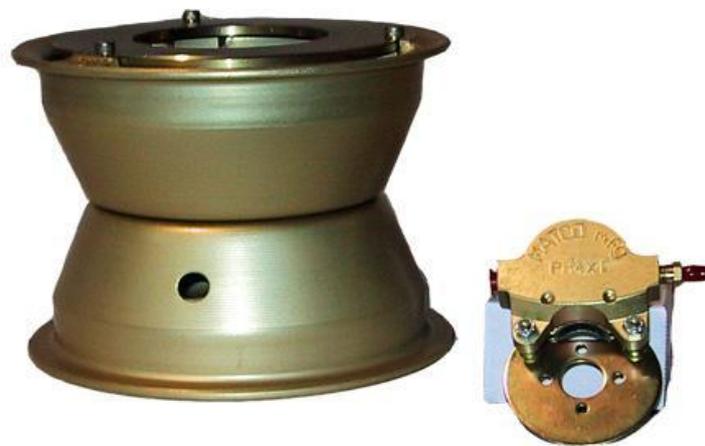
**Figure 3:** Landing gear wheel hub assembly and the type of brake calliper that was featured on the aircraft.

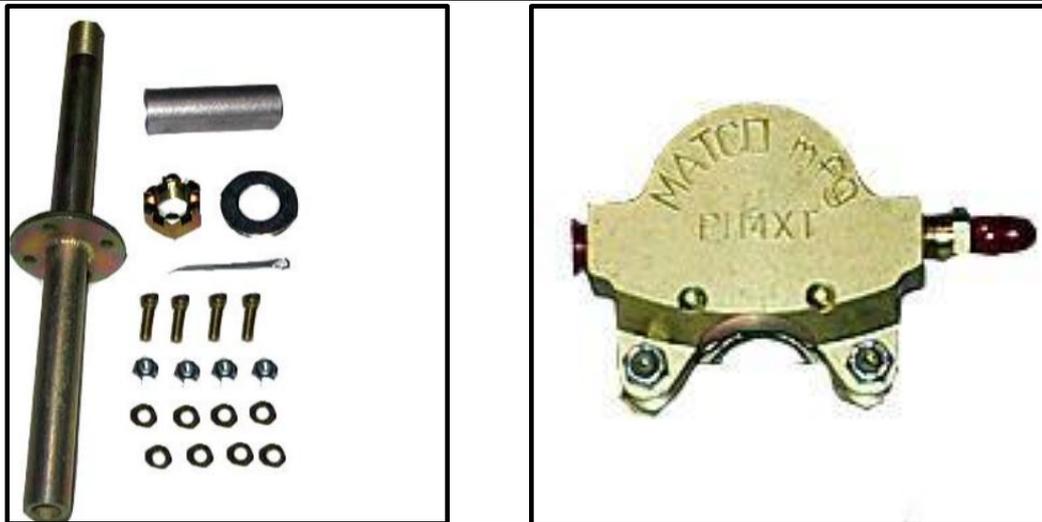
**Figure 4:** Main landing gear wheel axel components (left) and the brake calliper assembly (right).

Figure 4 shows the main landing gear wheel axle and its assembly components. According to the pilot's statement, the two brake calliper assembly attachment bolts failed and, thus, rotated with the wheel and locked it. The bolts failure was determined to be due to rust. There was no Service Bulletin released by the manufacturer for this component. The aircraft was also a non-type certified aircraft and was engaged in a proving flight for the acquisition of an Authority-to-fly (ATF) Certificate.

6. During the landing roll, the brake assembly bolts failed under the load after the brakes were engaged. The investigation revealed that both bolts had corroded over time and, subsequently, fractured due to metal fatigue which was exacerbated by rust. Despite the pilot conducting a standard pre-flight inspection, the deteriorated condition of the bolts was not externally visible (to the pilot) and, thus, was undetected.

The aircraft veered off the runway during the landing roll after which the left main landing gear collapsed due to a failed brake calliper that was caused by a fractured attachment bolt.
