LIMITED OCCURRENCE INVESTIGATION REPORT – FINAL

Reference Number	CA18/2/3/10482						
Classification	Accident	Date	23 August 2024	Time	0820Z		
Type of Operation	Training (Part 141)						
Location							
Place of Departure	Rhino Park Airfield, Gauteng Province		Place of Intended Landing	Rhino Park Airfield, Gauteng Province			
Place of Occurrence	During the take-off roll on Runway 09 at Rhino Park Airfield						
GPS Co-ordinates	Latitude	25° 50' 03.0" S	Longitude	028° 32' 22.0" E	Elevation	4770 ft	
Aircraft Information							
Registration	ZU-SEL						
Make; Model; S/N	Shadow Lite CC; Jabiru J230 (Serial Number: 828)						
Damage to Aircraft	Substantial			Total Aircraft Hours	431.1		
Pilot-in-command							
Licence Type	Student Pilot Licence (SPL)		Gender	Male	Age	44	
Licence Valid	Yes	Total Hours	70		Total Hours on Type	68.2	
Total Hours 30 Days	14.2		Total Flying on Type Past 90 Days		24.2		
People On-board	1+0	Injuries	0	Fatalities	0	Other (on ground)	0

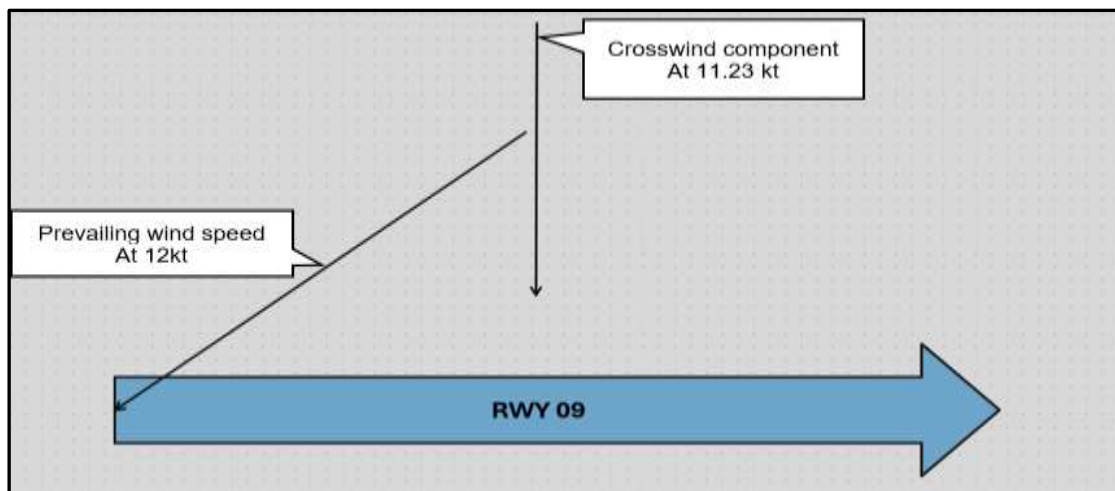
Angular difference (θ =RWY09-Wind direction) = $(90-40)^\circ=50^\circ$

($XWC = V \times \text{Sin}\theta$): XWC =Crosswind component; Wind Speed(V)=12 kts

$XWC=12 \times \text{Sin}50^\circ=11.34$ kts

Figure 2: Crosswind component illustration.

The crosswind component was within the acceptable limit (below 14 knots).

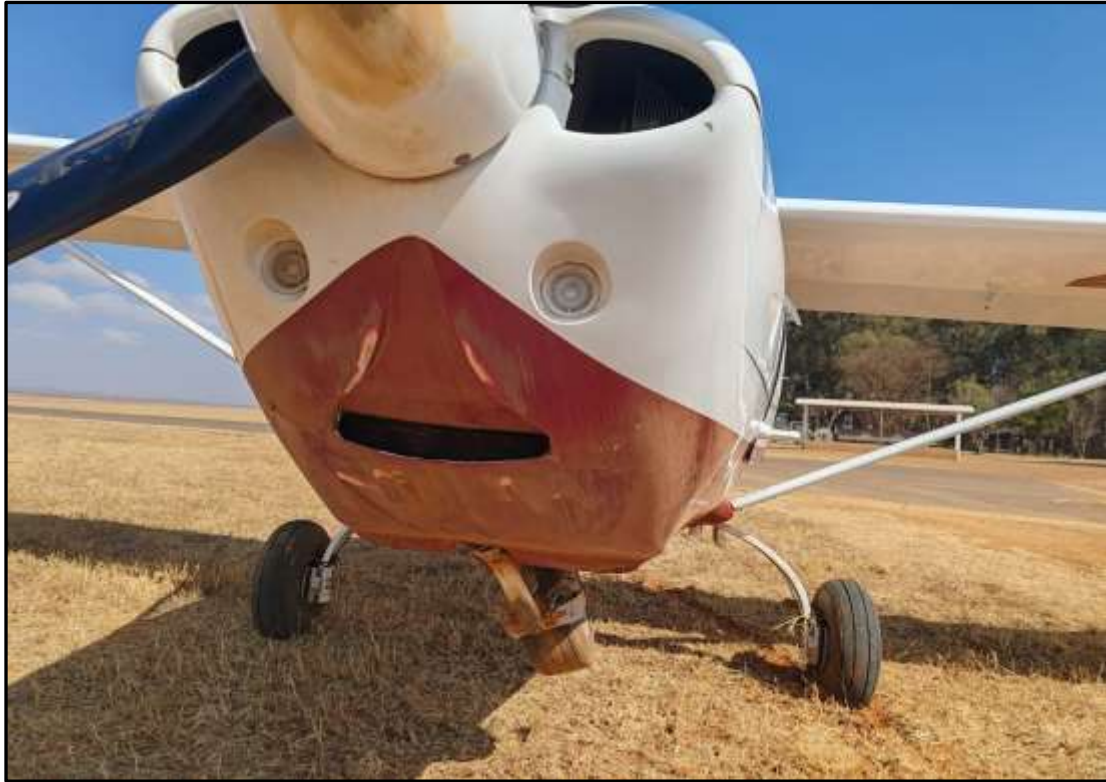
Figure 3: The collapsed nose landing gear strut after impact with the concrete edge of the taxiway. (Source: Operator)

8. The student pilot inadequately managed the crosswind and did not apply full aileron and sufficient rudder to maintain direction; this led to the aircraft veering off the runway. The nose wheel's impact with the edge of the taxiway and the subsequent damage was a result of the failure to control the aircraft.

Loss of control of the aircraft due to a crosswind which caused the aircraft to veer off to the left of the runway, followed by the nose wheel impacting the concrete edge of the taxiway and the resultant damage to the nose gear, propeller spinner and propeller blades.

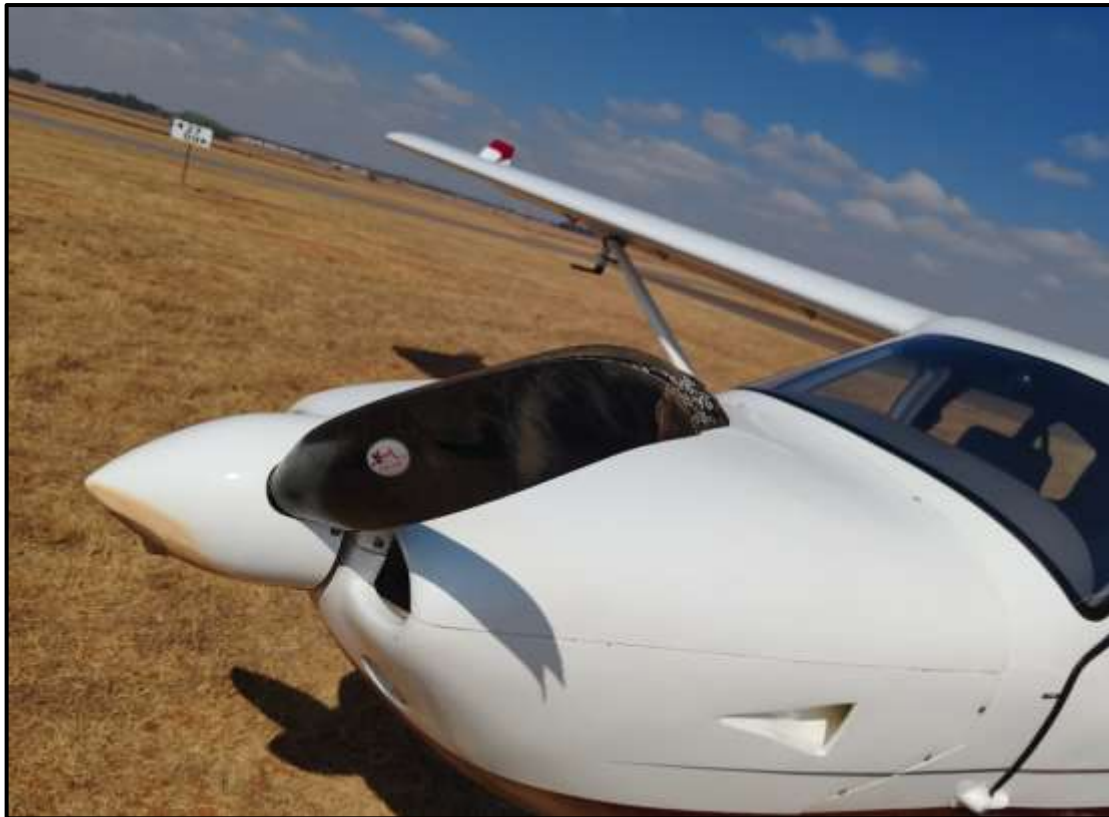
Figure 4: The damaged propeller spinner and blade tips. (Source: Operator)
