<b>LIMITED OCCURRENCE INVESTIGATION REPORT</b>
--

<b>Reference Number</b>	CA18/2/3/10483						
<b>Classification</b>	Accident	<b>Date</b>	29 August 2024	<b>Time</b>	1000Z		
<b>Type of Operation</b>	Private (Part 94)						
<b>Location</b>							
Place of Departure	Stellenbosch Airfield (FASH), Western Cape Province		Place of Intended Landing	Stellenbosch Airfield (FASH), Western Cape Province			
Place of Occurrence	During approach for landing on Runway 19 at Stellenbosch Airfield (FASH)						
GPS Co-ordinates	Latitude	33°58'45.70" S	Longitude	18°49'19.20" E	Elevation	290 ft	
<b>Aircraft Information</b>							
Registration	ZU-MAP						
Make; Model; S/N	Aeroprakt (Serial Number: 076)						
Damage to Aircraft	Substantial		Total Aircraft Hours	2484.7			
<b>Pilot-in-command</b>							
Licence Type	Private Pilot Licence (PPL)		Gender	Male		Age	44
Licence Valid	Yes	Total Hours	129.3		Total Hours on Type	47.5	
Total Hours Past 30 Days	1.8		Total Flying Hours on Type Past 90 Days	15.5

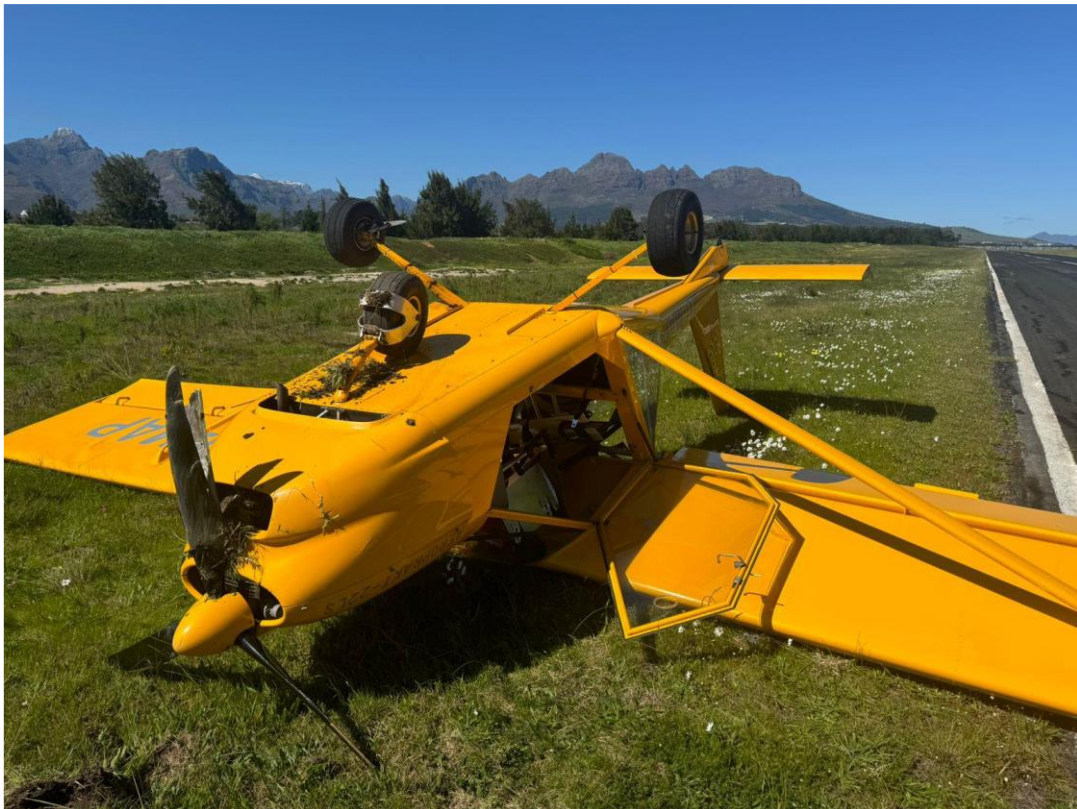
<b>People On-board</b>	1 + 1	<b>Injuries</b>	0	<b>Fatalities</b>	0	<b>Other (on ground)</b>	0
<b>What Happened</b>							
<p>On Thursday, 29 August 2024, a pilot and a passenger on-board an Aeroprakt aircraft with registration ZU-MAP took off on a private flight from Stellenbosch Airfield (FASH) in the Western Cape province with the intention to land back at the same airfield. Visual meteorological conditions (VMC) by day prevailed at the time of the flight which was conducted under the provisions of Part 94 of the Civil Aviation Regulations (CAR) 2011 as amended.</p> <p>The pilot stated that they took off and routed to Franschhoek via Paarl before they returned to FASH. During approach for landing on Runway 19 at FASH, the airspeed was 60 knots (kts), and the flaps were set at 10-degrees. The aircraft touched down with the main landing gear and ballooned, whereafter the nose wheel dug into the mud and collapsed (broke). The aircraft nosed over and rested (inverted) on the left side of Runway 19. The occupants were not injured. The aircraft sustained substantial damage to the nose wheel, wings and tail section.</p>

**Figure 2:** The aircraft as it came to rest after the accident. (Source: Pilot)

The aircraft ballooned after landing, likely due to excessive nose-up elevator control inputs during the round-out which resulted in an aircraft coming to rest in an inverted position.
