**LIMITED OCCURRENCE INVESTIGATION REPORT – FINAL**

<b>Reference Number</b>	CA18/2/3/10484						
<b>Classification</b>	Accident	<b>Date</b>	29 August 2024		<b>Time</b>	1025Z	
<b>Type of Operation</b>	Private (Part 94)						
<b>Location</b>							
<b>Place of Departure</b>	Rhino Park Airfield, Gauteng Province		<b>Place of Intended Landing</b>		Secunda Aerodrome (FASC), Mpumalanga Province		
<b>Place of Occurrence</b>	During landing on Runway 29 at Secunda Aerodrome (FASC)						
<b>GPS Co-ordinates</b>	<b>Latitude</b>	26°31'24.65" S	<b>Longitude</b>	29°10'18.38" E	<b>Elevation</b>	5 261ft	
<b>Aircraft Information</b>							
<b>Registration</b>	ZU-PPL						
<b>Make; Model; S/N</b>	Shadow Lite CC; Jabiru J430 (Serial Number: 524)						
<b>Damage to Aircraft</b>	Minor		<b>Total Aircraft Hours</b>		1 605.7		
<b>Pilot-in-command</b>							
<b>Licence Type</b>	Commercial Pilot Licence (CPL)		<b>Gender</b>	Male		<b>Age</b>	41
<b>Licence Valid</b>	Yes	<b>Total Hours</b>	374		<b>Total Hours on Type</b>	63.2

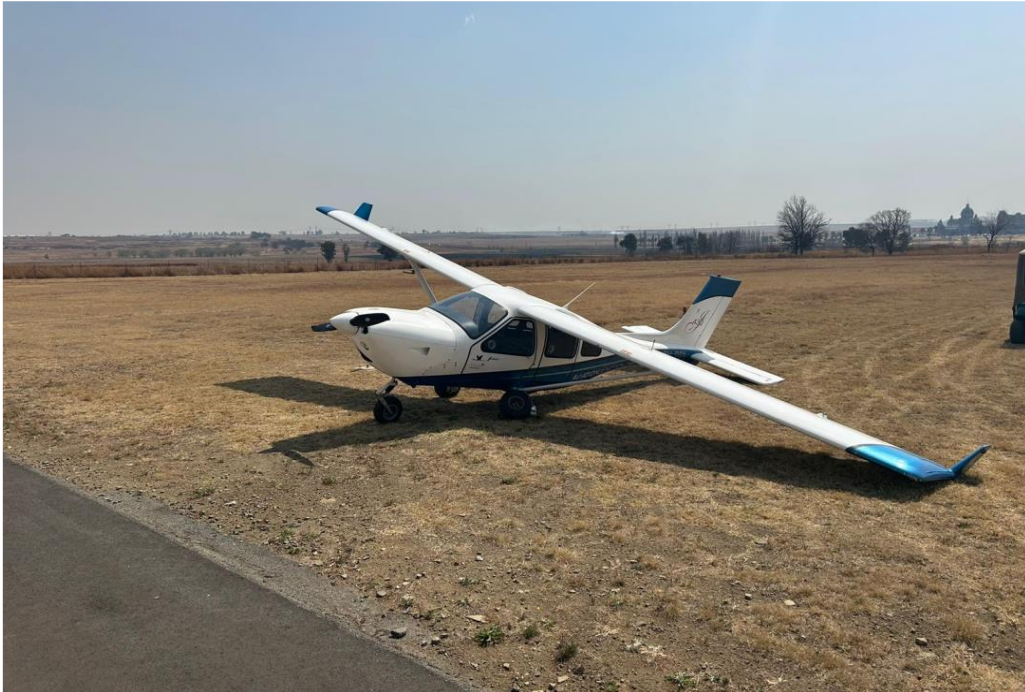
attitude on the grass area next to the runway and facing south. The aircraft sustained minor damage. No person on-board the aircraft was injured.

**Figure 1:** The aircraft as it came to rest. (Source: Operator)

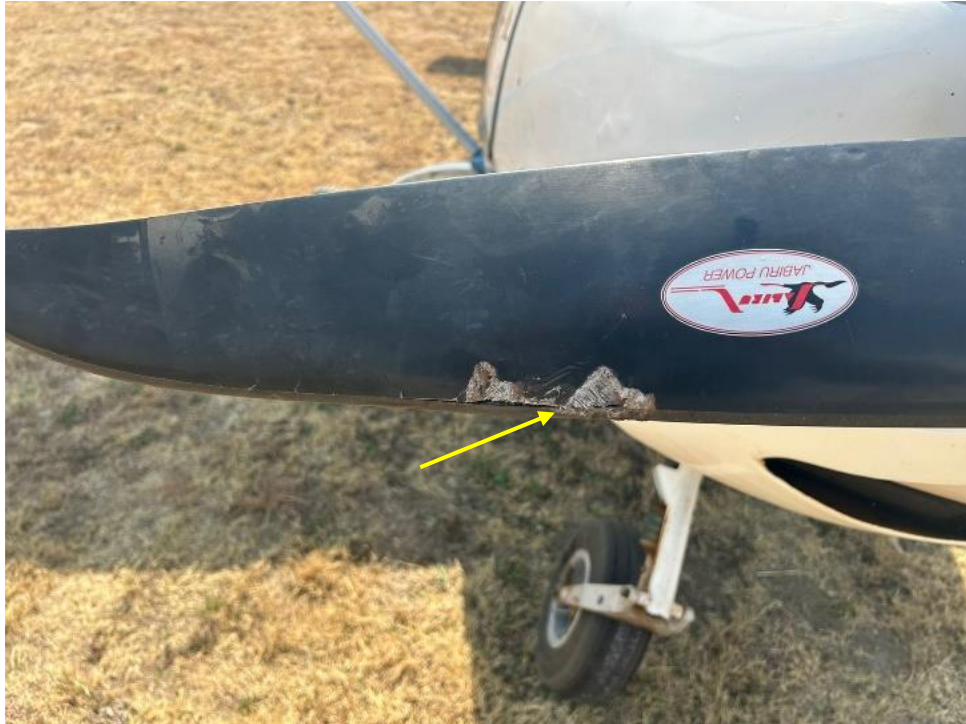
**Figure 3:** Damage on the composite propeller leading edge. (Source: Operator)

The inspection results of the aircraft by the approved person (AP) post-accident at FASC indicated damage to the LMG leg brake caliper, the propeller blade (1), and the ventral fin. The brakes were modulated, and they operated satisfactory. The AP conducted the runout tests on both the crankshaft and propeller flange; both were found to be within limits in accordance with (IAW) the Jabiru engine manual JEM002-11, paragraph 9, 29. The LMG leg was temporarily repaired. The damaged propeller and the LMG leg brake caliper were replaced. The engine was subjected to a ground run, and it met all parameters in accordance with (IAW) the operator's manual. No vibrations were observed or felt during the engine run. After the temporary repairs to the LMG leg, the Regulator (SACAA) granted the operator a special flight permit IAW Part 24.02.4 of the CAR, and the aircraft was ferried to the AP's facility at Spring Aerodrome (FASI) in Gauteng province.

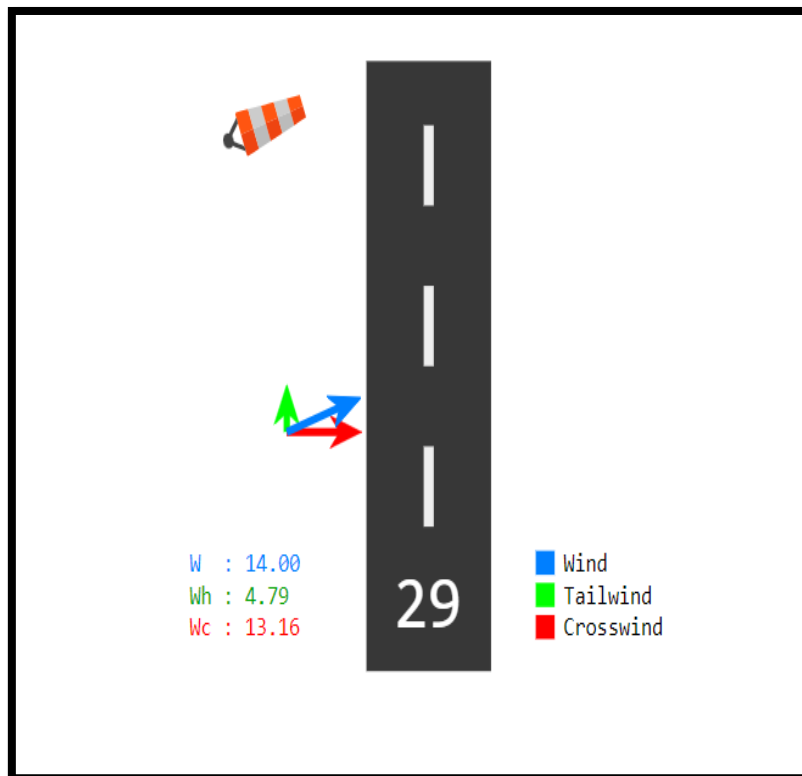
The crosswind component at the time of the flight was calculated at 13.16 knots from the left. A Jabiru J 430 aircraft has a maximum crosswind velocity of 14 knots demonstrated at full flap setting. A pilot would have no challenge landing with 14 knots crosswind.

Figure 4: Crosswind calculation. (Source: e6bx.com/wind-components)

2.5	The aircraft was affected by a crosswind of 13.16 knots (maximum is 14 knots) and tailwind of 4.79 which exacerbated floating of the aircraft above the runway.
