LIMITED OCCURRENCE INVESTIGATION REPORT – FINAL

Reference Number	CA18/2/3/10485						
Classification	Accident	Date	31 August 2024		Time	1309Z	
Type of Operation	Training (Part 141)						
Location							
Place of Departure	Grand Central Airport (FAGC), Gauteng Province		Place of Intended Landing	Grand Central Airport (FAGC), Gauteng Province			
Place of Occurrence	Approximately 850 metres (m) from the threshold of Runway 35 at FAGC in Gauteng Province						
GPS Co-ordinates	Latitude	25°59'28.5" S	Longitude	28°08'34.2" E	Elevation	5 325ft	
Aircraft Information							
Registration	ZS-IOI						
Make; Model; S/N	Cessna Aircraft Company; C172L (Serial Number: 172-60301)						
Damage to Aircraft	Substantial			Total Aircraft Hours	15592.1		
Pilot-in-command							
Licence Type	Student Pilot Licence (SPL) Aeroplane		Gender	Male		Age	22
Licence Valid	Yes	Total Hours	69.1		Total Hours on Type	29.1	
Total Hours 30 Days	5.3		Total Flying on Type Past 90 Days	20.8

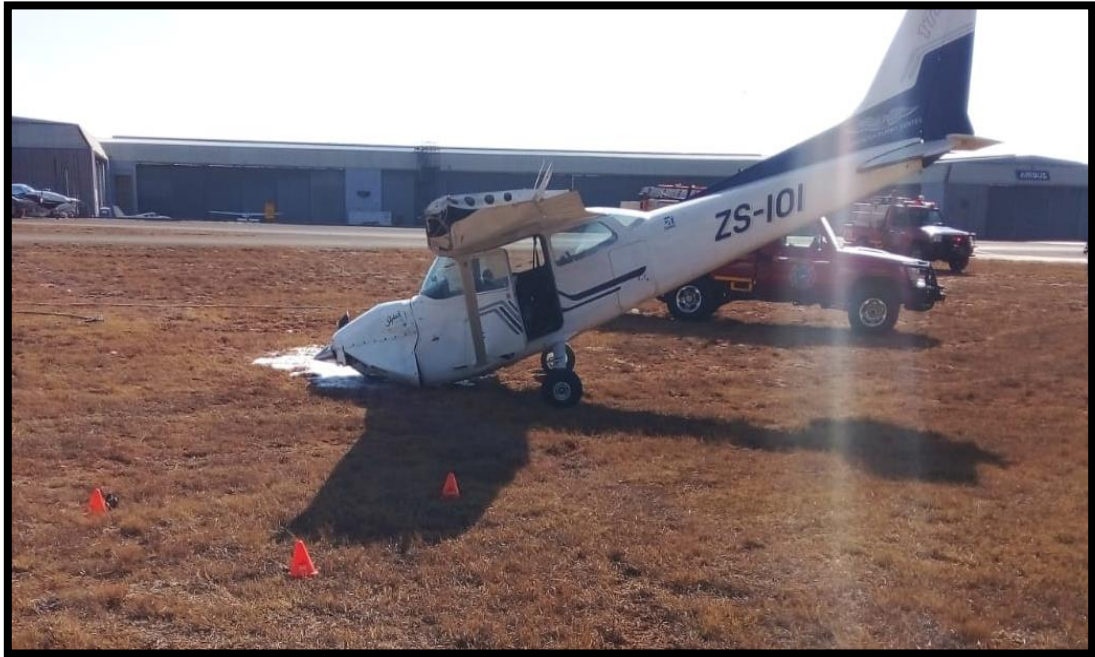
Figure 1: The aircraft as it came to a stop after exiting the runway. (Source: Owner)

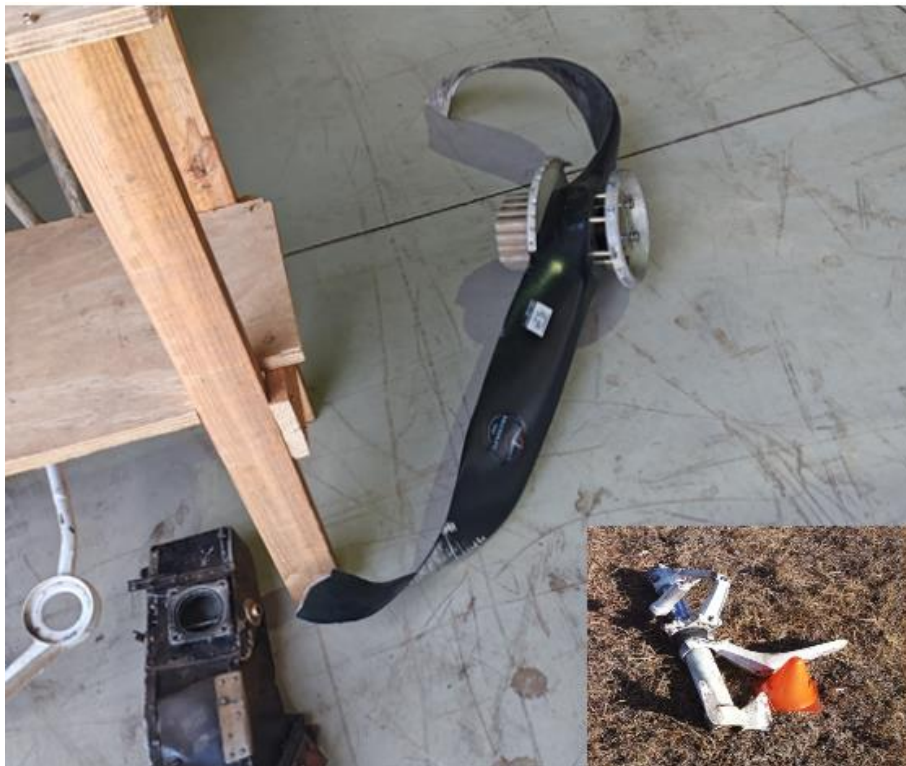
Figure 2: The damage on the propeller blades indicates maximum power on impact with the ground. The inset picture shows the nose gear strut after the accident.

Probable Cause(s)
The student pilot did not set up the aircraft for a crosswind landing and flared too early which caused the aircraft to balloon and stall before it landed with the nose wheel first.
Contributing Factor(s)
<ul style="list-style-type: none"> • The crosswind was more than the limit the aircraft could handle. • The student pilot delayed conducting a go-around after the first missed attempt. • The student pilot had limited crosswind landing experience.
Safety Action(s)
A remedial programme was set up for the student pilot.

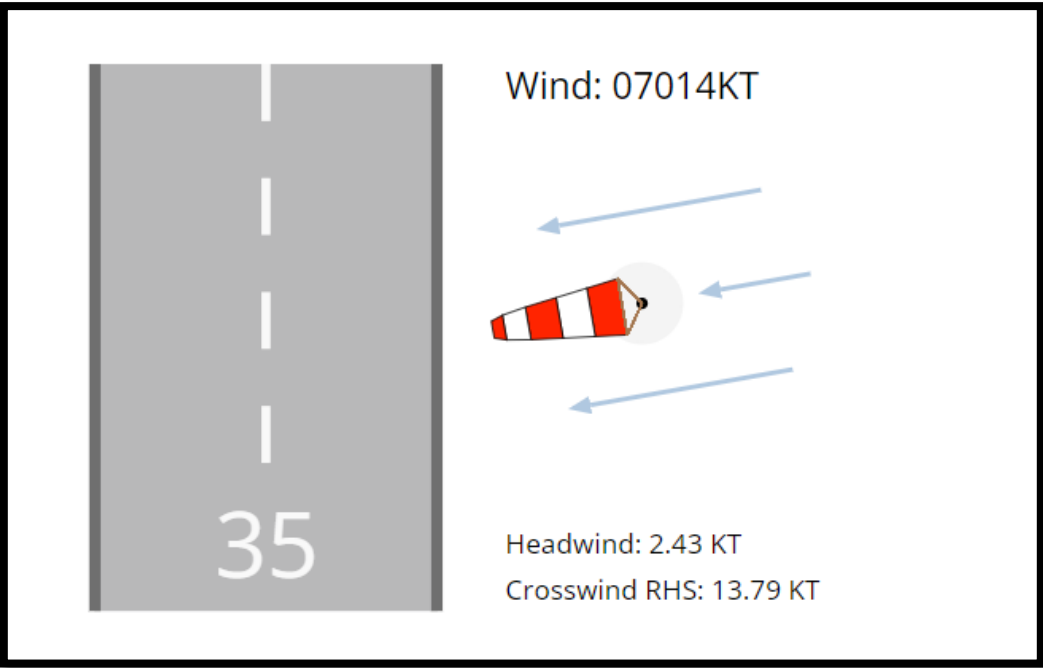
Figure 4: Crosswind calculation on Runway 35. (Source: <https://aerotoobox.com/crosswind/>)
