LIMITED OCCURRENCE INVESTIGATION REPORT – FINAL

Reference Number	CA18/2/3/10486						
Classification	Accident	Date	1 September 2024		Time	1515Z	
Type of Operation	Private (Part 94)						
Location							
Place of Departure	Port Elizabeth Airport (FAPE), Eastern Cape Province		Place of Intended Landing		Woodman Farm Airstrip near Plettenberg Bay, Western Cape Province		
Place of Occurrence	On Runway 12 at Woodman Farm Airstrip near Plettenberg Bay, Western Cape Province						
GPS Co-ordinates	Latitude	33°59'00" S	Longitude	024°08'00" E	Elevation	253ft	
Aircraft Information							
Registration	ZU-EMV						
Make; Model; S/N	Shadow Lite CC; Jabiru 430 (Serial Number: 375)						
Damage to Aircraft	Substantial			Total Aircraft Hours	1 302.9		
Pilot-in-command							
Licence Type	Private Pilot Licence (PPL)		Gender	Male		Age	68
Licence Valid	Yes	Total Hours	1 526		Total Hours on Type	1 226.1	
Total Hours 30 Days	0.8		Total Flying on Type Past 90 Days	6.4

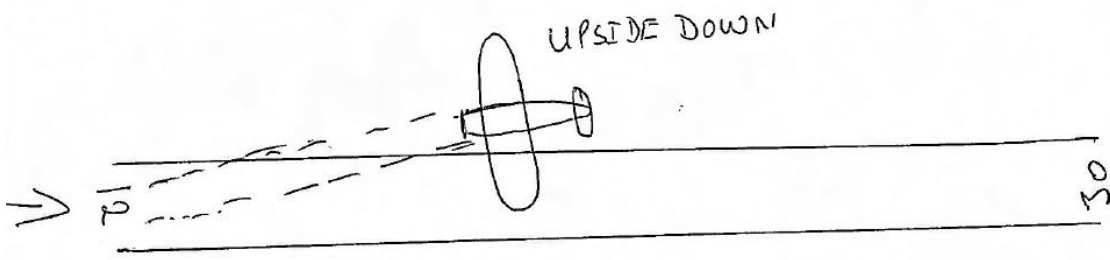
Figure 1: A depiction of the sketched sequence of events. (Source: Pilot)

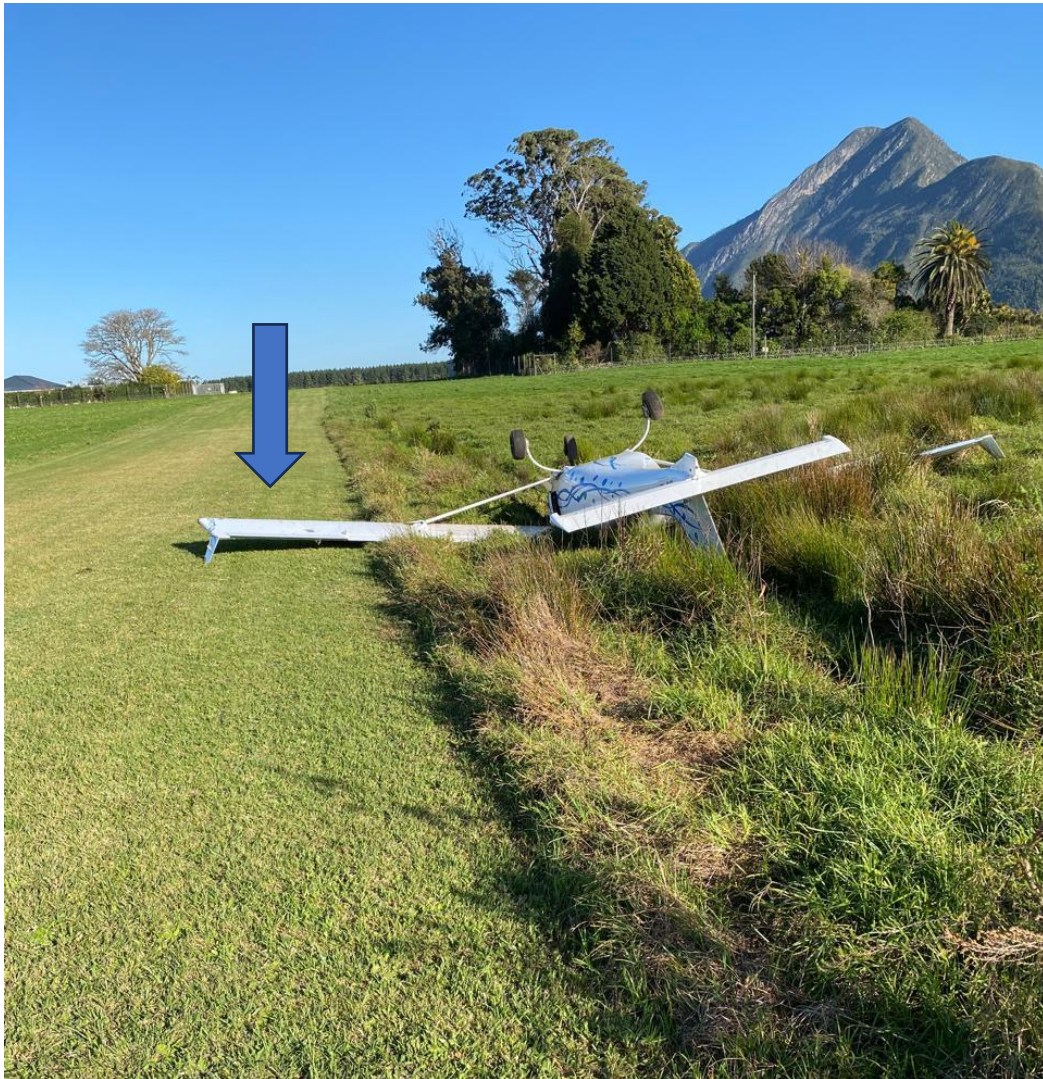
Figure 2: The blue arrow shows the direction of landing and the aircraft post-accident. (Source: Pilot)

5. The Certificate of Registration (C of R) was issued to the present owner on 6 March 2007.
6. During the landing roll, the pilot lost directional control of the aircraft, and it veered off to the left and exited the runway; the nose wheel rolled over a trench and the aircraft flipped over.

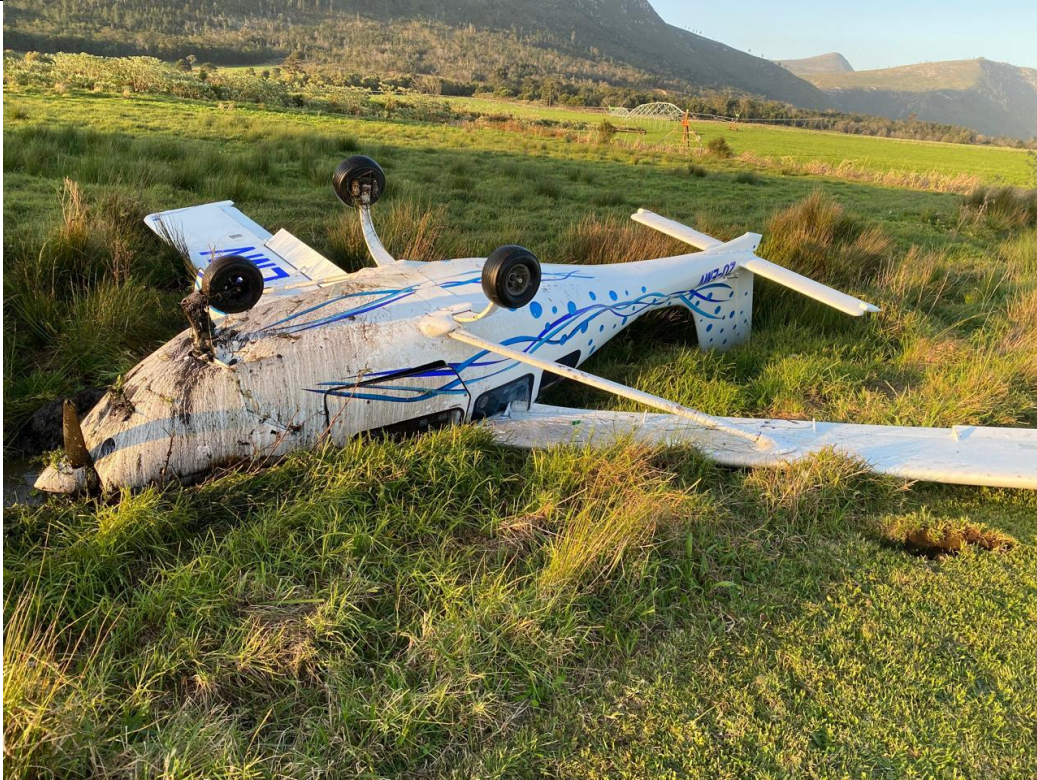
Figure 3: Final resting position of the aircraft. (Source: Pilot)

Loss of directional control during the landing roll which resulted in the aircraft veering off to the left and exiting the runway; the nose wheel rolled over a trench and the aircraft flipped over.

Safety message: In the interest of safety, pilots and co-pilots are advised to be vigilant during critical phases of flight such as take-offs and landings, and to be careful of hazardous objects and terrain.
