**LIMITED OCCURRENCE INVESTIGATION REPORT**

<b>Reference Number</b>	CA18/2/3/10487						
<b>Classification</b>	Accident	<b>Date</b>	3 September 2024		<b>Time</b>	1150Z	
<b>Type of Operation</b>	Training (Part 141)						
<b>Location</b>							
Place of Departure	Wonderboom Aerodrome (FAWB), Gauteng Province		Place of Intended Landing	Wonderboom Aerodrome (FAWB), Gauteng Province			
Place of Occurrence	Run-up bay near Runway 29 at Wonderboom Aerodrome (FAWB)						
GPS Co-ordinates	Latitude	25°39'20.21" S	Longitude	028°13'31.93" E	Elevation	4089 ft	
<b>Aircraft Information</b>							
Registration	ZS-EAD						
Make; Model; S/N	Cessna 172F (Serial Number: 172-52464)						
Damage to Aircraft	Substantial			Total Aircraft Hours	6010.56		
<b>Pilot-in-command</b>							
Licence Type	Commercial Pilot Licence (CPL)		Gender	Male		Age	27
Licence Valid	Yes	Total Hours	1896.6		Total Hours on Type	961.2	
Total Hours Past 30 Days	37.2		Total Flying Hours on Type Past 90 Days	65.9

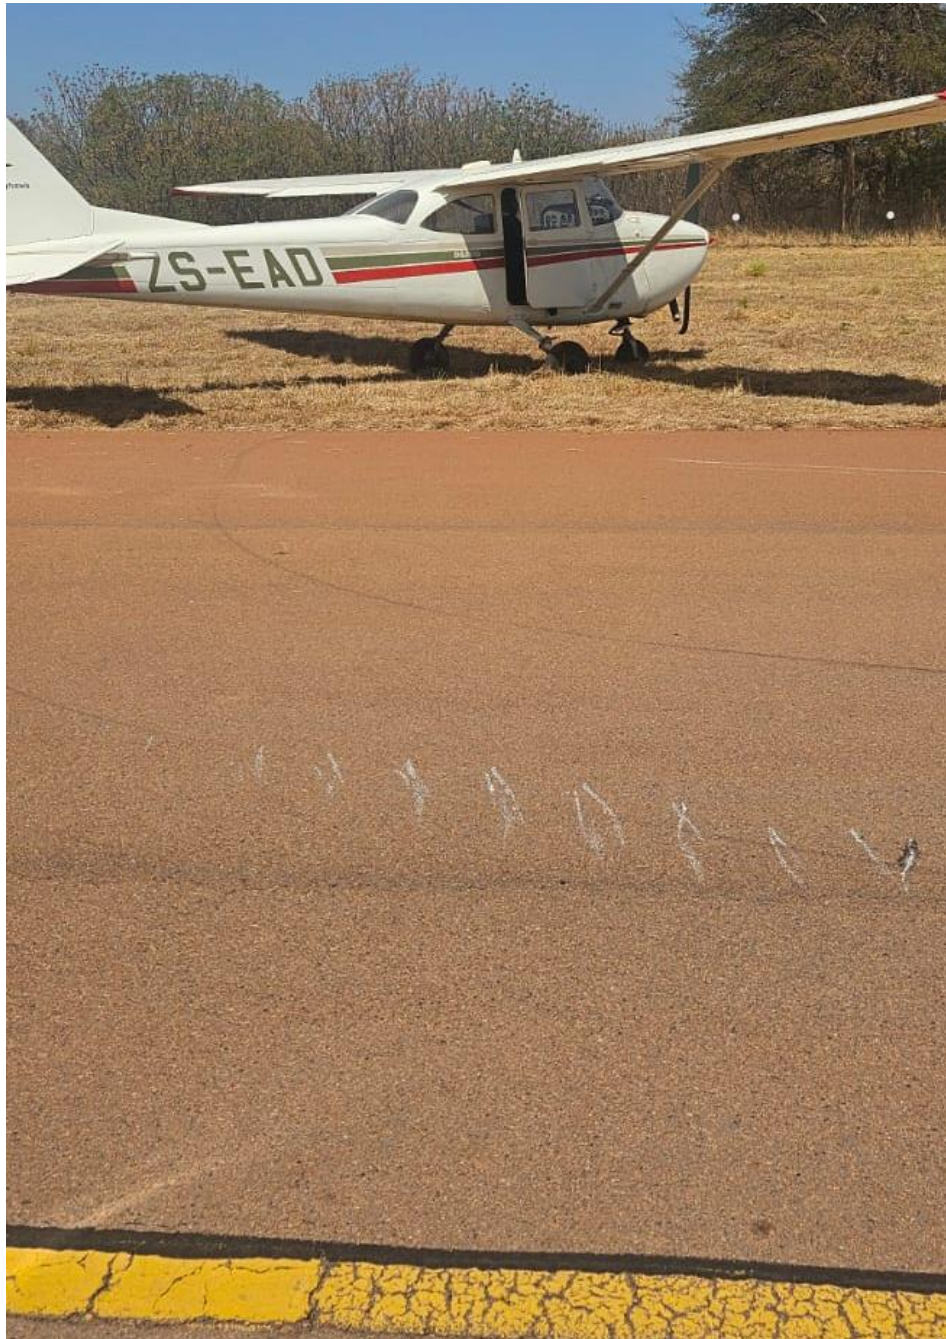
<b>People On-board</b>	1 + 1	<b>Injuries</b>	0	<b>Fatalities</b>	0	<b>Other (on ground)</b>	0
<b>What Happened</b>							
<p>On Tuesday morning, 3 September 2024, a flight instructor (FI) and a student pilot (SP) on-board a Cessna 172F aircraft with registration ZS-EAD were taxiing towards the run-up bay for Runway 29 with the intention to take off from Wonderboom Aerodrome (FAWB) to the Wonderboom general flying area, Gauteng province. Visual meteorological conditions (VMC) by day prevailed at the time of the flight which was conducted under the provisions of Part 141 of the Civil Aviation Regulations (CAR) 2011 as amended.</p> <p>The flight instructor stated that a Cessna Citation aircraft was conducting power checks at the run-up bay as they taxied to the run-up bay near Runway 29. The Cessna 172F entered the run-up bay with the intention to conduct pre-take-off checks; it taxied behind the Cessna Citation towards the next available spot. After reaching the area behind the Cessna Citation, it was jet blasted which caused the left wing to lift up; subsequently, the right wing and the propeller contacted the ground. The aircraft came to rest on the grass area beyond the perimeter of the run-up bay. The crash alarm was activated, and the Aircraft Rescue and Firefighting (ARFF) team responded to the accident site. The flight instructor and the student pilot disembarked from the aircraft unassisted and unharmed. The aircraft sustained substantial damage to the right wing and the propeller.</p>

**Figure 2:** The aircraft as it came to rest after the accident. (Source: Pilot)

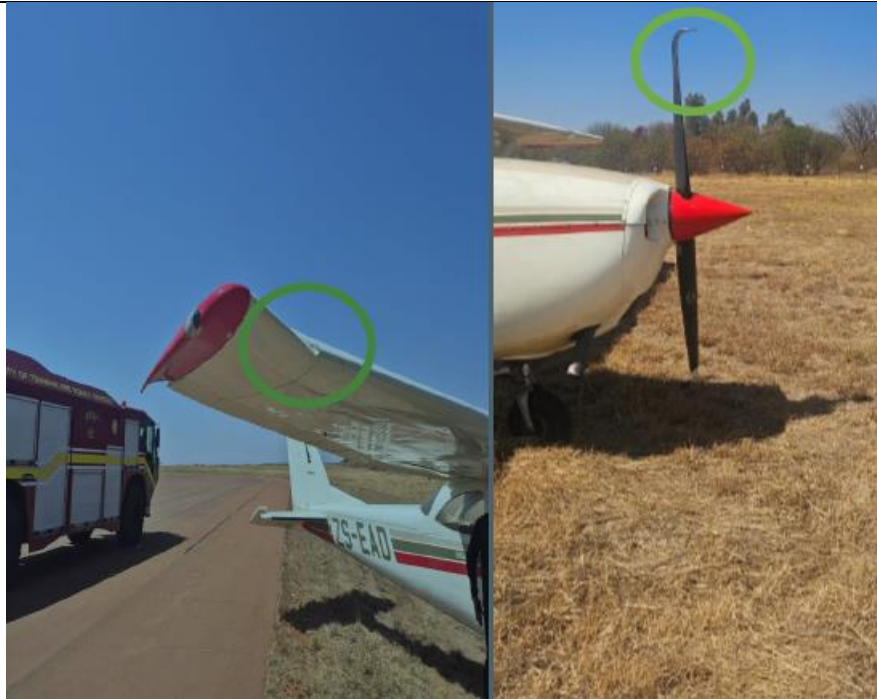
**Figure 3:** The aircraft sustained damage to the wing tip and the propeller. (Source: Pilot)

<u>Aircraft Information</u>
<ol style="list-style-type: none"> <li>5. The aircraft had a Certificate of Registration (C of R) that was issued to the current owner on 28 July 2021.</li> <li>6. The aircraft had a valid Certificate of Airworthiness (C of A) that was issued on 31 March 2024 with an expiry date of 31 March 2025.</li> <li>7. The aircraft was issued a Certificate of Release to Service (CRS) on 2 August 2024 at 4389.1 hours with an expiry date of 1 August 2025 or at 4489.1 hours, whichever occurs first. There were no defects recorded in the flight folio at the time of the accident flight.</li> </ol>
<b>Probable Cause</b>
The Cessna 172 taxied behind the Cessna Citation without leaving adequate spacing (room) to avoid jet blast.
<b>Contributing Factor</b>
None.
<b>Safety Action(s)</b>
None.
