LIMITED OCCURRENCE INVESTIGATION REPORT – FINAL

Reference Number	CA18/2/3/10488						
Classification	Accident	Date	4 September 2024	Time	1030Z		
Type of Operation	Private (Part 91)						
Location							
Place of Departure	Kitty Hawk Aerodrome (FAKT), Gauteng Province			Place of Intended Landing	Kego Mining Aerodrome, Mpumalanga Province		
Place of Occurrence	Runway 34 at Kego Mine Aerodrome						
GPS Co-ordinates	Latitude	25°53'35.70" S	Longitude	028°59'02.57" E	Elevation	5 196 feet	
Aircraft Information							
Registration	ZS-MSA						
Make; Model; S/N	Cessna Aircraft Company; T210L (Serial Number 210-61107)						
Damage to Aircraft	Substantial			Total Aircraft Hours	6 837.2		
Pilot-in-command							
Licence Type	Airline Transport Pilot Licence (ATPL)		Gender	Male		Age	30
Licence Valid	Yes	Total Hours	4 788.0		Total Hours on Type	81.0	
Total Hours Past 30 Days	58.1		Total Hours on Type Past 90 Days	23.7			
People On-board	1 + 0	Injuries	0	Fatalities	0	Other (on ground)	0

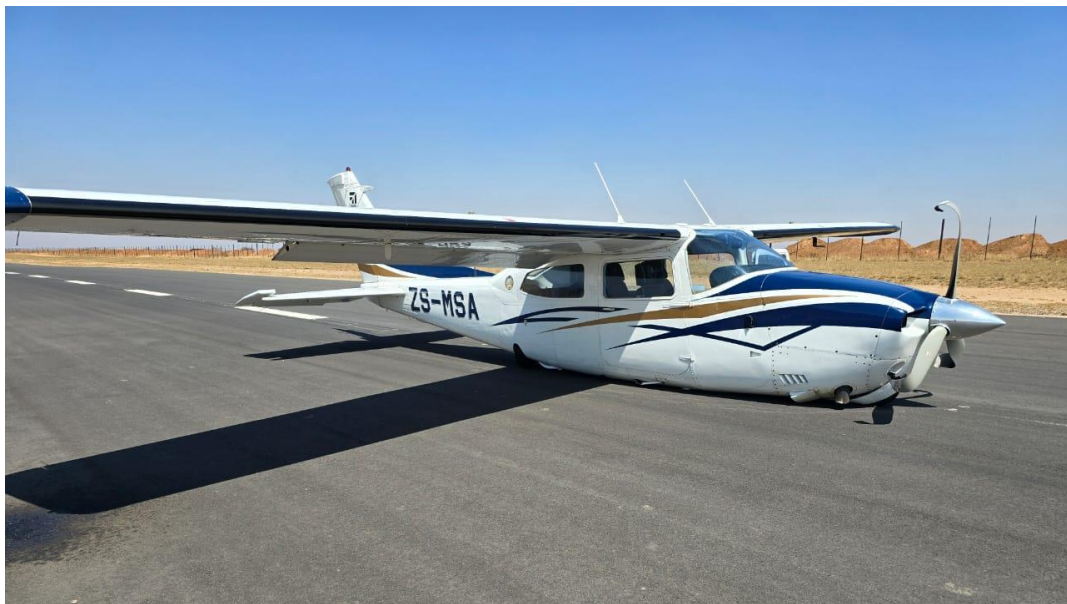
Figure 2: The aircraft after it had stopped on the runway with the landing gear retracted. (Source: Pilot)

2.5	The aircraft landed with the landing gear retracted even though it was fitted with a serviceable landing gear warning system.
3.	<u>Aerodrome and Meteorological Information</u>

Probable Cause	
The pilot stated that he did not perform his before-landing checks and proceeded with the approach to land which resulted in a wheels-up landing.	
Contributing Factor	
Omission to conduct pre-landing checklist as required in the lading procedures.	
Safety Action(s)	
None.	
Safety Message and/or Safety Recommendation/s	
None.	
About this Report	
<p><i>The decision to conduct a limited investigation is based on factors including whether the cause is known and the evidence supporting the cause is clear, the level of safety benefit likely to be obtained from an investigation, and that will determine the scope of an investigation. For this occurrence, a limited investigation has been conducted, and the Accident and Incident Investigations Division (AIID) has relied on the information submitted by the affected person/s and organisation/s to compile this limited report. The report has been compiled using information supplied in the initial notification, as well as from follow-up desktop inquiries to bring awareness of potential safety issues to the industry in respect of this occurrence, as well as possible safety action/s that the industry might want to consider in preventing a recurrence of a similar occurrence.</i></p> <p><i>All times given in this report are Co-ordinated Universal Time (UTC) and will be denoted by (Z). South African Standard Time is UTC plus 2 hours.</i></p>

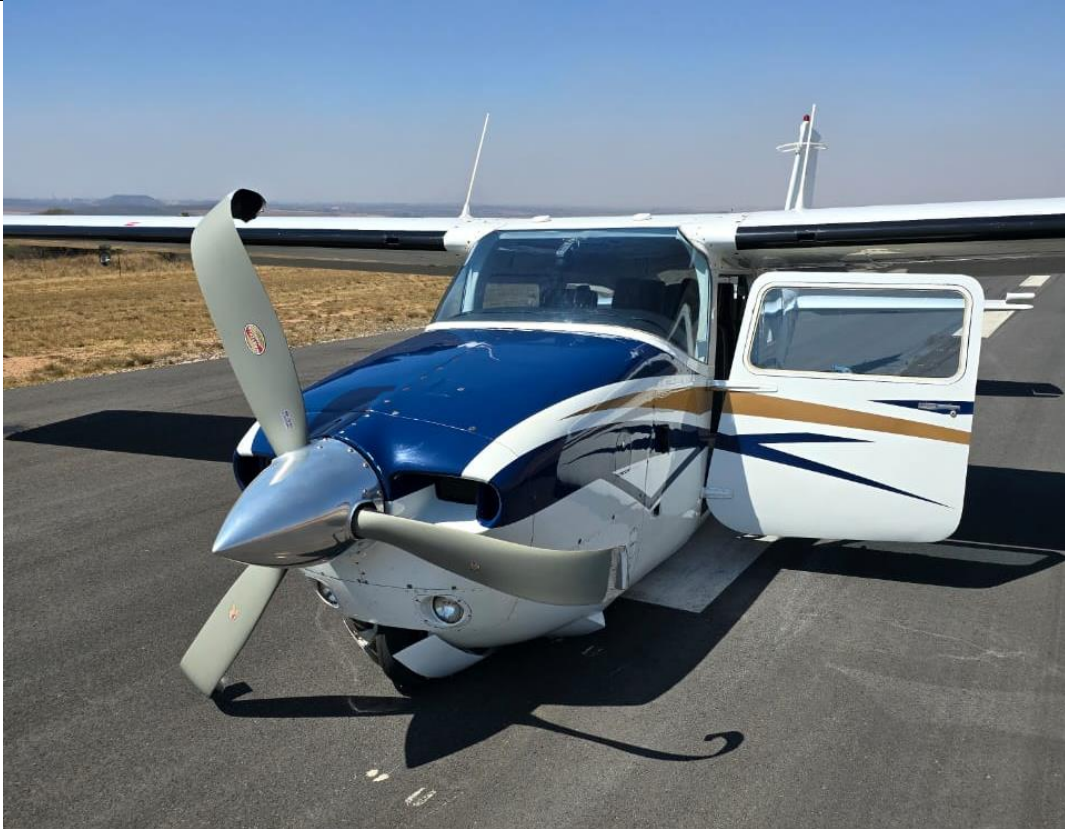
Figure 3: The front view of the aircraft after the accident. (Source: Pilot)
