LIMITED OCCURRENCE INVESTIGATION REPORT – FINAL

Reference Number	CA18/2/3/10489						
Classification	Accident	Date	5 September 2024	Time	1237Z		
Type of Operation	Training (Part 141)						
Location							
Place of Departure	Virginia Airport (FAVG), KwaZulu-Natal Province	Place of Intended Landing	Richards Bay Airport (FARB), KwaZulu-Natal Province				
Place of Occurrence	On Runway 05 at Richards Bay Airport (FARB), KwaZulu-Natal Province						
GPS Co-ordinates	Latitude	28°44'13.05" S	Longitude	32°05'37.17" E	Elevation	103 ft	
Aircraft Information							
Registration	ZU-STB						
Make; Model; S/N	The Airplane Factory; Sling 2 (Serial Number: 244)						
Damage to Aircraft	Substantial	Total Aircraft Hours	2795.60				
Pilot-in-command							
Licence Type	Student Pilot Licence (SPL) Aeroplane	Gender	Female	Age	19		
Licence Valid	Yes	Total Hours	70.7	Total Hours on Type	70.7		
Total Hours 30 Days	14.6	Total Flying on Type Past 90 Days	27.9				
People On-board	1+0	Injuries	0	Fatalities	0	Other (on ground)	0

**This report is issued by:
Accident and Incident Investigations Division
South African Civil Aviation Authority
Republic of South Africa**

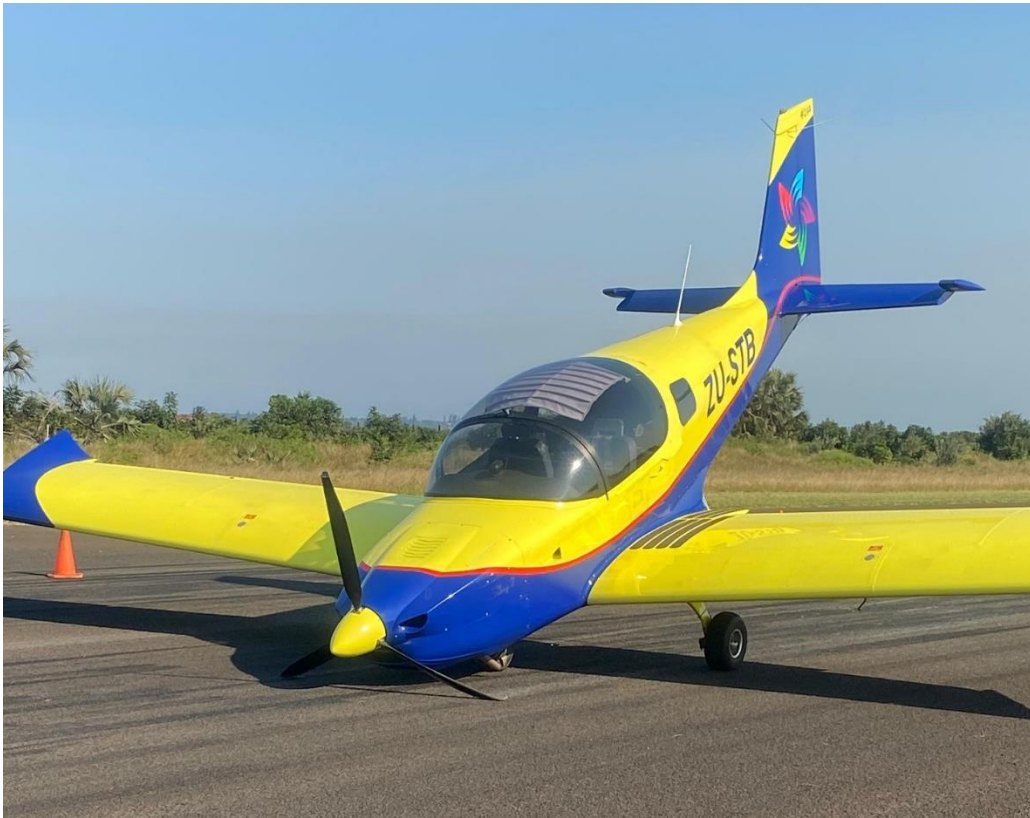
Figure 1: The aircraft on the runway after the accident. (Source: Owner)

Probable Cause(s)
It is likely that the student pilot flared too early and the aircraft porpoised and landed hard with the nose landing gear first.
Contributing Factor(s)
Failure to go-around after applying full power.
Safety Action(s)
None.
Safety Message and/or Safety Recommendation/s
None.
About this Report
<i>The decision to conduct a limited investigation is based on factors including whether the cause is known and the evidence supporting the cause is clear, the level of safety benefit likely to be obtained from an investigation and that will determine the scope of an investigation. For this occurrence, a limited investigation has been conducted, and the Accident and Incident Investigations Division (AIID) has relied on the information submitted by the affected person/s and organisation/s to compile this limited report. The report has been compiled using information supplied in the initial notification, as well as from follow-up desk top enquiries to bring awareness of potential safety issues to the industry in respect of this occurrence, as well as possible safety action/s that the industry might want to consider in preventing a recurrence of a similar occurrence.</i>

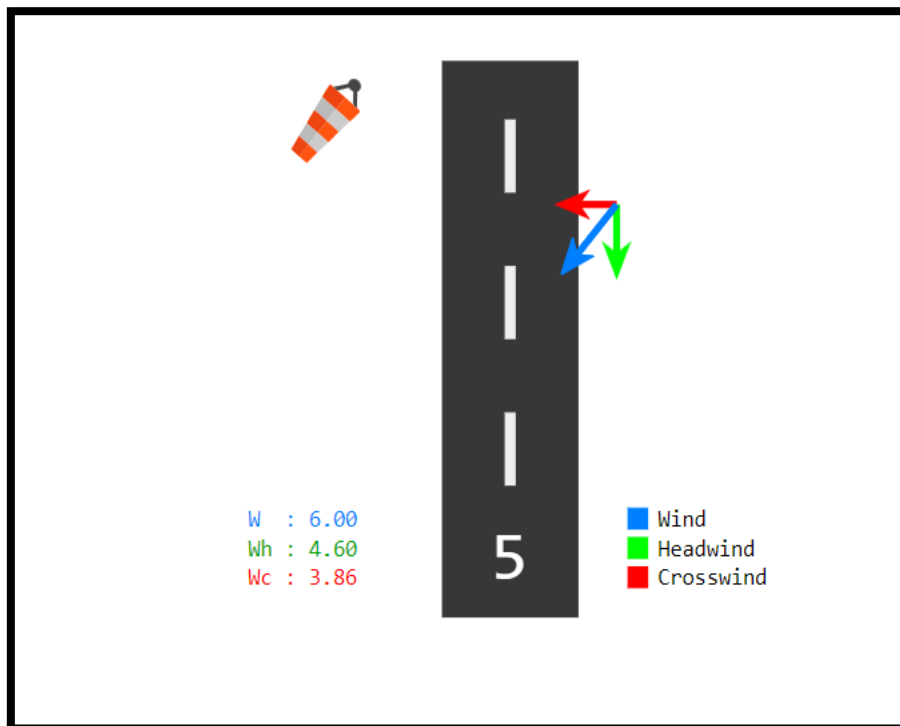
Figure 2: The crosswind was 3.86 knots on Runway 05. (Source: <https://e6bx.com/wind>)

2.6 The maximum demonstrated crosswind for the aircraft type is 15 kts (Figure 4); on the day of the accident, the reported crosswind was 3.86 kts.

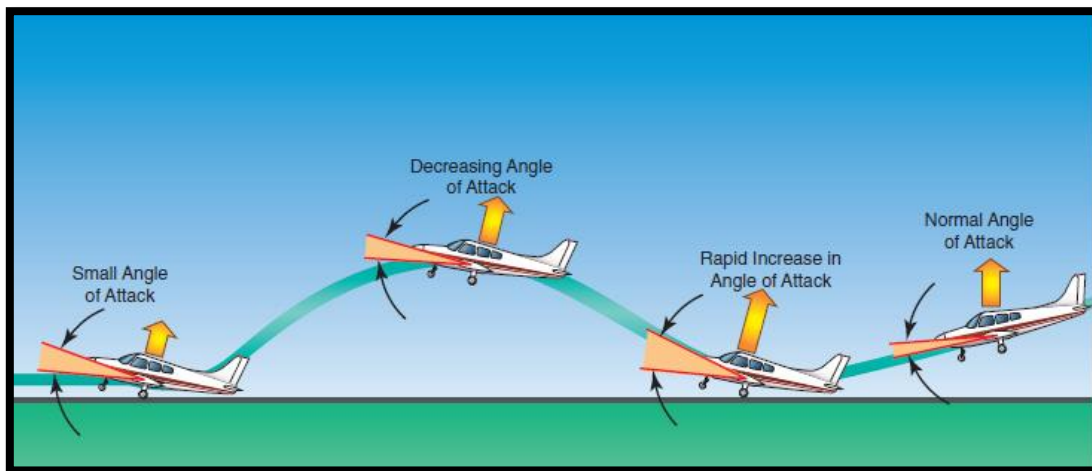
In a bounced landing that is improperly recovered, the airplane comes in nose first, setting off a series of motions that imitate the jumps and dives of a porpoise — hence the name (Figure 6). The problem is improper airplane attitude at touchdown, sometimes caused by inattention, not knowing where the ground is, mistiming or forcing the airplane onto the runway.

Figure 6: Illustration of porpoising during touchdown. (Source: FAA Airplane Flying Handbook)
