LIMITED OCCURRENCE INVESTIGATION REPORT – FINAL

| Reference Number | CA18/2/3/10490 | | | | | | |
| Registration | ZS-NSX | | | | | | |
| Make; Model; S/N | Piper Aircraft Corporation; PA-32RT-300T (Serial number: 32R-7987-300T) | | | | | | |

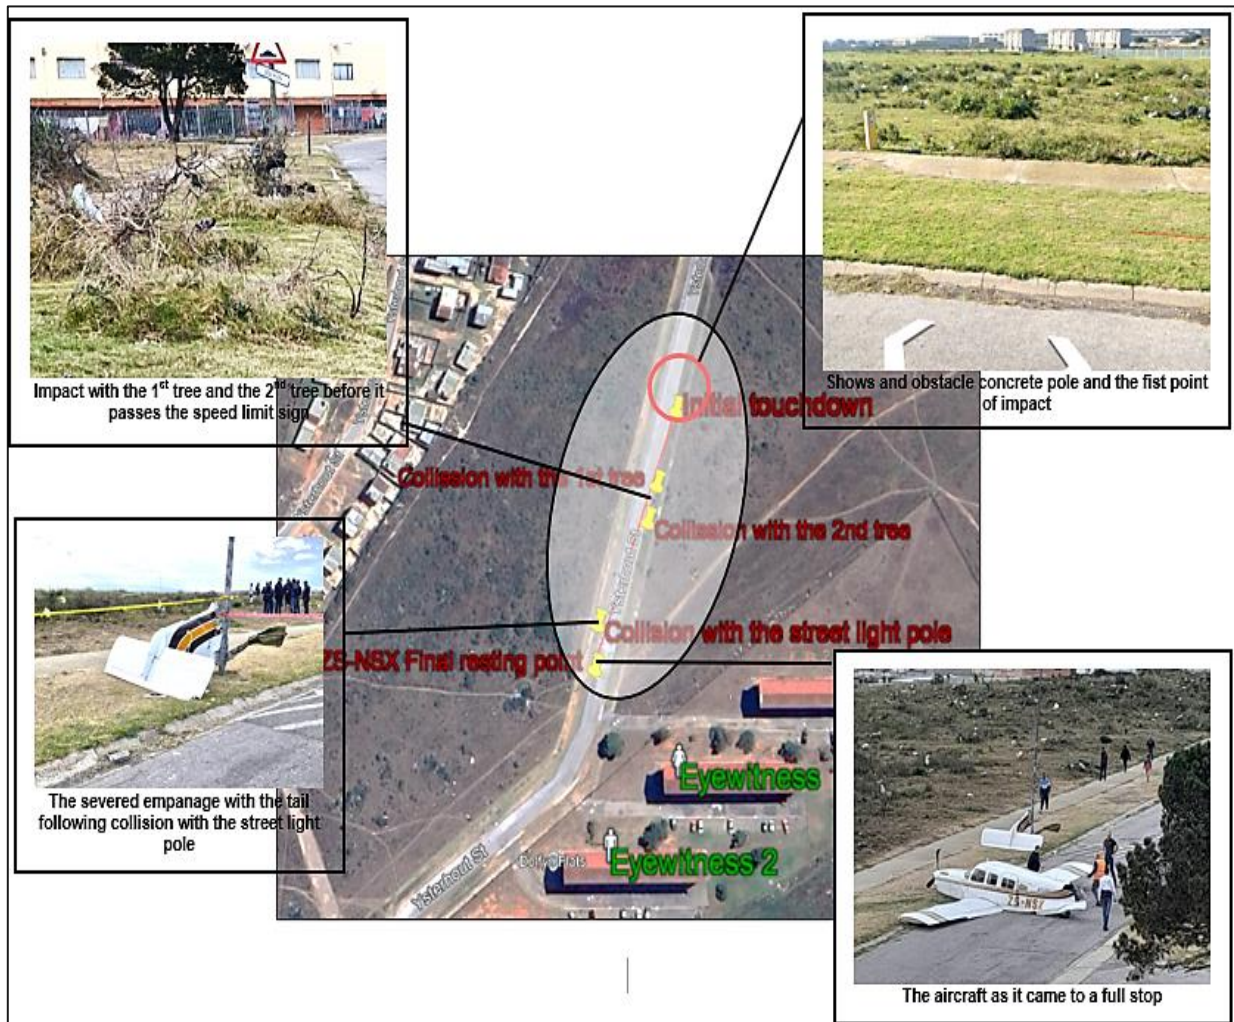
During approach, the pilot pitched the aircraft's nose down due to space limitation. The aircraft initially impacted the grass-covered ground on the left side of the road; it then skidded on its belly for approximately 115 metres (m). It struck a tree with its left wing (middle part of the leading edge) about 29m after touchdown and struck a second tree 15m further down the road with its left-wing tip which caused the aircraft to rotate 90° to the left. It skidded over a speed hump and impacted a steel streetlight pole approximately 40m after the second tree, which severed the empennage. The streetlight was damaged (see Figure 4). The aircraft ground-looped 180° to the right and came to rest 15m from the street pole. The pilot and the passengers disembarked from the aircraft unassisted; they were not injured.

Figure 1: The accident site with plotted sequence of events.

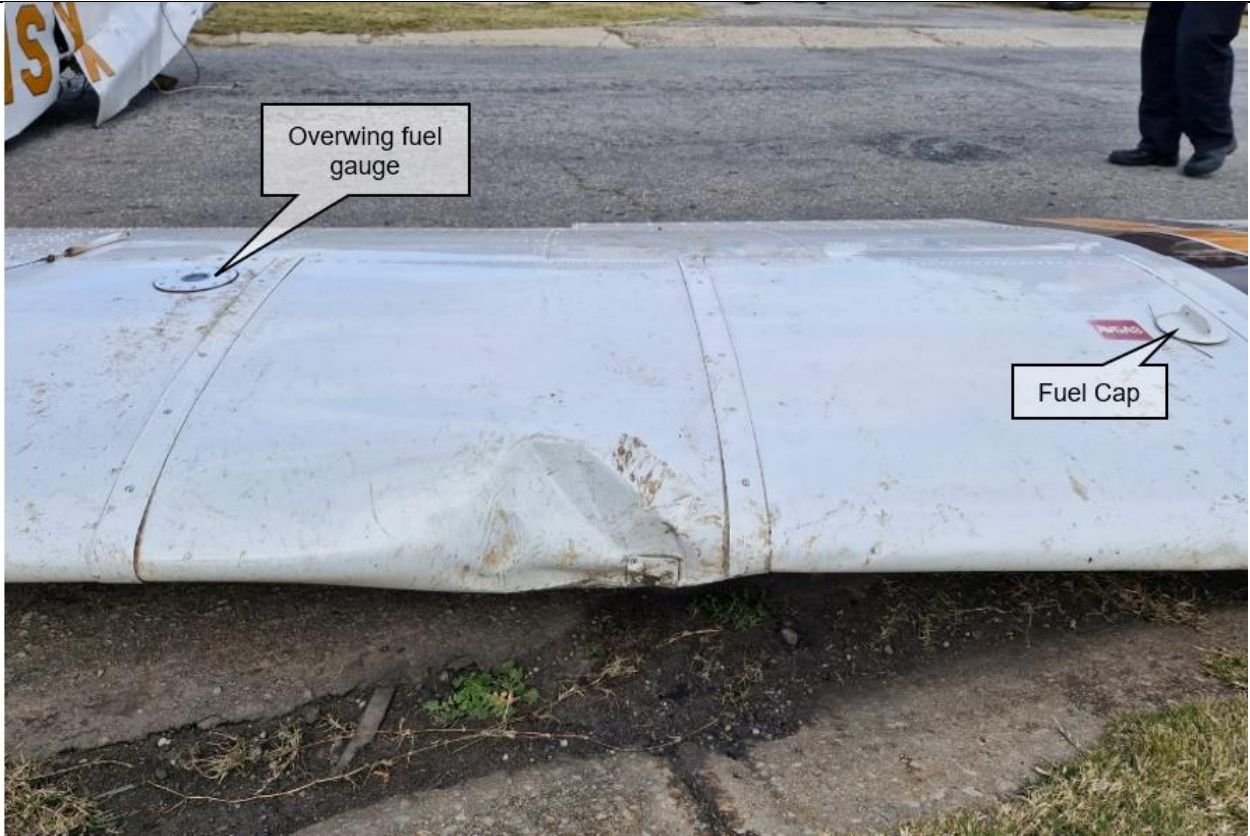
Figure 2: Damage from the initial impact with the first tree.

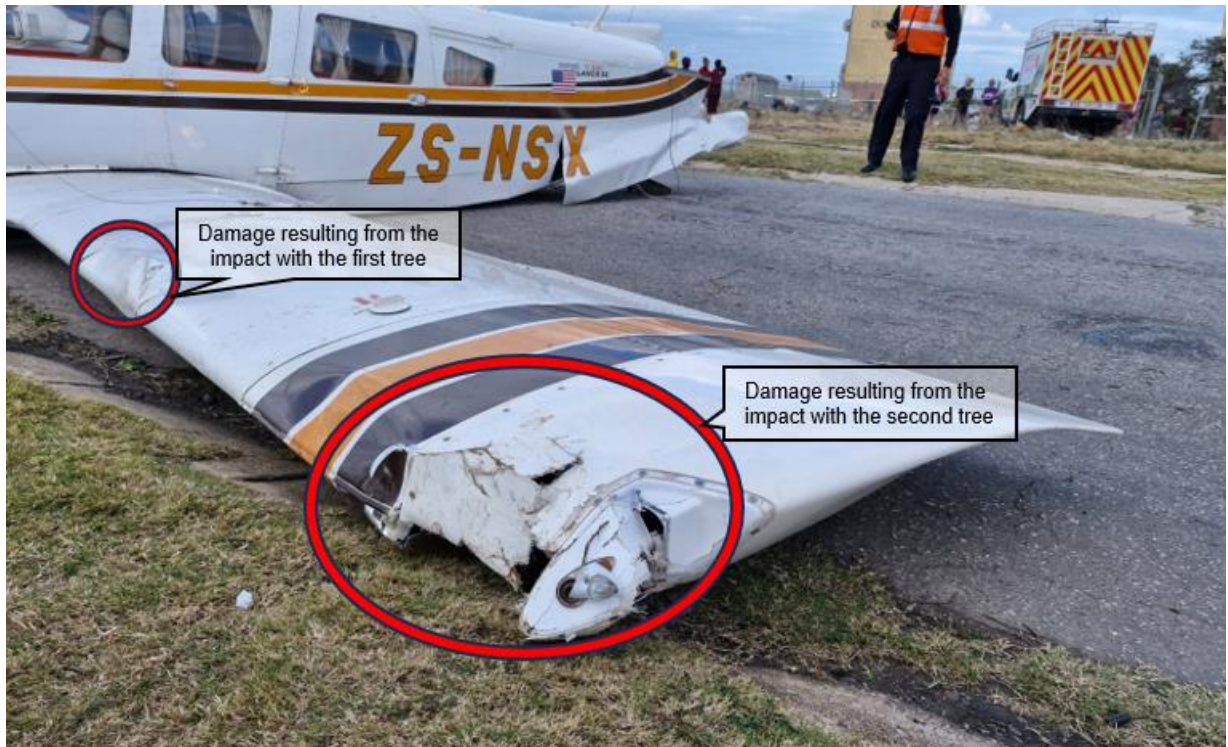
Figure 3: The damaged wing tip after the second impact with the tree.

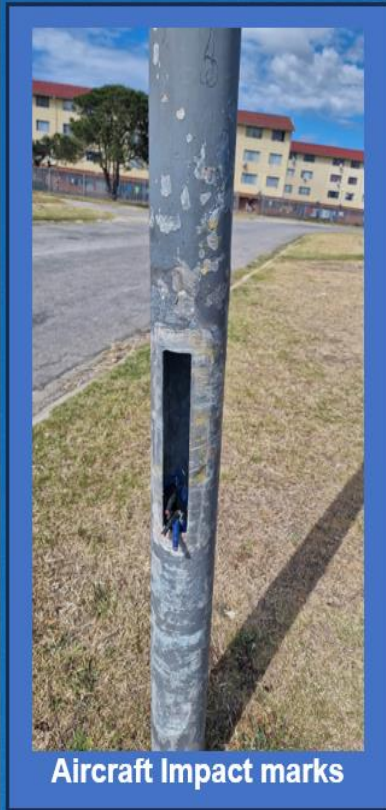
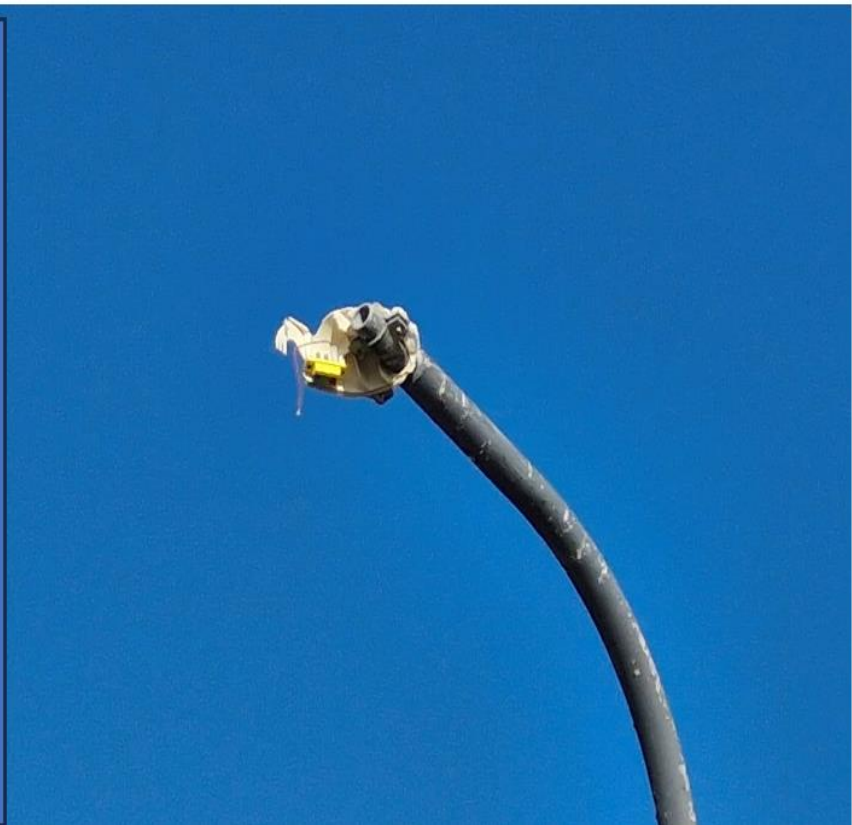
Figure 4: The damaged streetlamp.

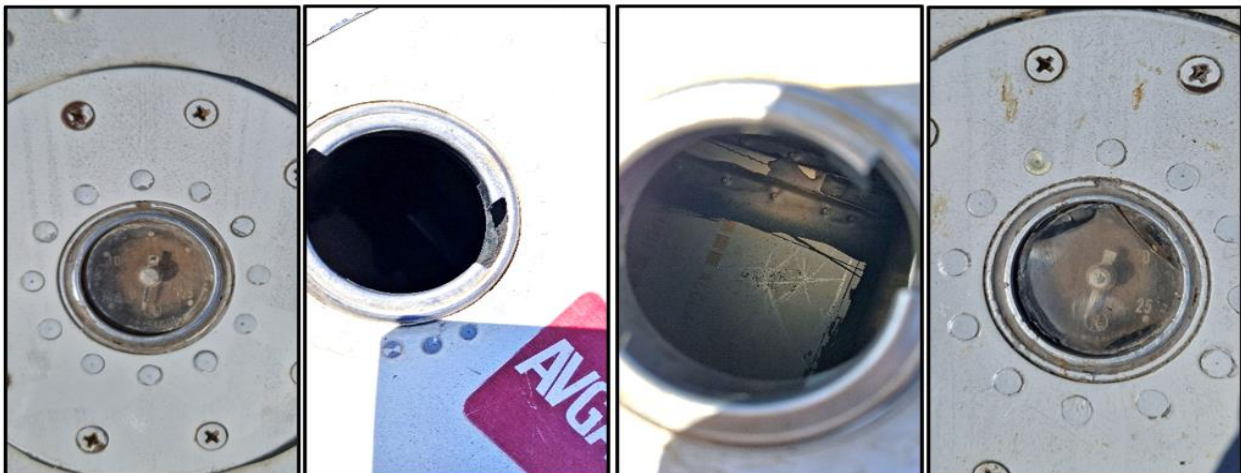
After the accident, the aircraft maintenance engineer (AME) inspected the aircraft on site. The inspection revealed that both fuel tanks were empty (see Figure 5). No fuel spillage was observed at the accident site.

Figure 5: The left and right fuel tanks were empty, and the gauges indicated zero.

| Findings |
|---|
| Fuel exhaustion caused the engine to stop in-flight, and the pilot executed an unsuccessful forced landing on a suburban road in a residential area. |

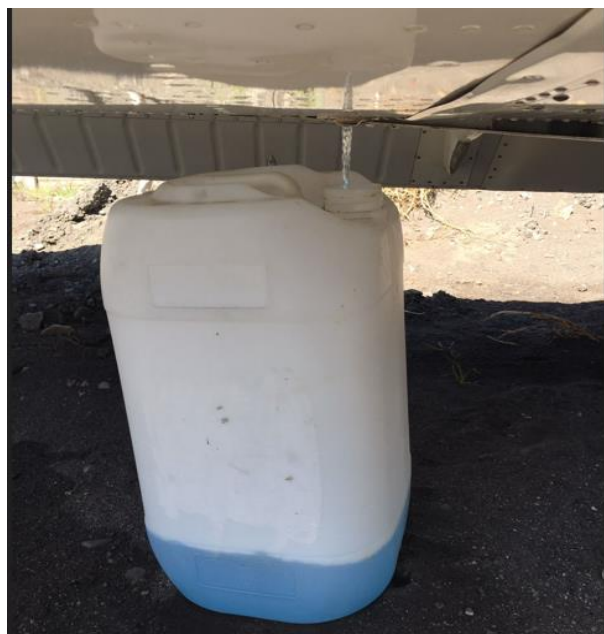
The pilot drained approximately 5 litres of fuel from the left tank into a 20-litre container; the amount of fuel remaining was less than the recommended unusable fuel of 15 litres.

Figure 6: Approximately 5 litres of fuel was drained from the left tank.
