AIRCRAFT ACCIDENT REPORT AND EXECUTIVE SUMMARY

Reference:		CA18/2/3/10491	
Aircraft Registration	ZS-MCR	Date of Accident		11 September 2024		Time of Accident	1155Z
Type of Aircraft	Piper 34-200T			Type of Operation		Training (Part 141)	
Pilot-in-command Licence Type		Airline Transport Pilot Licence		Age	44	Licence Valid	Yes
Pilot-in-command Flying Experience			Total Flying Hours		12472	Hours on Type	66.5
Last Point of Departure		Springs Aerodrome (FASI), Gauteng Province					
Next Point of Intended Landing		Brakpan Aerodrome (FABB), Gauteng Province					
Damage to Aircraft		Substantial					
Location of the accident site with reference to easily defined geographical points (GPS readings if possible)							
Brakpan Aerodrome (FABB) on the left side of RWY 36 at GPS co-ordinates: 26°14'06.51" South 028°17'57.07" East, at a field elevation of 5380 feet (ft)							
Meteorological Information		Surface wind: 320° at 13kts; visibility: 9999m; temperature: 21°C; dew point: 10°C; QNH: 1024

Reference Number : CA18/2/3/10491
Occurrence Category : Accident (Category 1)
Type of Operation : Training (Part 141)
Name of Operator : Airborne Aviation
Aircraft Registration : ZS-MCR
Aircraft Make and

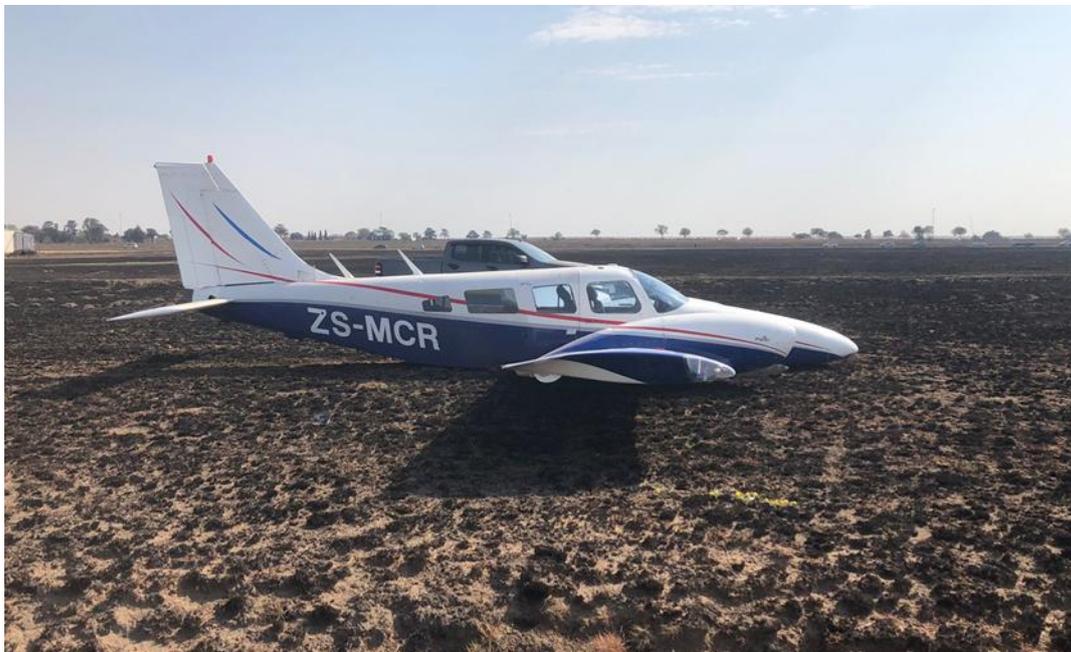
Figure 1: The aircraft after the accident. (Source: Operator)

1.3.1. The aircraft sustained damage to the underbelly and the right-side propeller, which broke off from the hub.

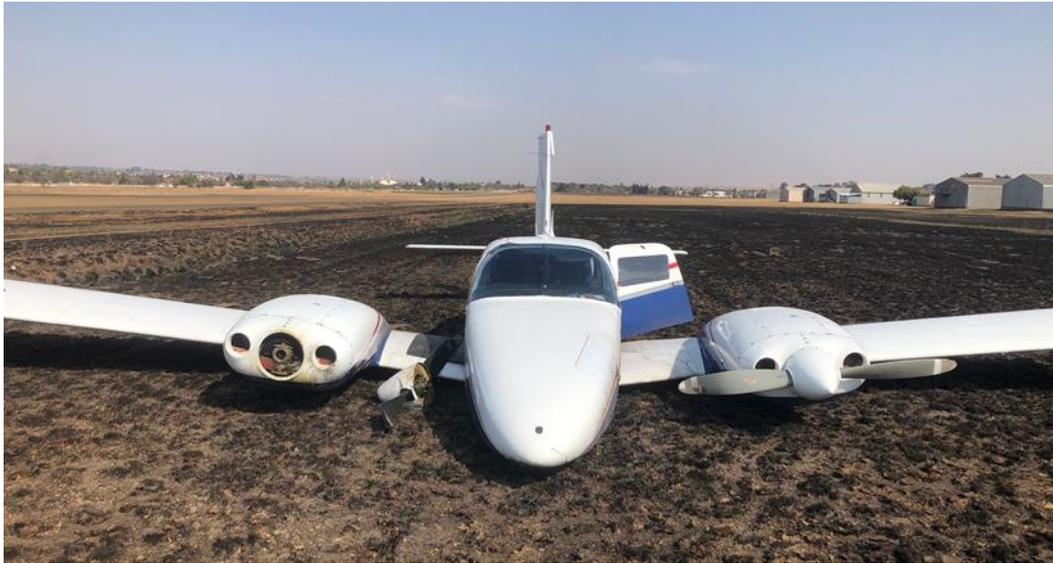
Figure 2: The right engine propeller separated from the flange during the accident sequence.
(Source: Operator)

1.12.2. The aircraft skidded for approximately 150m before it stopped. The right-side engine propeller separated from the flange, and the left-side propeller sustained damage to one of the blades. The aircraft was lifted and placed on supporting jacks and inspected; the undercarriage was undamaged, the aircraft had minor scratches to the underbelly.

1.16.1. The investigating team was contacted by the insurance-approved aircraft maintenance organisation (AMO) about collecting the engines and logbooks. The logbooks were handed over to the AMO, and the aircraft was repositioned to the AMO hangars. A teardown inspection was completed without any definitive results to the cause of failure. The AMO further indicated that the crankshaft of the right-side engine was broken due to the accident.

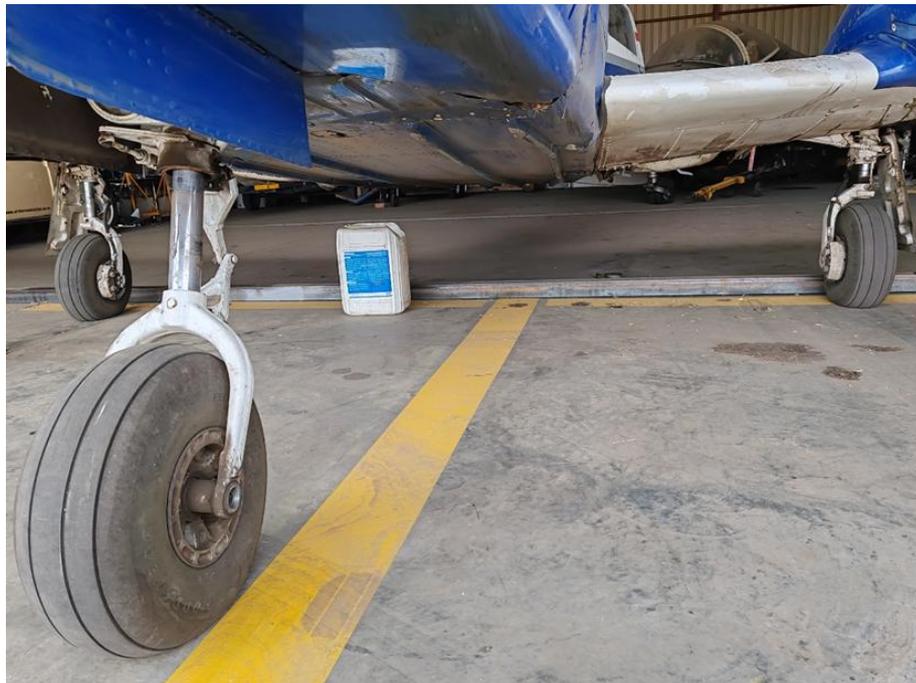
Figure 3: Scrape marks on the underbelly.
