LIMITED OCCURRENCE INVESTIGATION REPORT – FINAL

Reference Number	CA18/2/3/10492						
Classification	Accident	Date	14 September 2024	Time	1035Z		
Type of Operation	Private (Part 94)						
Location							
Place of Departure	Petit Aerodrome (FARA), Gauteng Province		Place of Intended Landing	Zandspruit Aerodrome, Limpopo Province			
Place of Occurrence	To the left of Runway 35 at Zandspruit Aerodrome						
GPS Co-ordinates	Latitude	24°22'15.32" S	Longitude	030°55'33.13" E	Elevation	1 617 feet	
Aircraft Information							
Registration	ZU-IJC						
Make; Model; S/N	Kitplanes for Africa; Bushbaby (Serial Number: 32)						
Damage to Aircraft	Substantial			Total Aircraft Hours	403.4		
Pilot-in-command							
Licence Type	National Pilot Licence (NPL)		Gender	Male		Age	40
Licence Valid	Yes	Total Hours	82.2		Total Hours on Type	28.7	
Total Hours Past 30 Days	2.3		Total Hours on Type Past 90 Days	2.3			
People On-board	1 + 1	Injuries	0	Fatalities	0	Other (on ground)	0

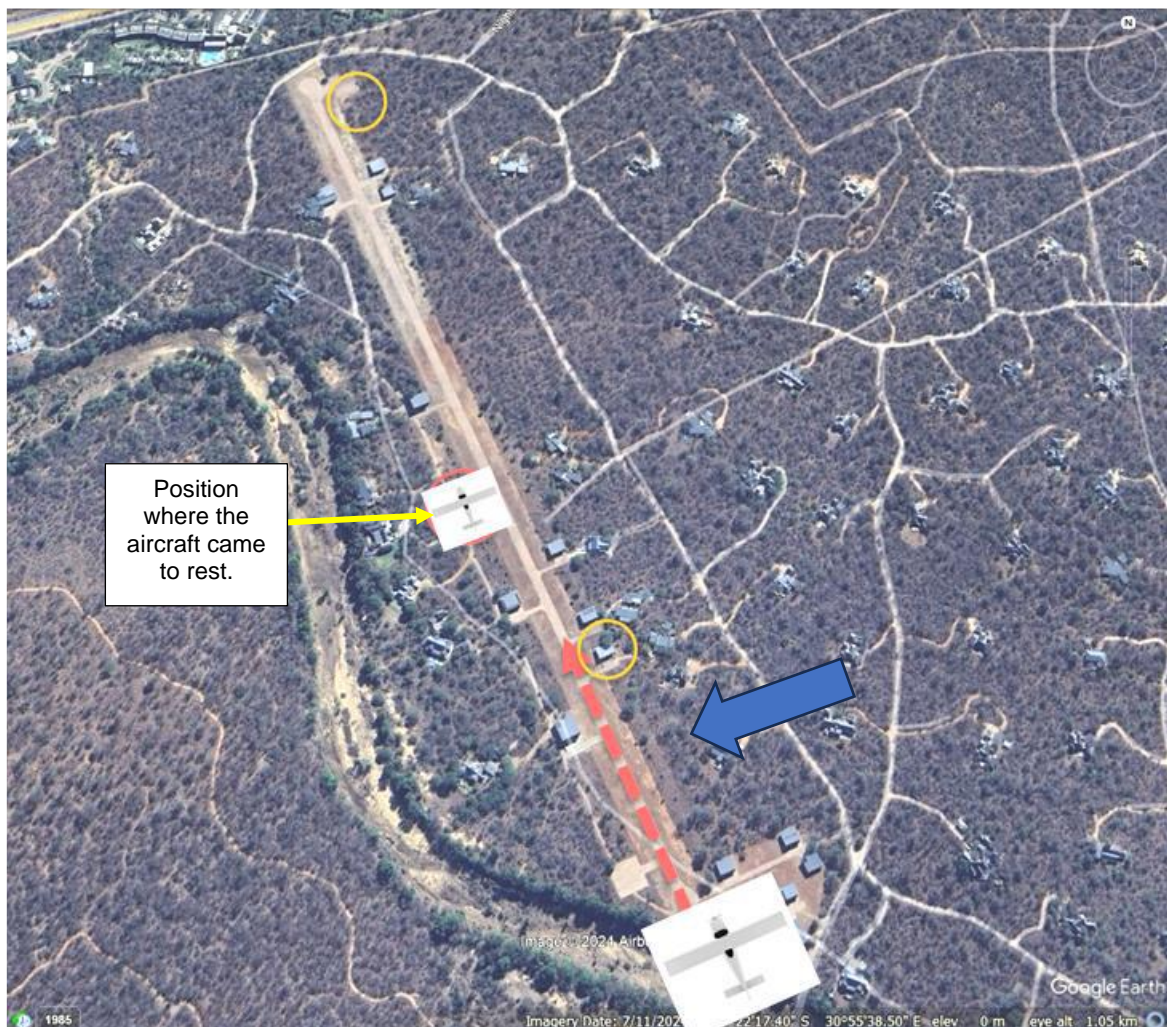
Figure 1: Windssocks in yellow circles. The blue arrow depicts a gust of wind from the east.
(Source: Google Earth)

- 3.1 The prevailing wind was from the east when the pilot joined overhead Zandspruit Aerodrome and opted to land on Runway 35. The temperature was 40°C, which contributed to thermal turbulent conditions that could render a stable approach problematic.

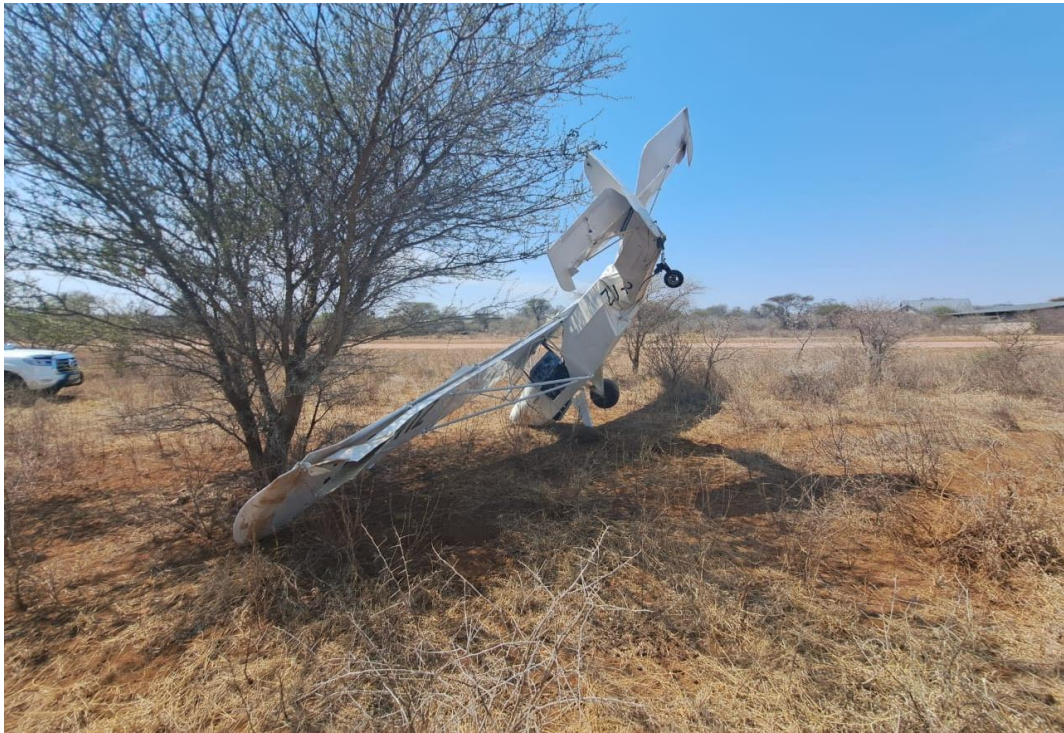
(whilst trying to avoid impacting the hangar). The aircraft careered into the bush terrain and came to rest in a nose-down attitude next to a tree. The aircraft sustained substantial structural damage. No person was injured. A video footage of the approach and the accident sequence was obtained from a closed-circuit television (CCTV) camera mounted on a hangar and facing south. *The camera was at a distance from where the accident occurred and, therefore, no screenshots of the video footage could be used in this report.* The description of the occurrence is in line with the footage.

Figure 2: The aircraft as it came to rest next to the runway. (Source: Pilot)

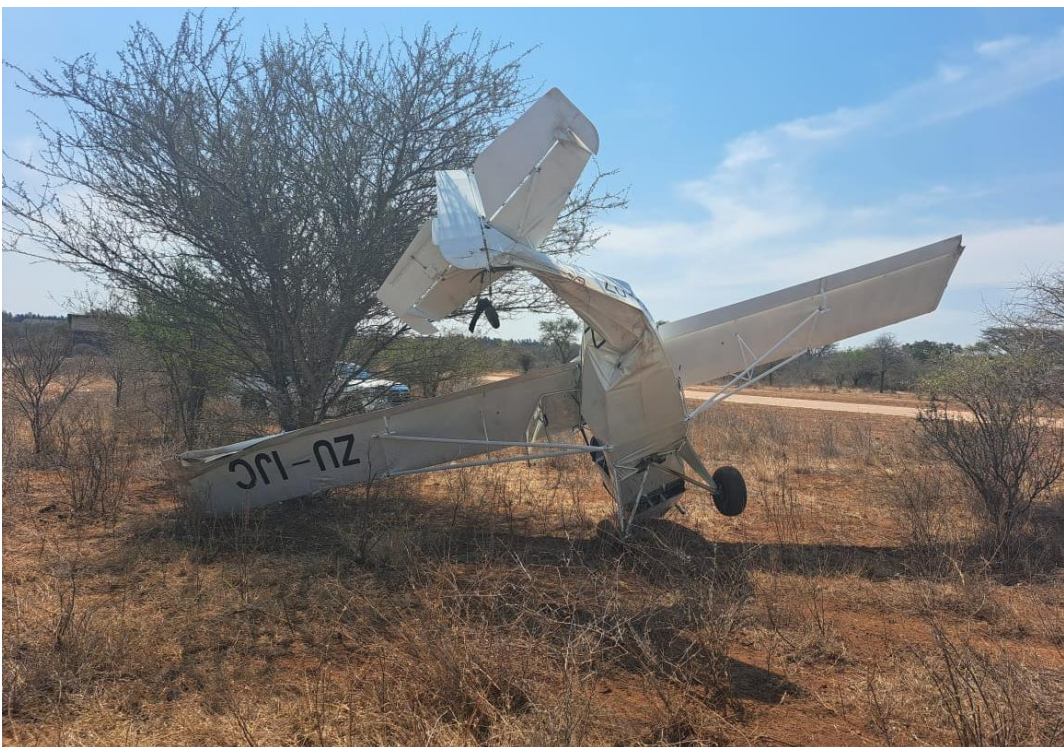
Figure 3: The aft view of the aircraft. (Source: Pilot)

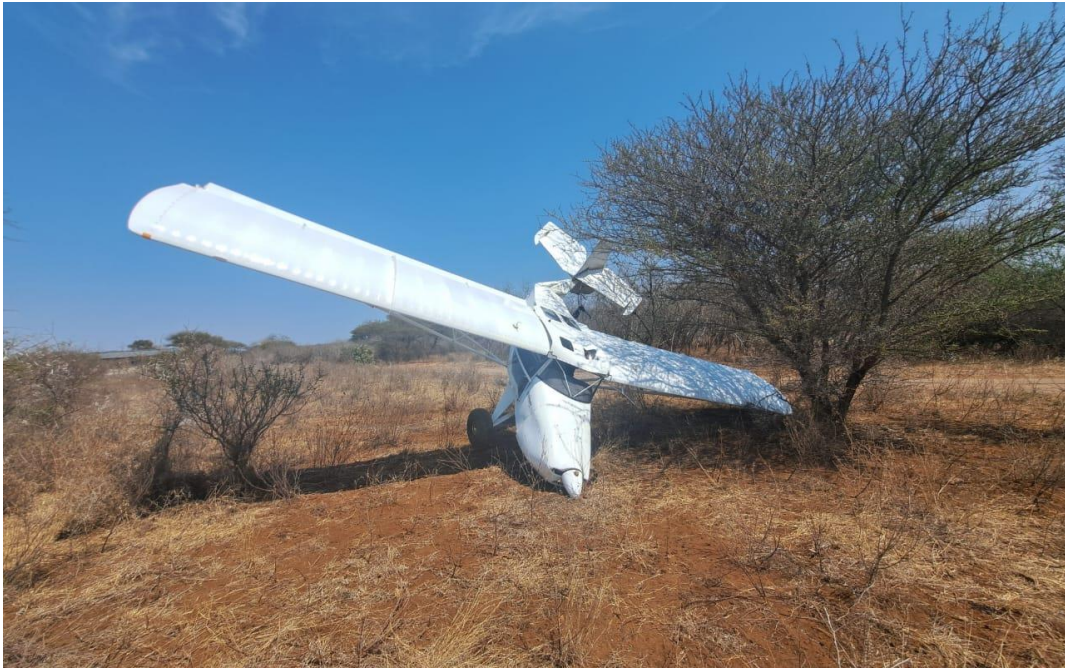
Figure 4: The front view of the aircraft. (Source: Pilot)

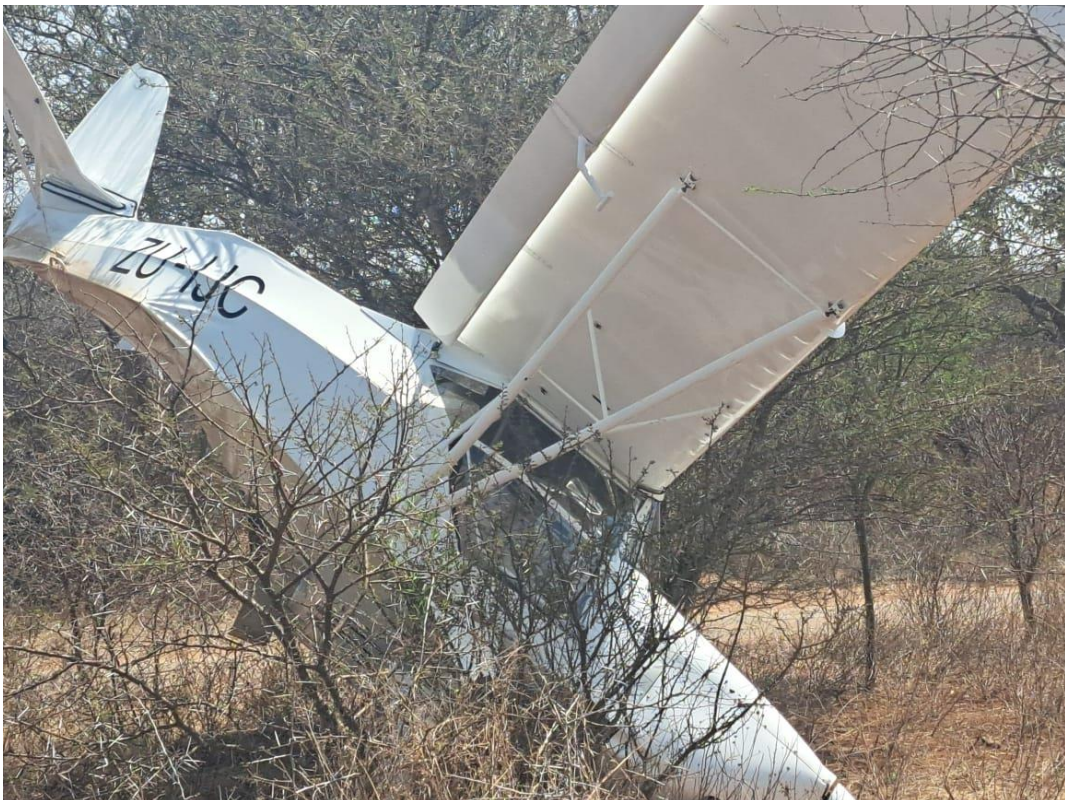
Figure 5: The side view of the aircraft. (Source: Pilot)

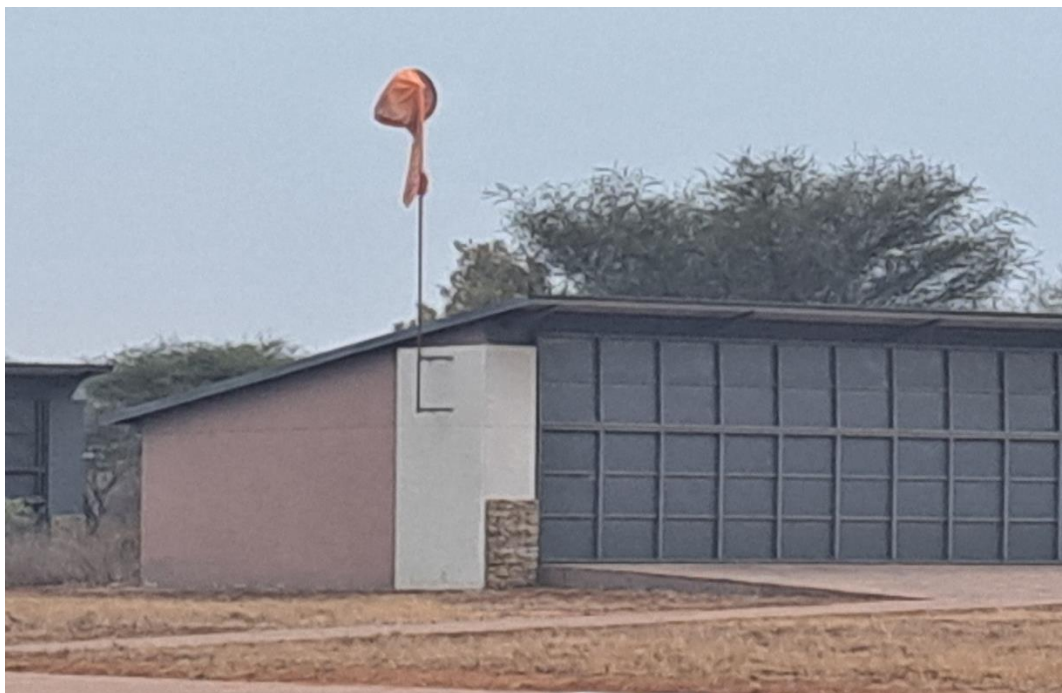
Figure 6: The tangled-up windssock. (Source: Pilot)

Contributing Factor
The pilot was unable to obtain an accurate wind indication based on the windsock on the southern side of the aerodrome (near the threshold of Runway 35) as it was tangled up.
Safety Action(s)
None.
Safety Message and/or Safety Recommendation/s
It is recommended that the Zandspruit Bush and Aero Estate Homeowners' Association (HOA) service the windsocks regularly to avoid a similar situation in which a windsock is tangled up. The windsocks provide essential information to pilots when planning their approach and landing phases for either Runway 17 or 35.
About this Report
<i>The decision to conduct a limited investigation is based on factors including whether the cause is known and the evidence supporting the cause is clear, the level of safety benefit likely to be obtained from an investigation, and that will determine the scope of an investigation. For this occurrence, a limited investigation has been conducted, and the Accident and Incident Investigations Division (AIID) has relied on the information submitted by the affected person/s and organisation/s to compile this limited report. The report has been compiled using information supplied in the initial notification, as well as from follow-up desktop inquiries to bring awareness of potential safety issues to the industry in respect of this occurrence, as well as possible safety action/s that the industry might want to consider in preventing a recurrence of a similar occurrence.</i>
