**LIMITED OCCURRENCE INVESTIGATION REPORT – FINAL**

| <b>Reference Number</b> | CA18/2/3/10494 | | | | | | |
| Registration | ZU-FBG | | | | | | |
| Make; Model; S/N | B & F Technik Polaris; FK14 B2 (Serial Number: B2-081) | | | | | | |

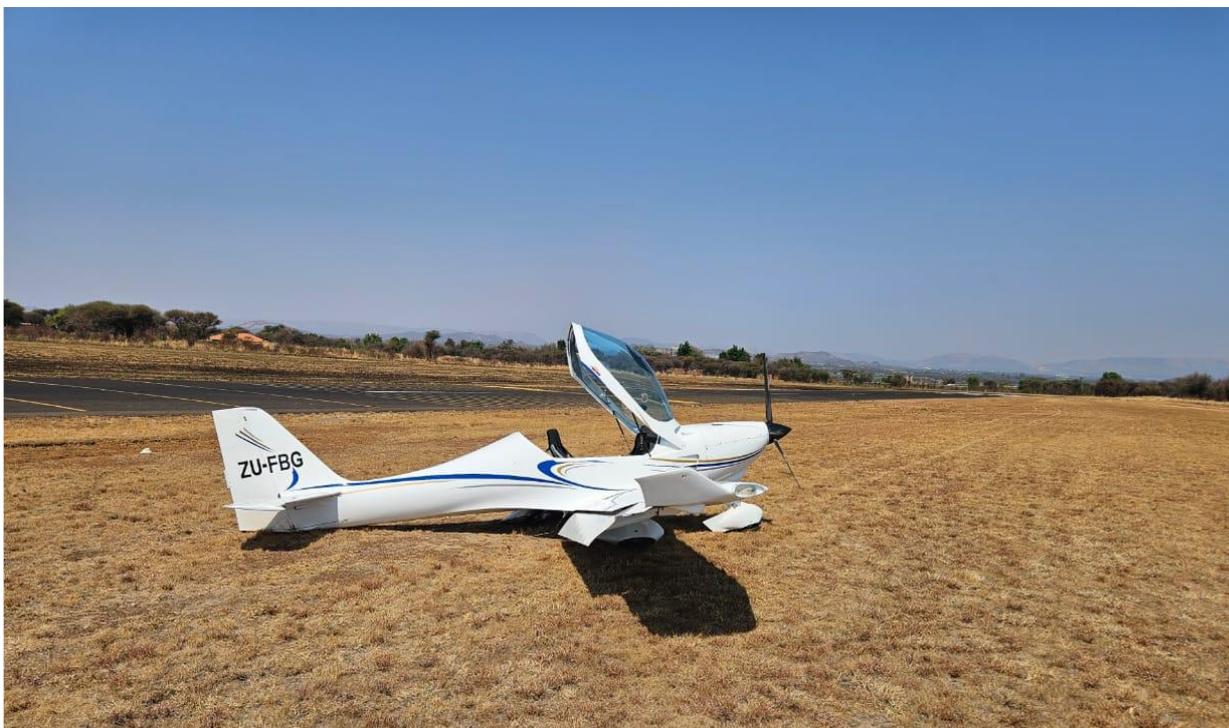
The two occupants were not injured during the accident sequence. The aircraft sustained substantial damage to the fixed main landing gear struts and the bottom of the fuselage.

**Figure 2:** The aircraft after the accident. (Source: Pilot)

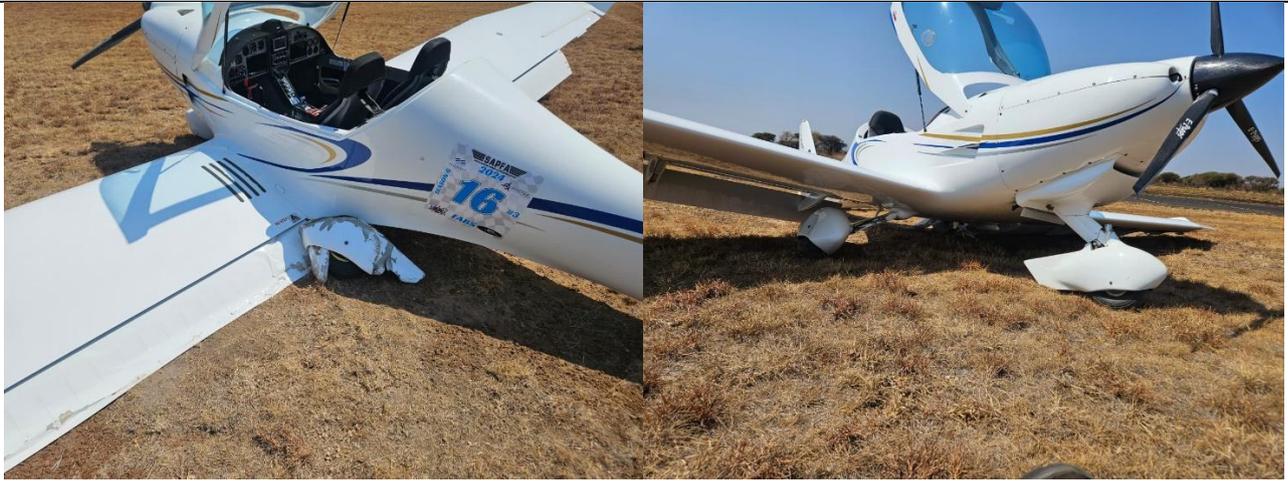
**Figures 3 and 4:** Damage to the aircraft. (Source: Pilot)

It is probable that the aircraft experienced wind shear on final approach, followed by a hard landing that led to the subsequent collapse of the main landing gear during the landing roll.
